Report on  
Geotechnical Investigation

Proposed Residential Subdivision  
32 Lovelle Street and 141 Yarrowa Road,  
Moss Vale

Prepared for  
Prime Moss Vale Pty Ltd

Project 40494.03  
April 2020

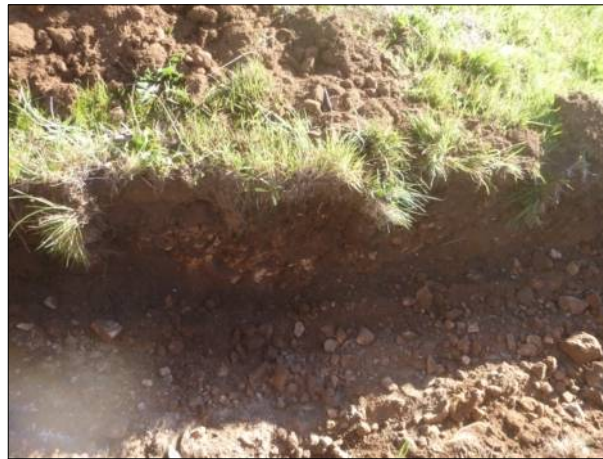
Pit 2 excavation.

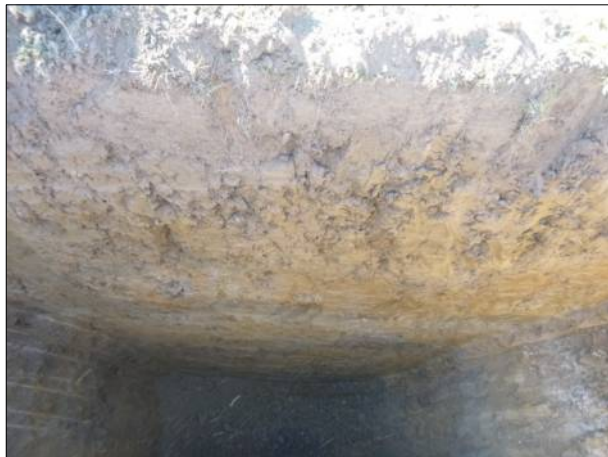
Pit 3 excavation.

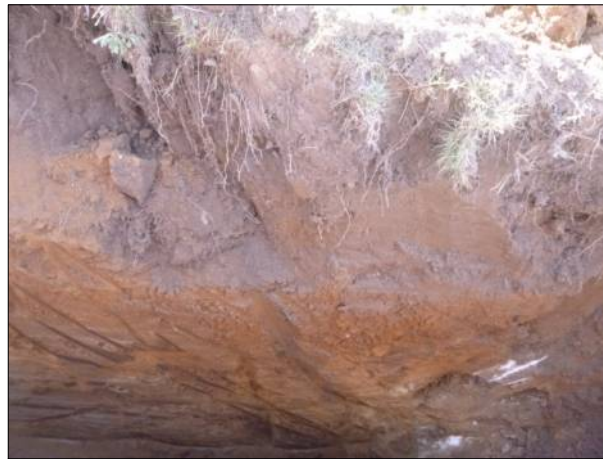
Pit 4 excavation.

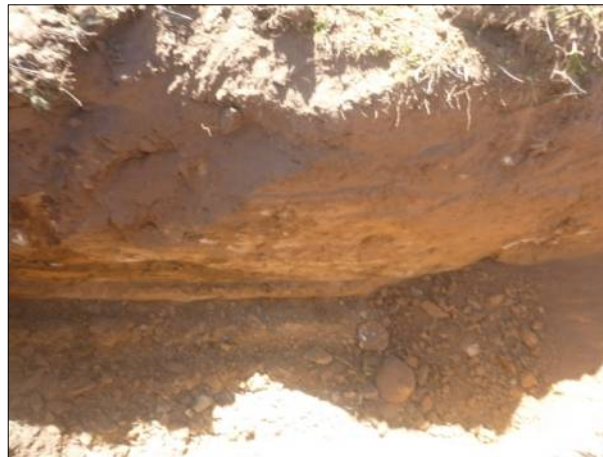
Pit 5 excavation.

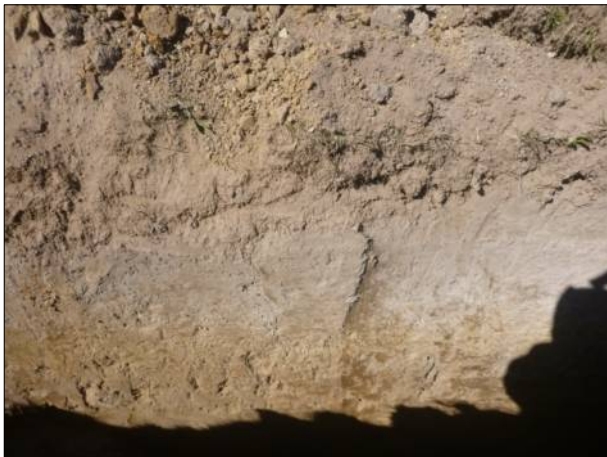
**Pit 6 excavation.**

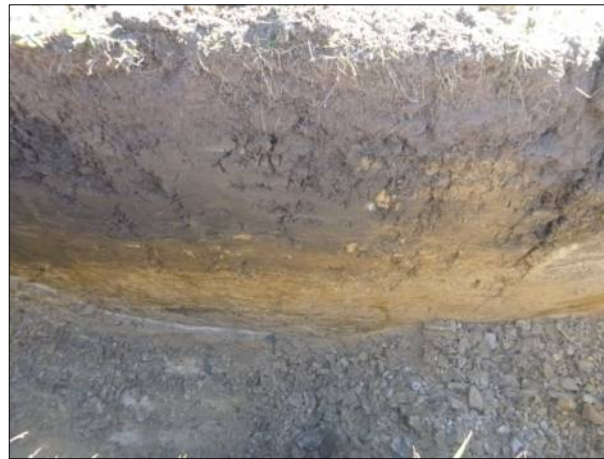
Pit 7 excavation.

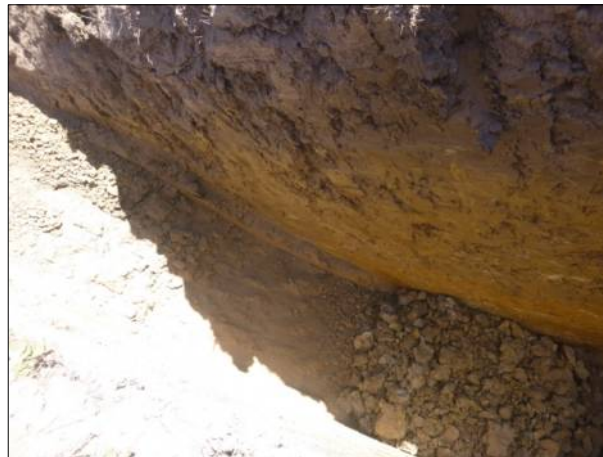
Pit 8 excavation.

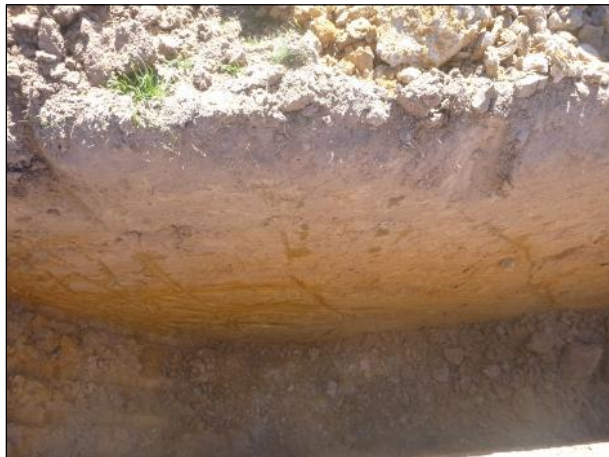
**Pit 22 excavation.**
