Structural Condition Report

**Allambie Cottages, 1256 Bells Line
of Road, Kurrajong NSW**

Transport for NSW / 28 February 2024

232063

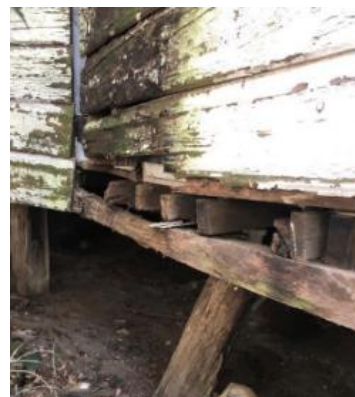
Figure 44 – Southern wall of northern cottage, 2021 (Dunnings Consulting Engineers, 2021)
