Residential Subdivision of No. 105 Cooby Road, Tullimbar NSW

Report on Preliminary Geotechnical Assessment

Our Ref: TERRA18320.Rep1.Rev1

15 August 2019

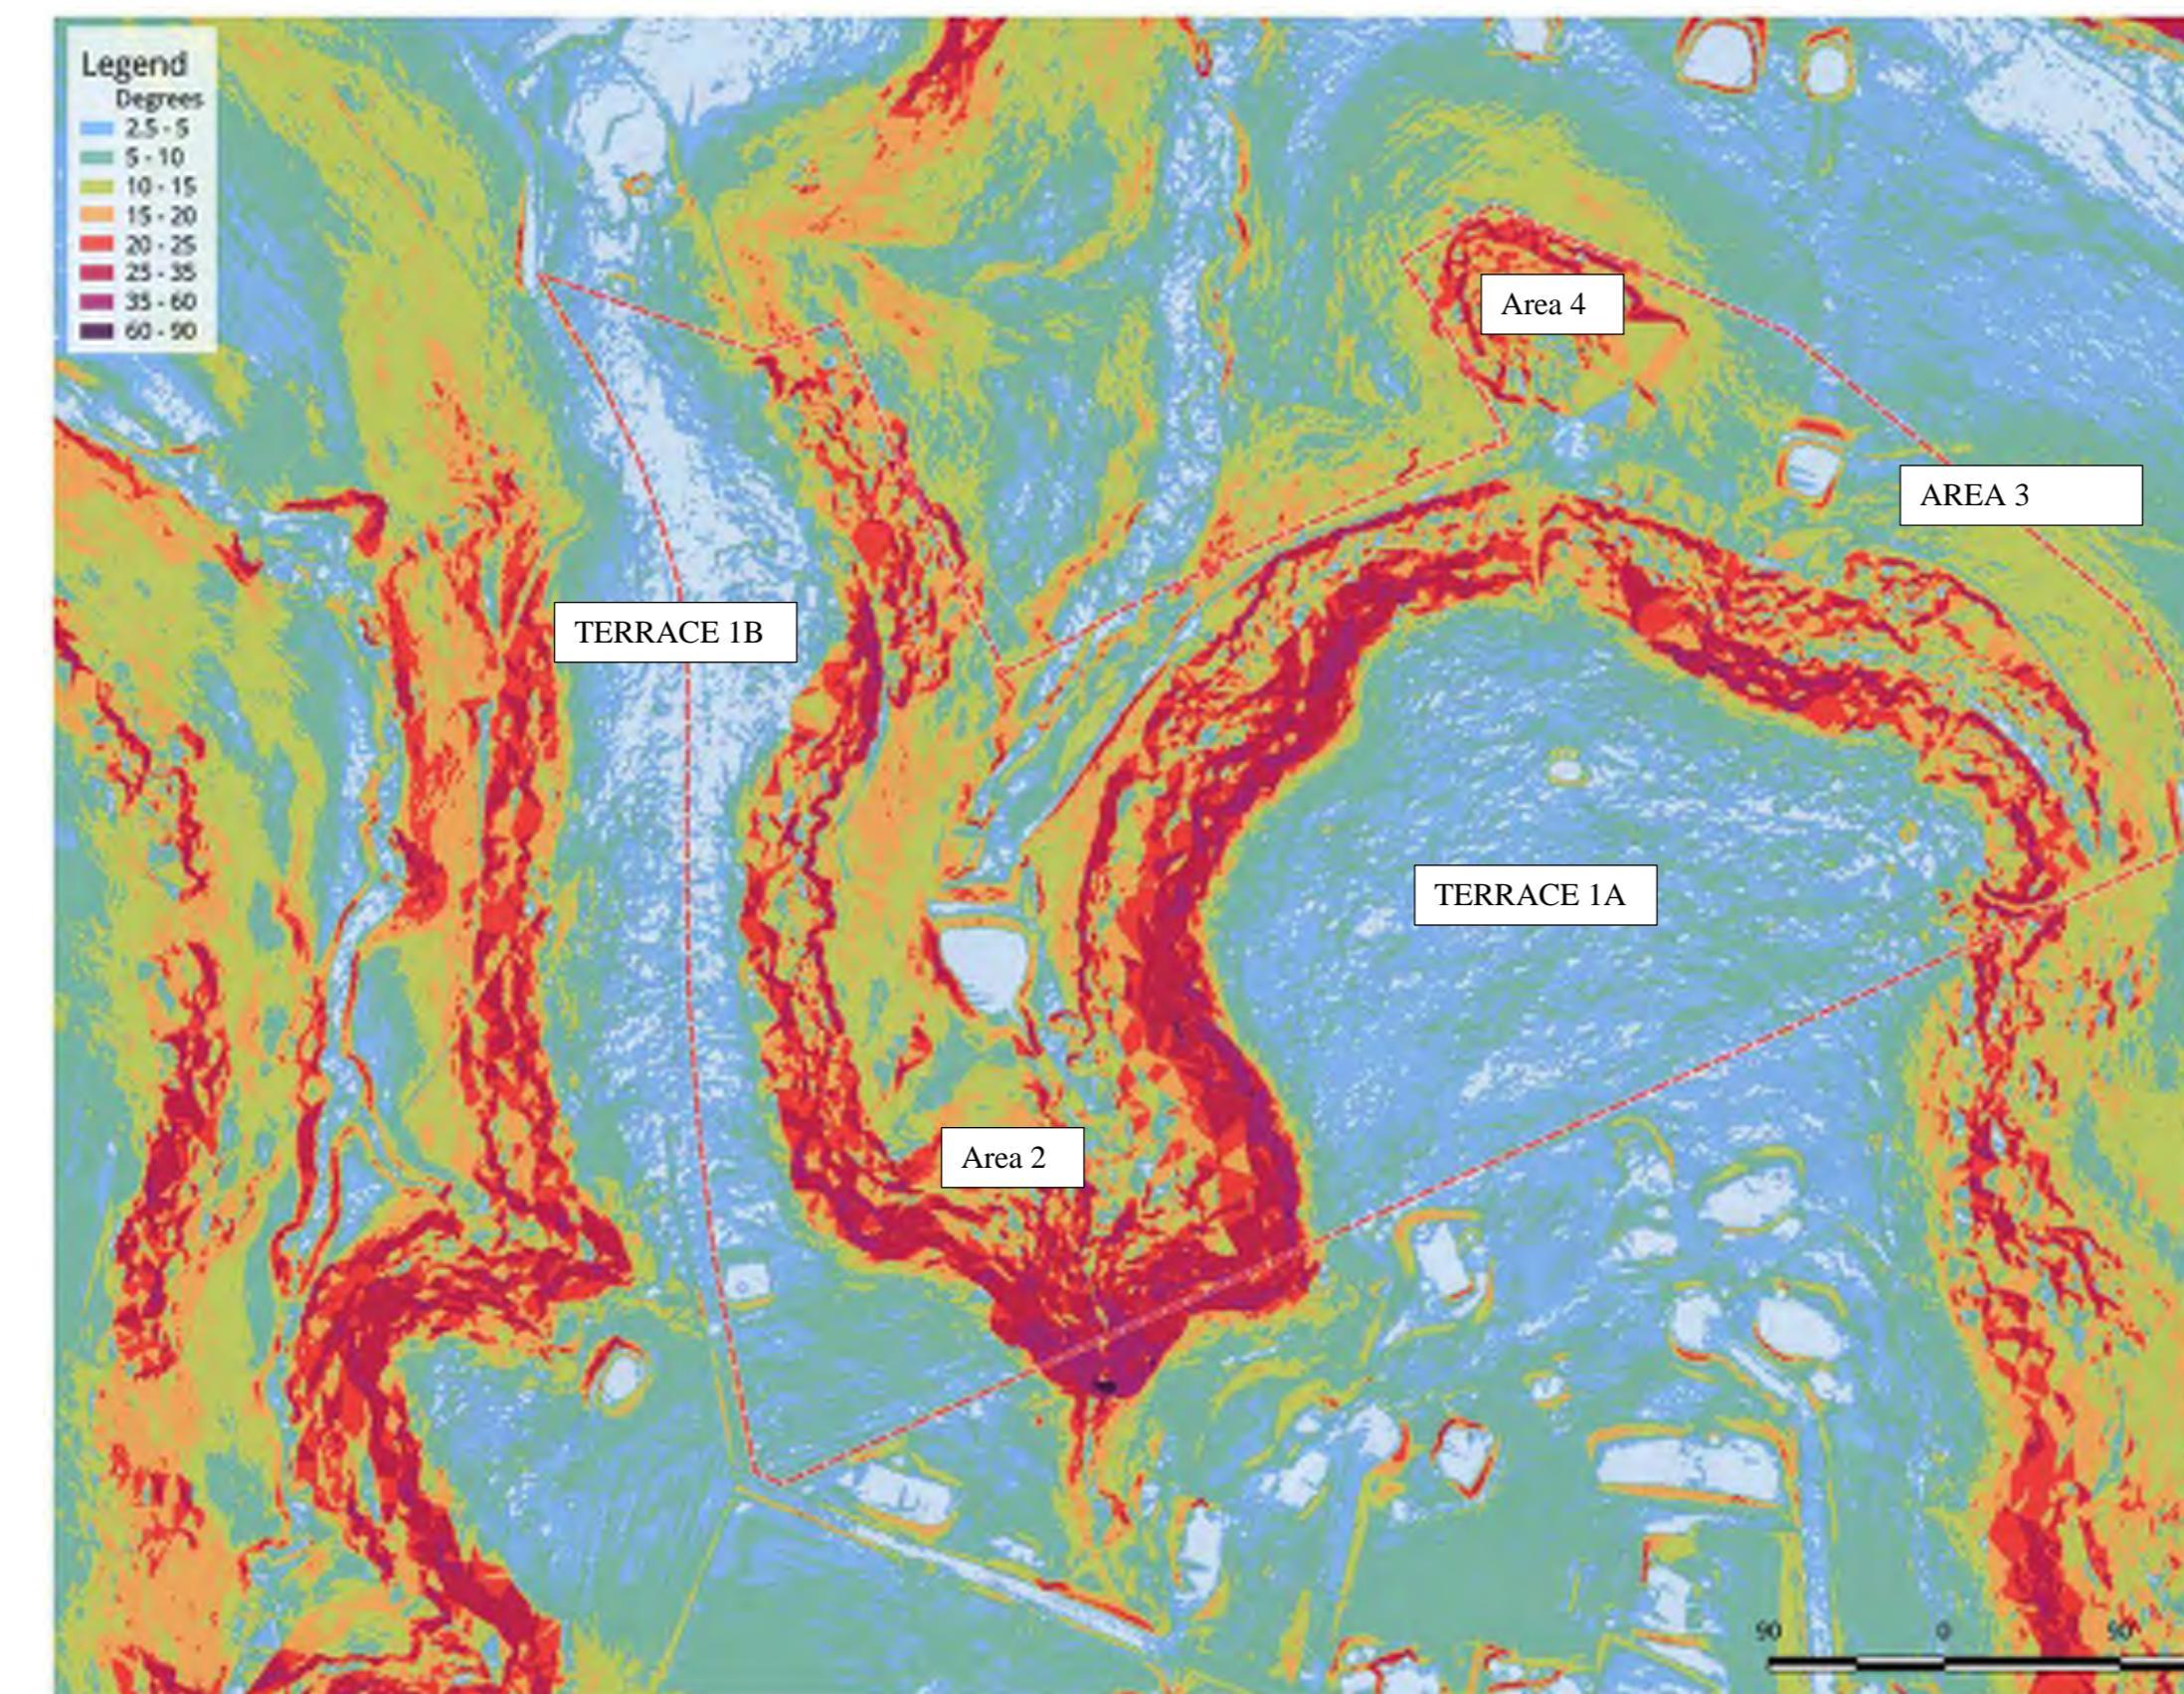
7 180 270	3000
client: Inde	sco
project: Geotechnical Investigation	for Proposed Subdivision
No. 105 Cooby Roa title: Slope Heat	
project no: TERRA18320	figure no: FIGURE 9

Slope heat mapping for the site is shown on Figure 9. This mapping shows:

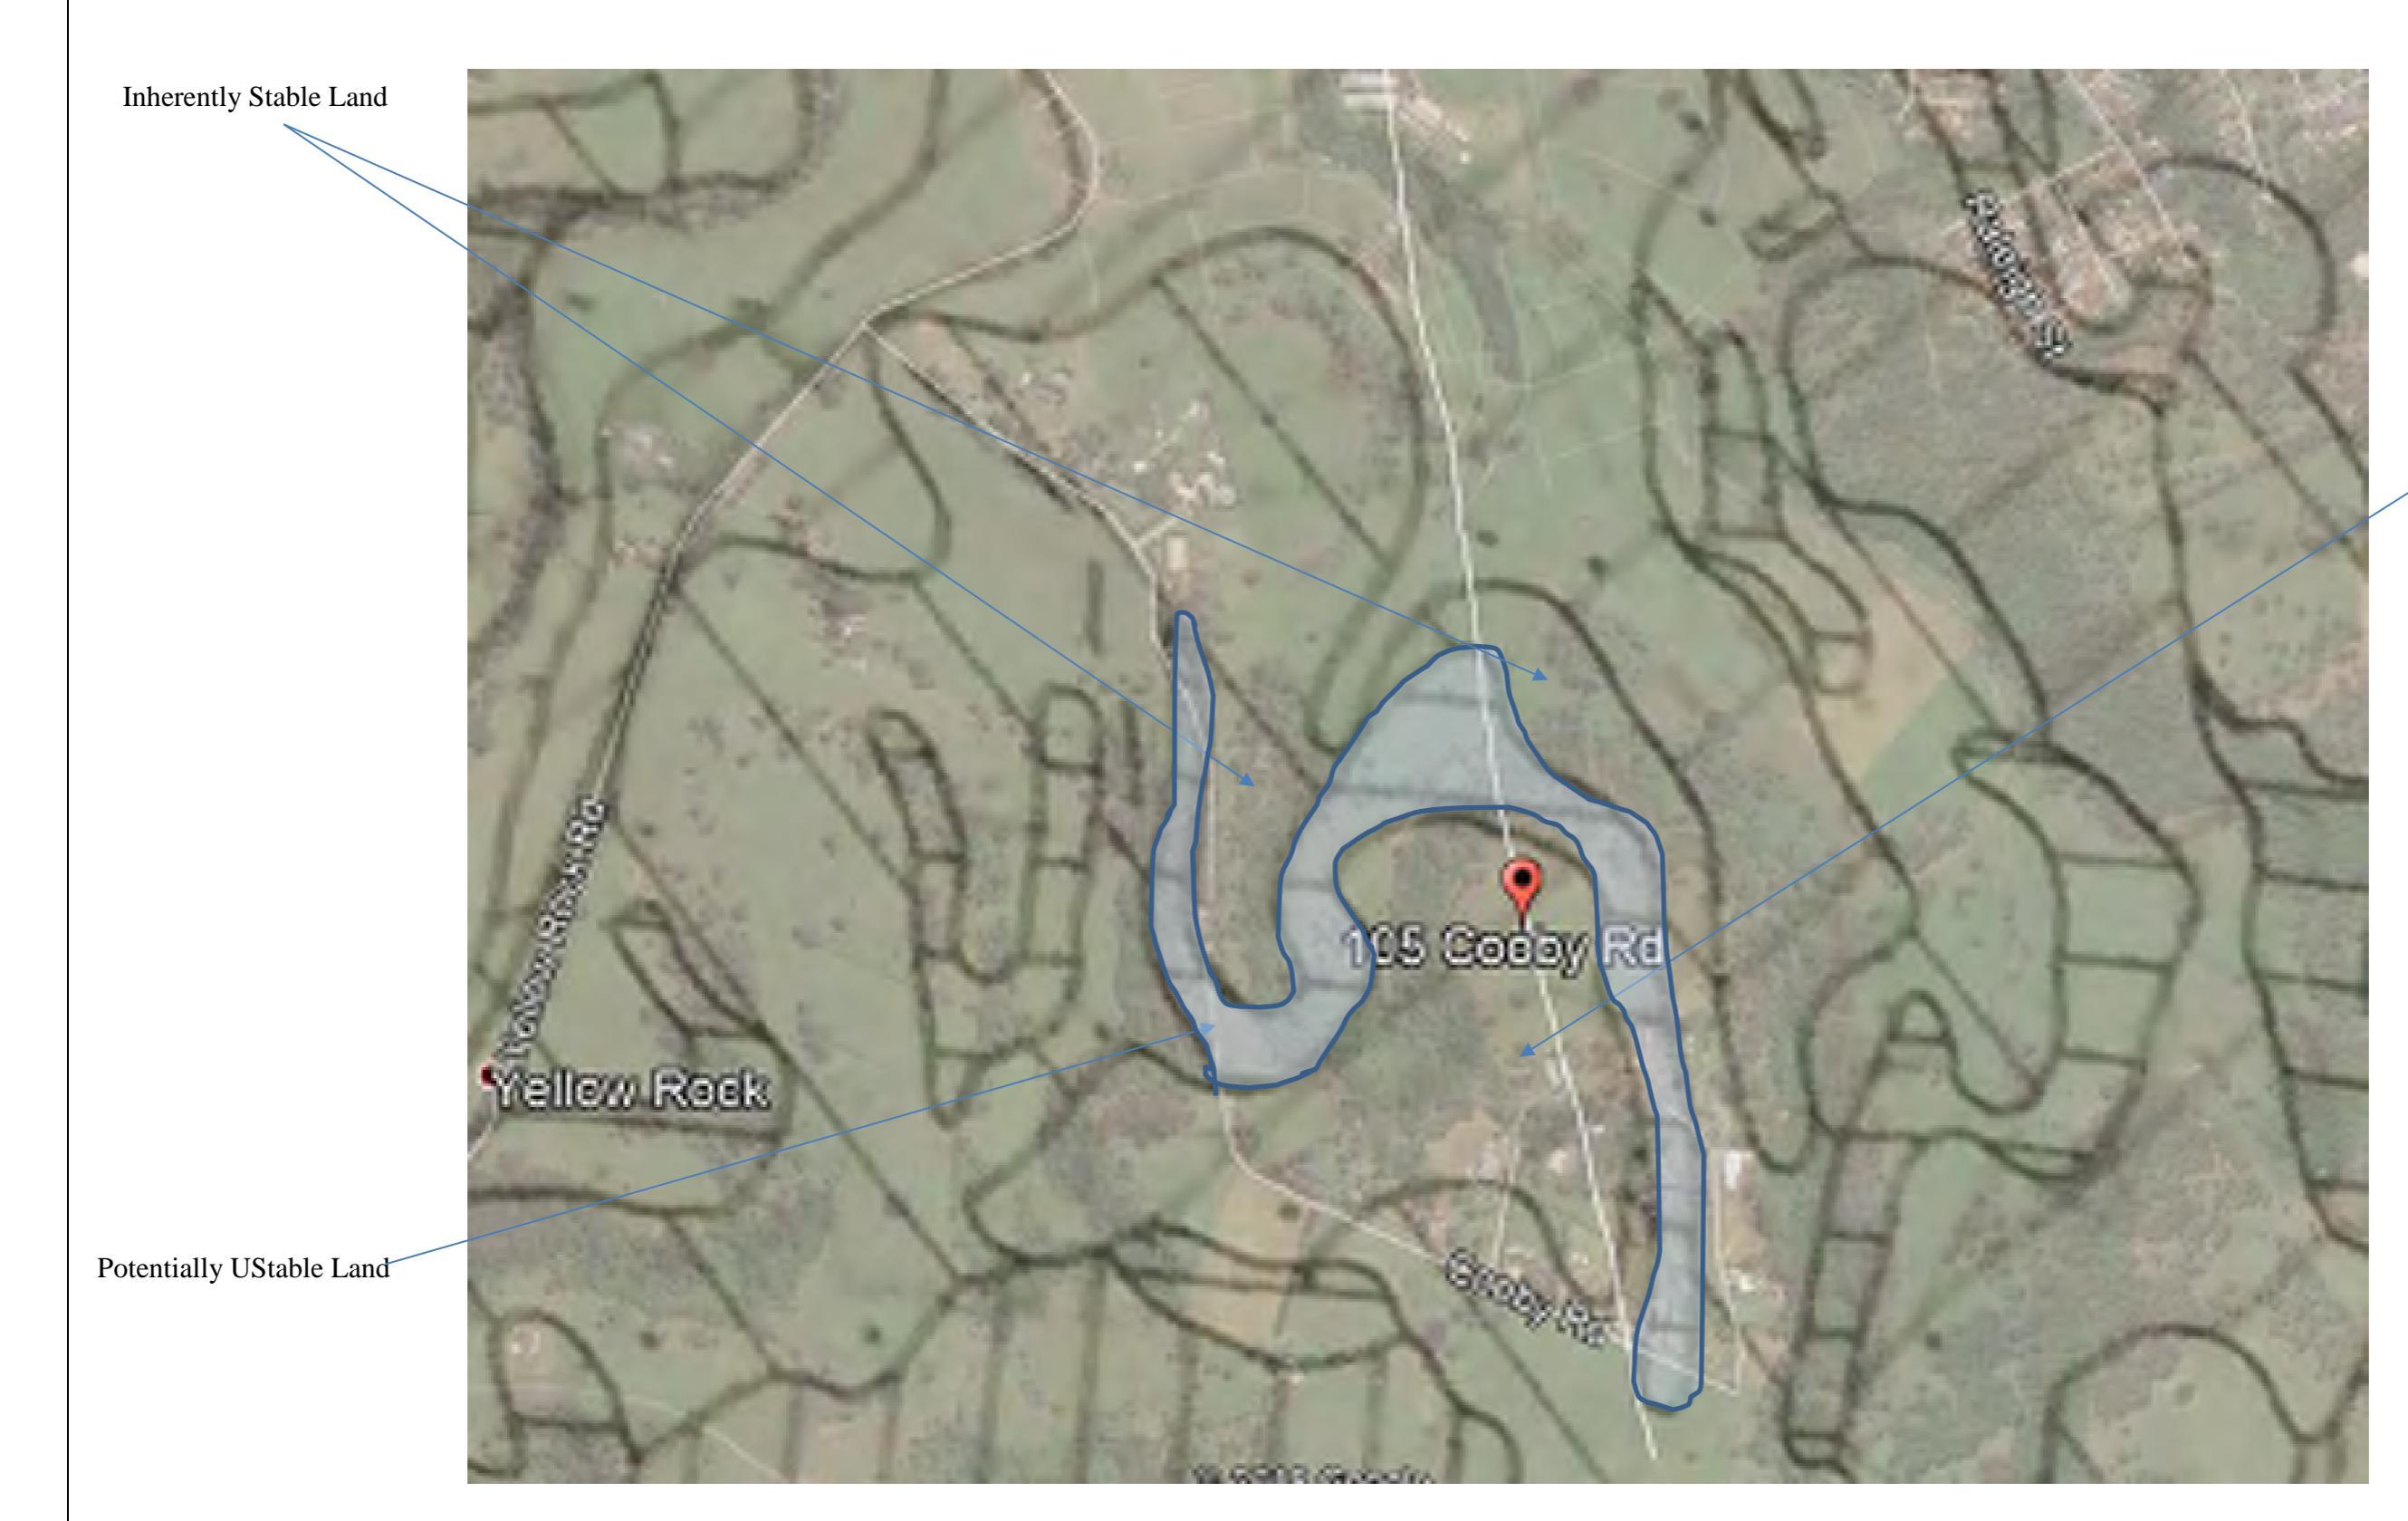
client:	Inde	sco				
project:	roject: Geotechnical Investigation for Proposed Subdivision No. 105 Cooby Road, Tullimbar NSW					
title:	Landslide Ri	sk Mapping				
project no	D: TERRA18320	figure no: FIGURE 10

- Potentially Unstable Land: Regions with steep slopes of 15 to 20 degrees. Excavation and/or fill placement or seepage could cause instability. Urban development is not recommended. Detailed geotechnical investigation must precede individual developments. Area 2 and Area 4 have been mapped by Neville as within this category

Figure 10 shows the mapping of the site as detailed by Neville. No recorded landslides were identified on or near the site (refer Figure 11)

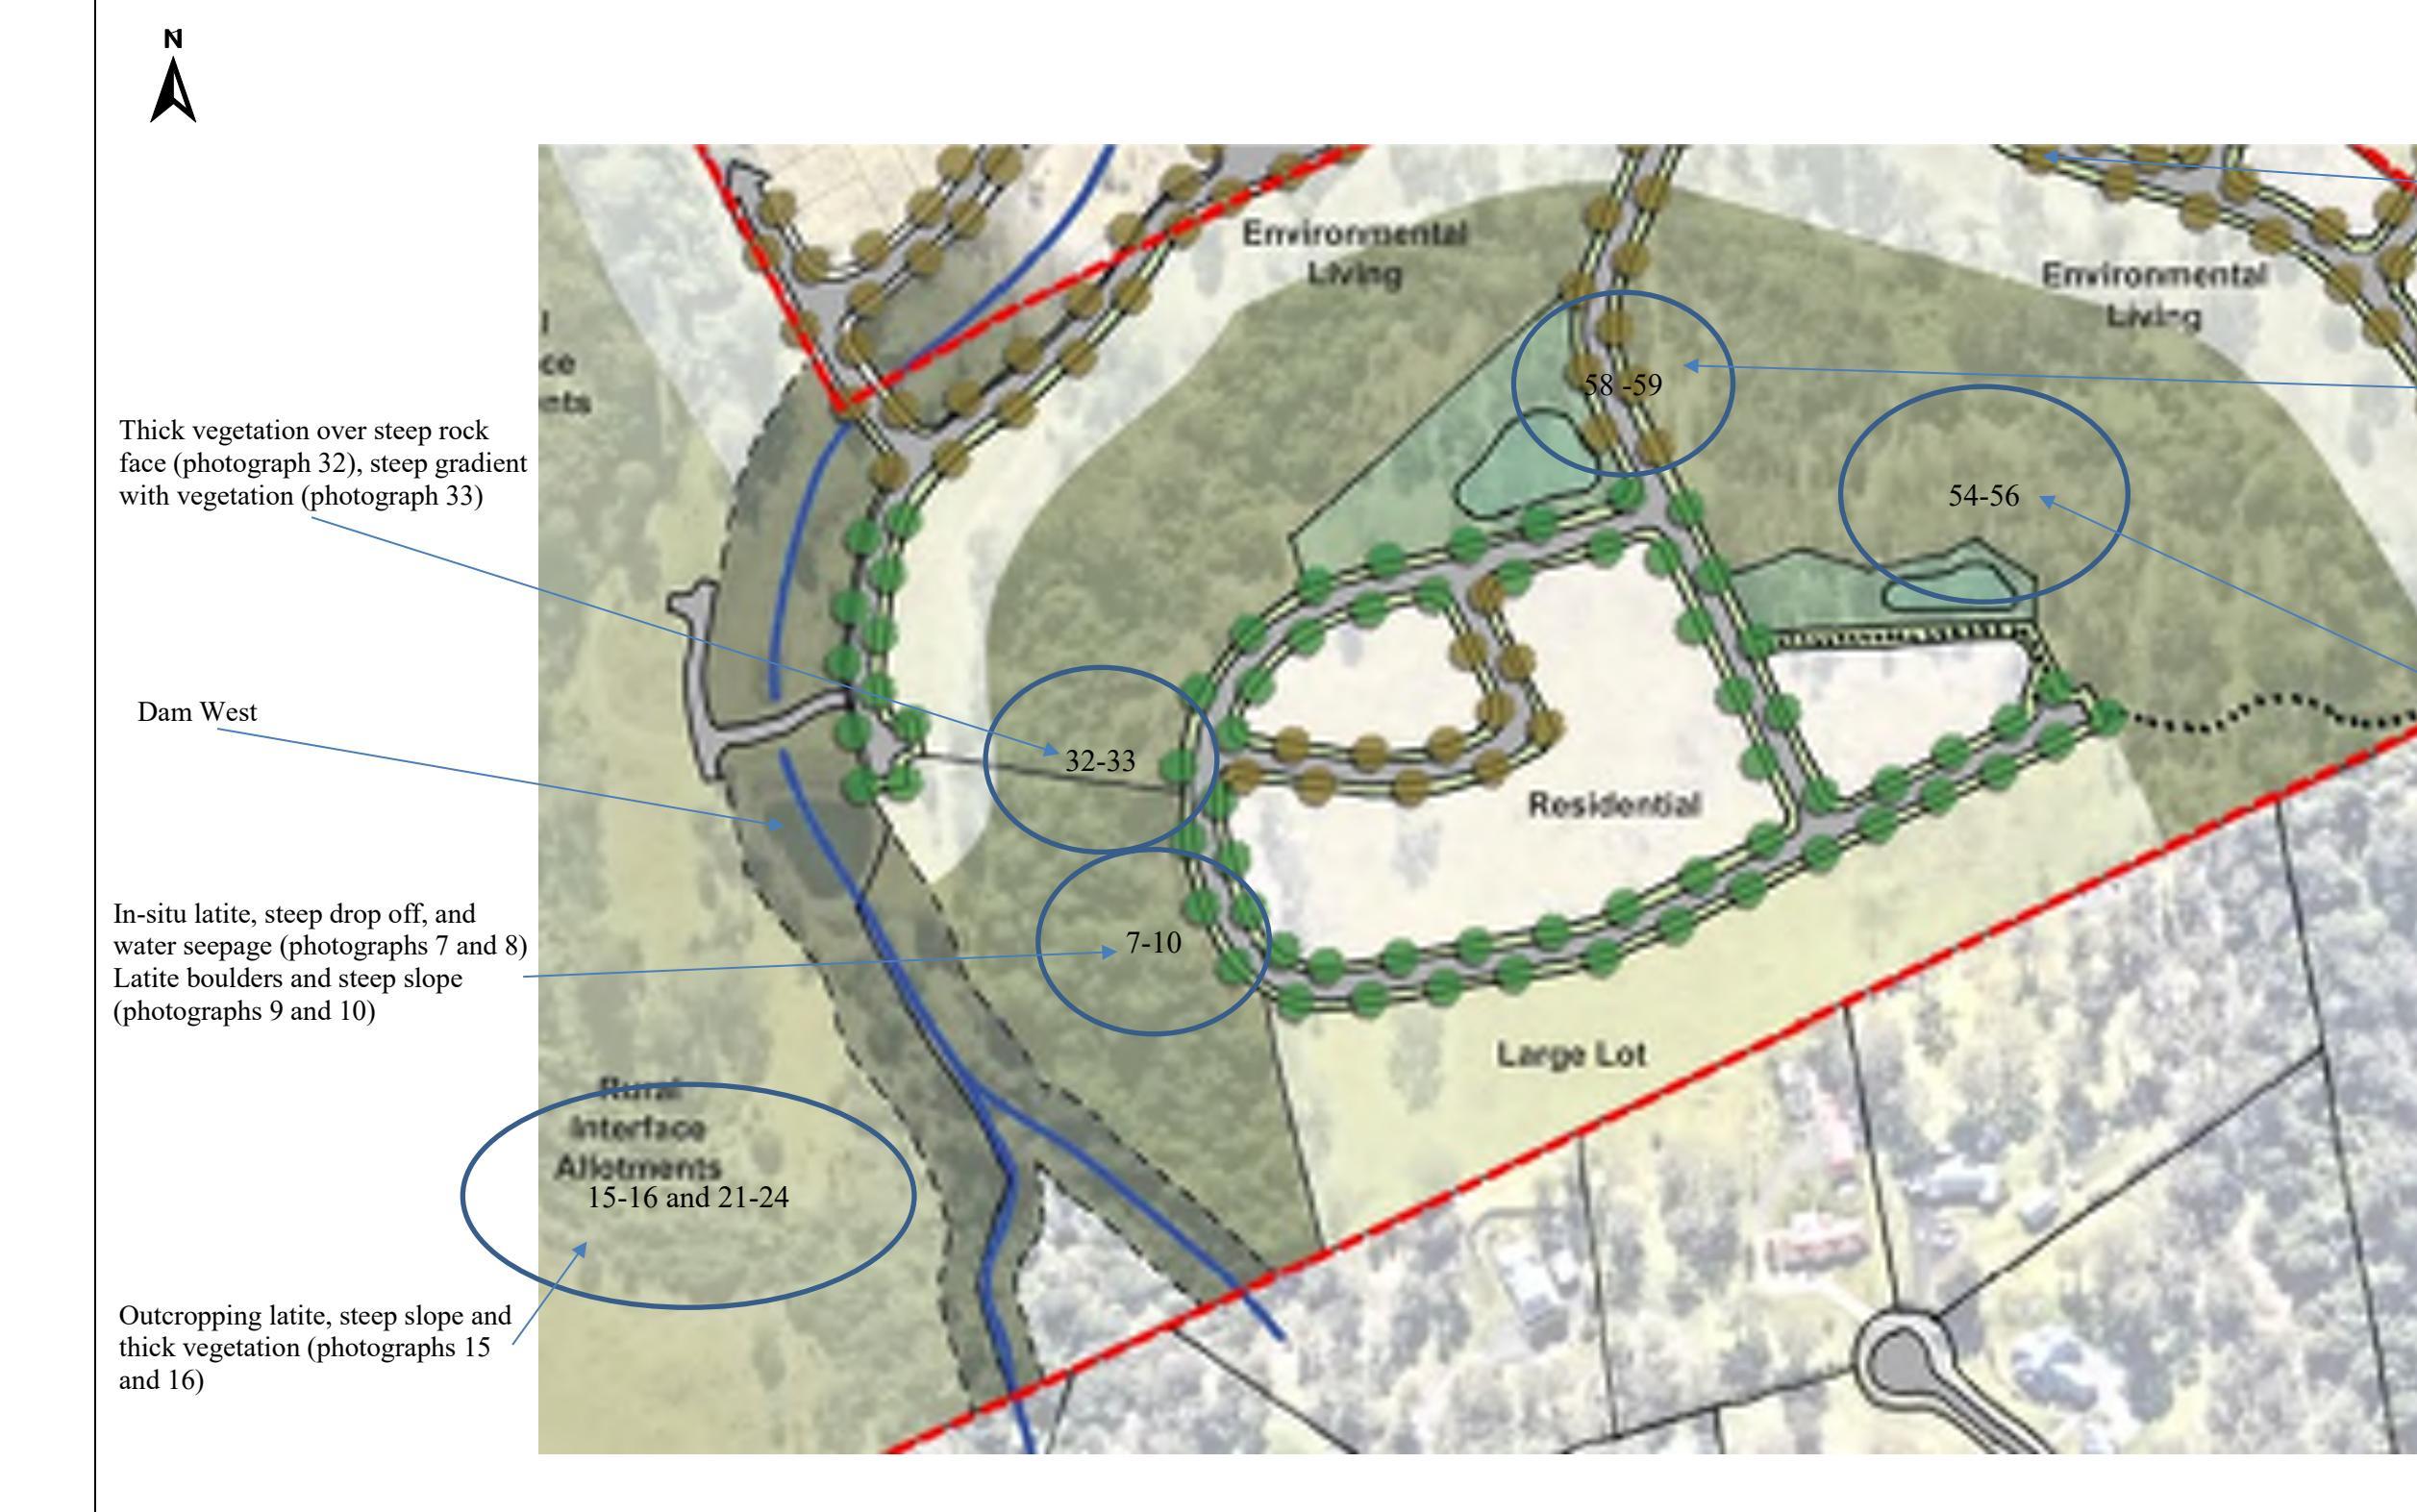
Steep access track with loose latite photograph 58), in-situ latite on the access track (photograph 59)

Very steep hill face with loose latite (photograph 54). Very steep hill face with loose latite under vegetation (photographs 55 and 56)

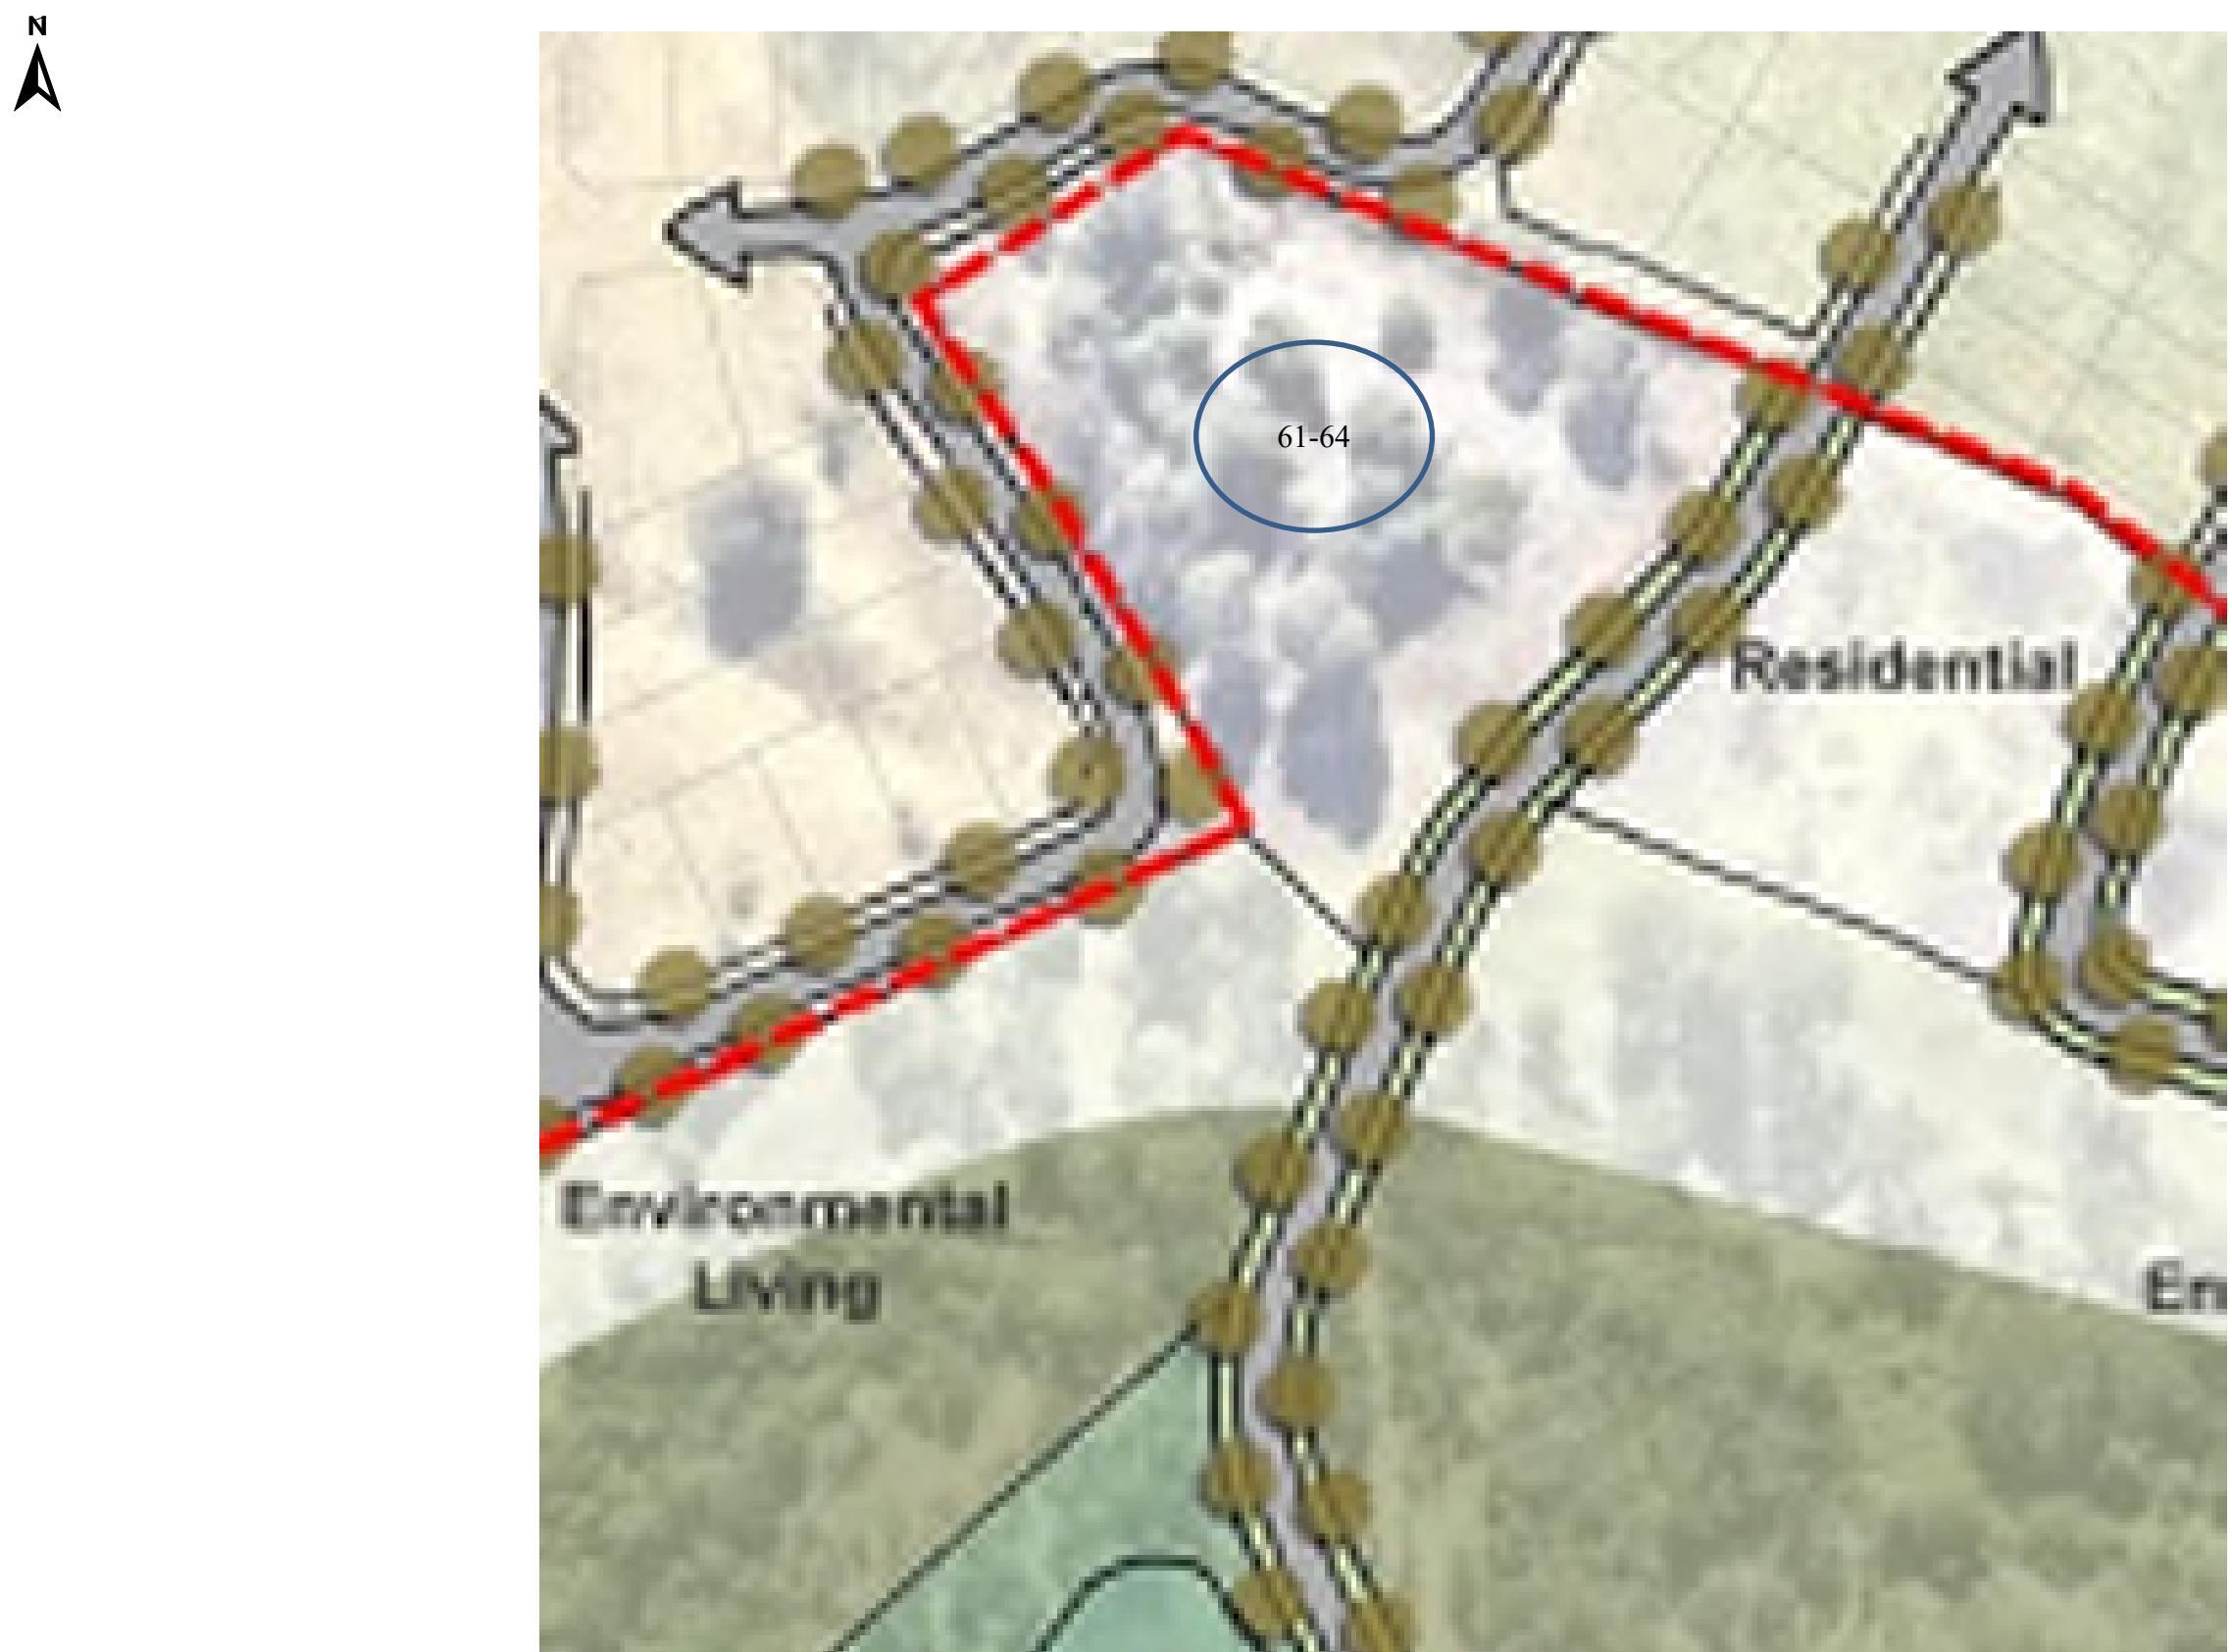
client:	Inde	sco	
project:	Geotechnical Investigation No. 105 Cooby Roa		
title:	Site Observat	tions- Area 4	
project no: TERRA18320 figure no: FIGURE 15

Area 4 (refer Figure 15 and photographs 61-64): Includes a small hill on the north-eastern corner of the site.

- The hill has an elevation of about 70m AHD.
- The slopes were typically moderate to steep. Boulders and cobbles of latite rock were visible on the ground surface.
- No signs of mass slope movement were visible (eg groups of leaning trees, tension cracks, debris piles). This is most likely due to the shallow depth to rock on the site. However, cobbles and small boulders were visible, indicating potential local slippage and rock fall from the slopes.

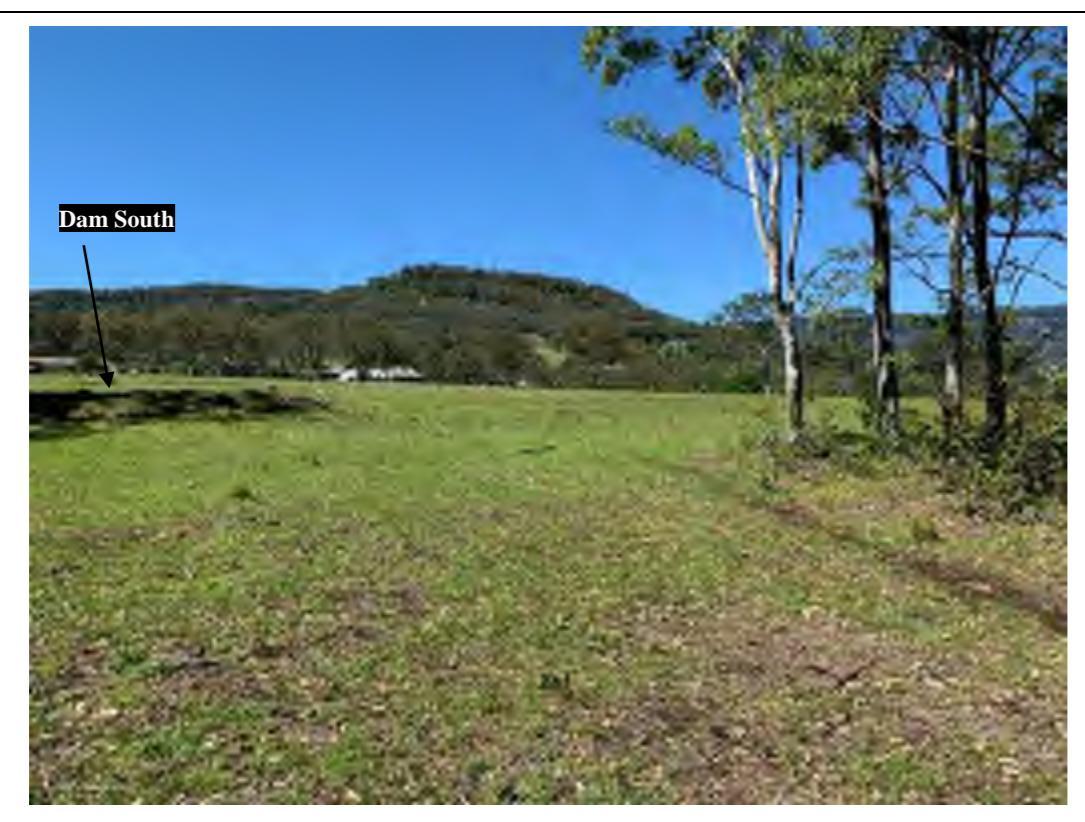
Photograph 1: View of Terrace 1A looking south from the northern end of Terrace 1A

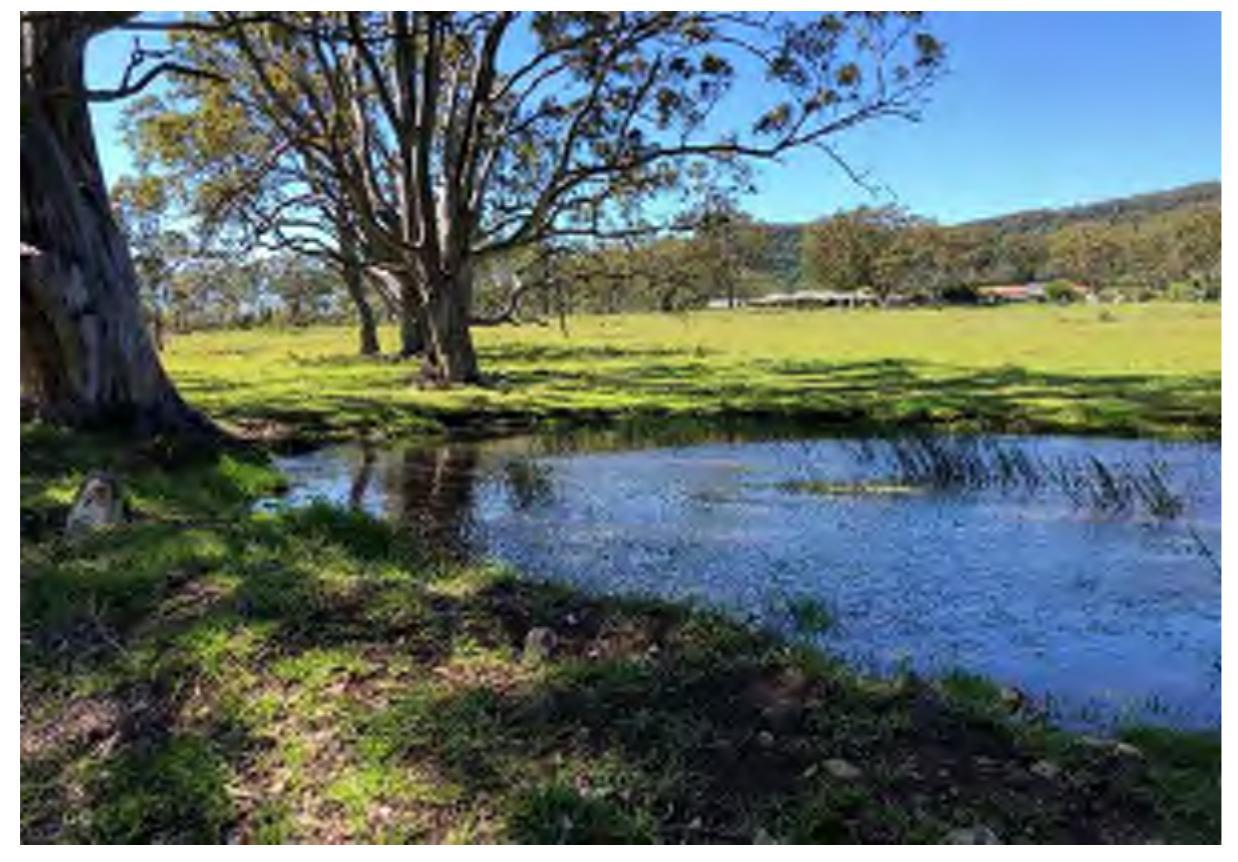
Photograph 3: View of Dam South on Terrace 1A looking south east

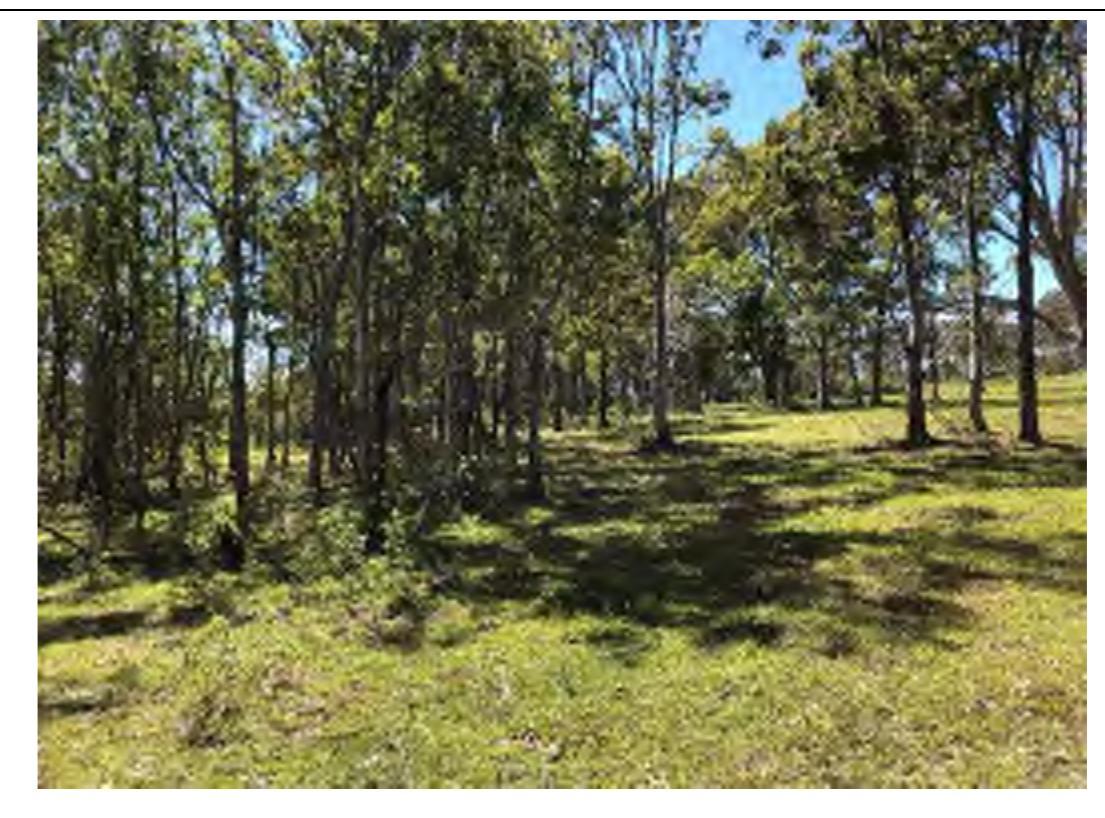
Photograph 2: View looking east across the northern boundary of Terrace 1A

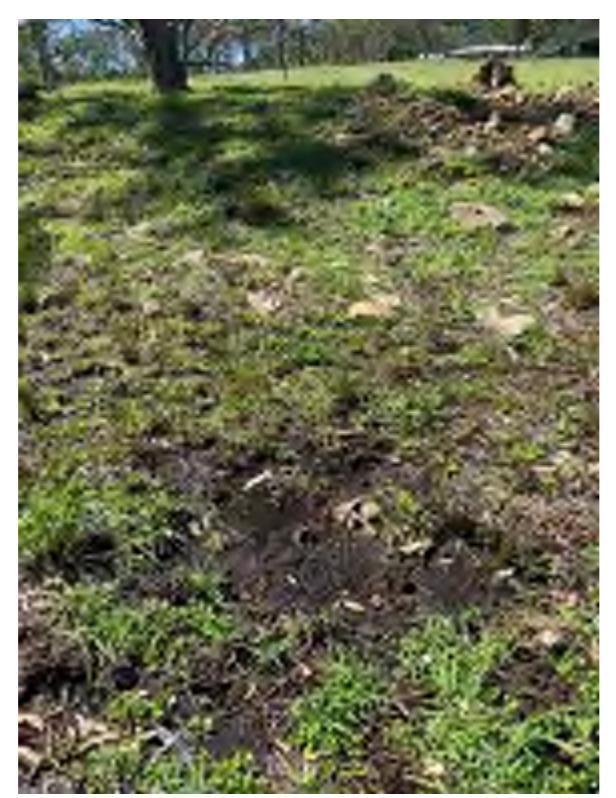
Photograph 5: View looking south east at the northern wall of Dam South showing dam seepage

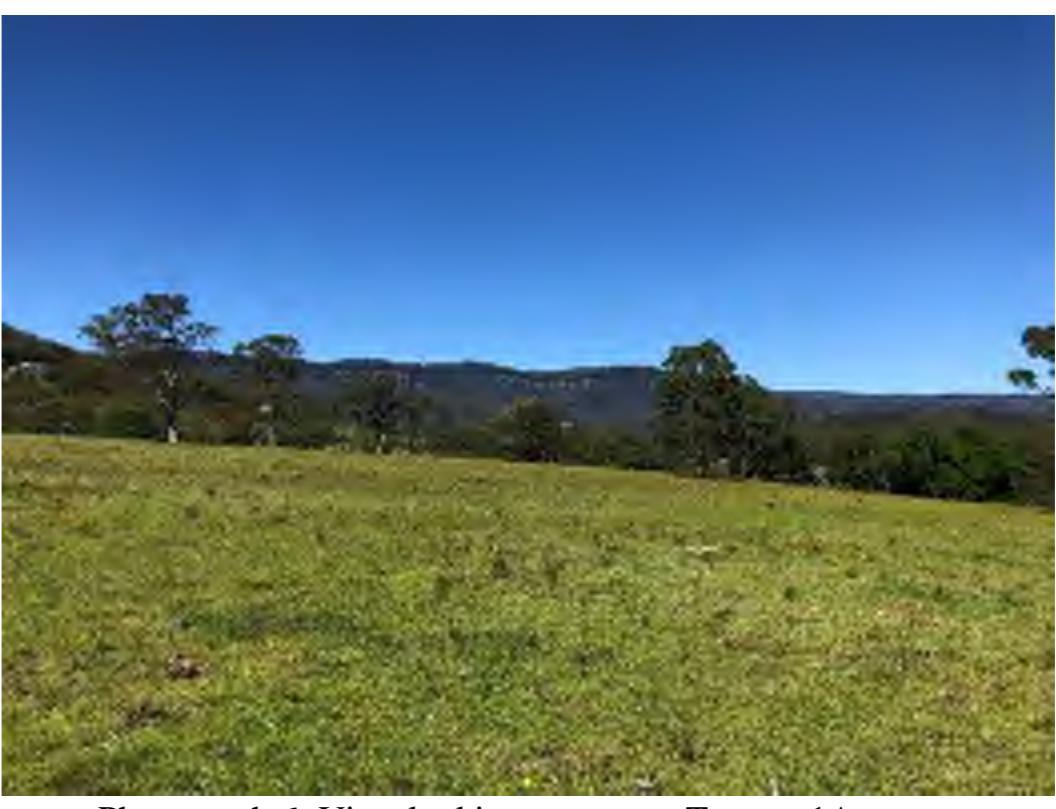
- Along the northern edge of the terrace (at the transition from Area 1 to Area 2), latite rock was visibly outcropping in many locations. The slopes were also extremely steep, with some rock outcroppings resulting in cliff /escarpment like slopes (refer Photographs 6 to 14). On the north-western corner of Terrace 1A, some seepage was also observed flowing along the shallow rock surface.

Photograph 6: View looking west over Terrace 1A

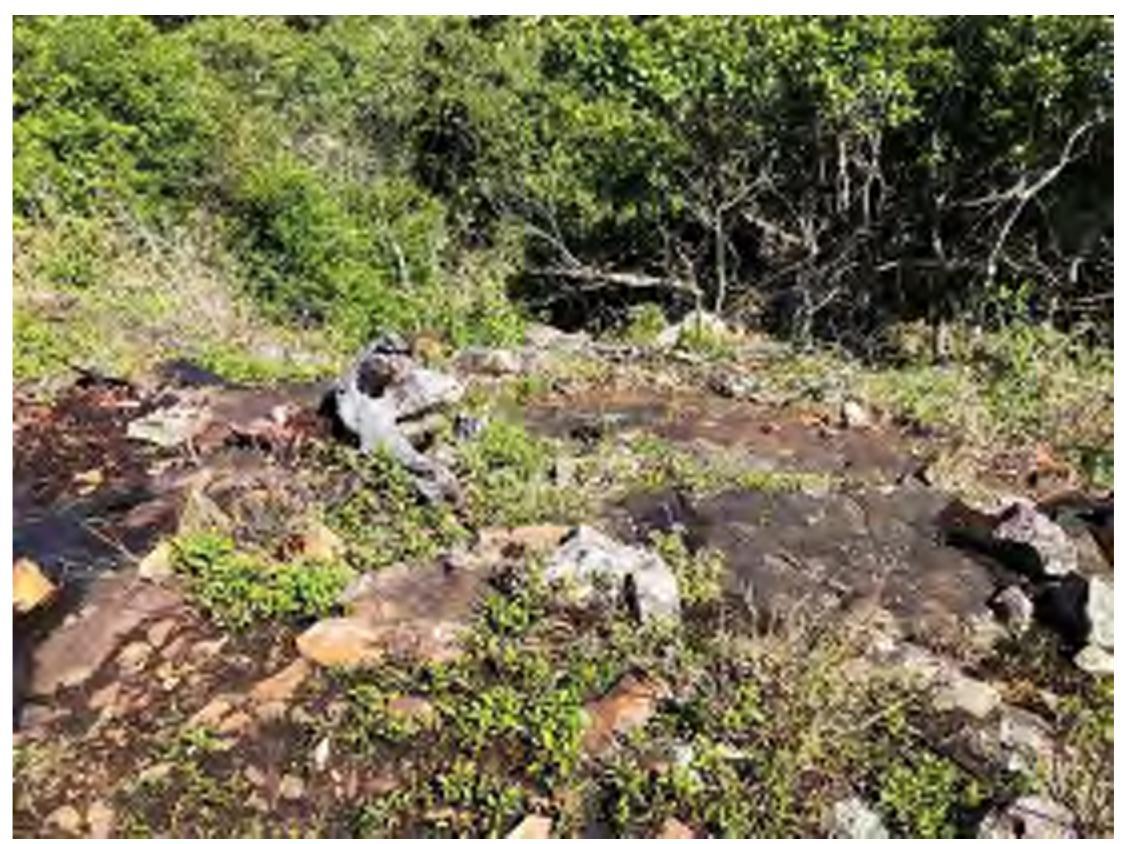
Photograph 8: Close up of photo 45 with water to the left and in-situ latite

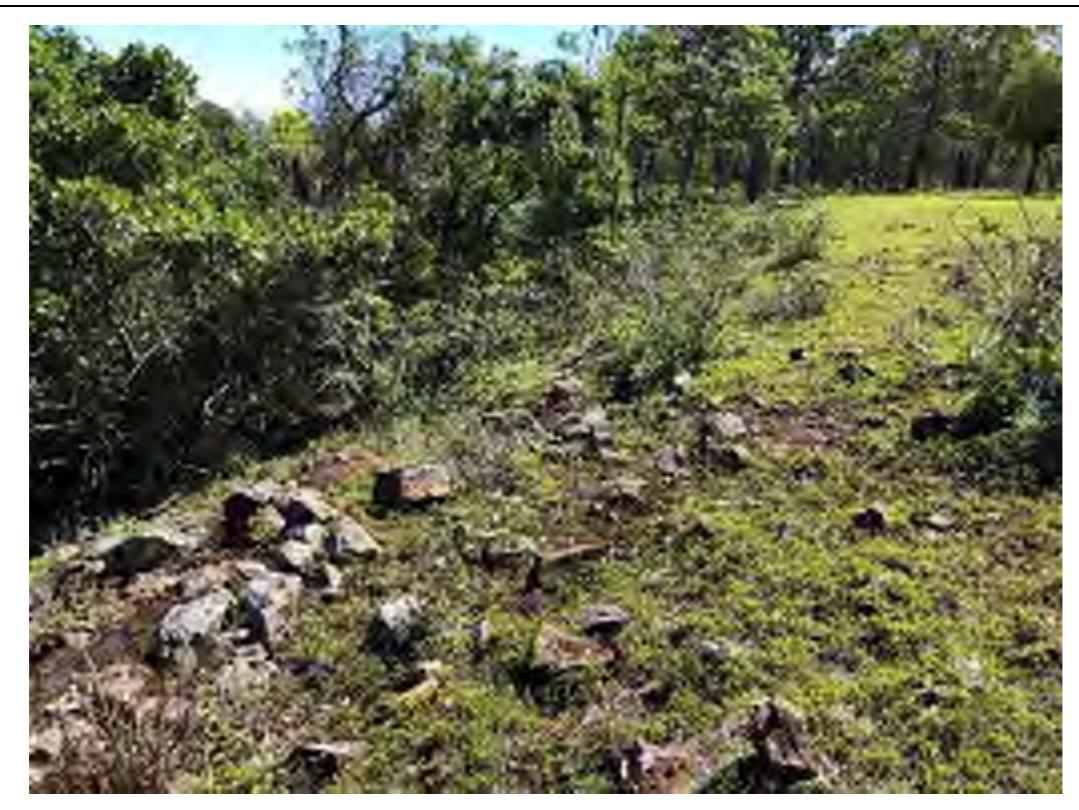
Photograph 9: View looking north along the boundary between Area 2 and Terrace 1A

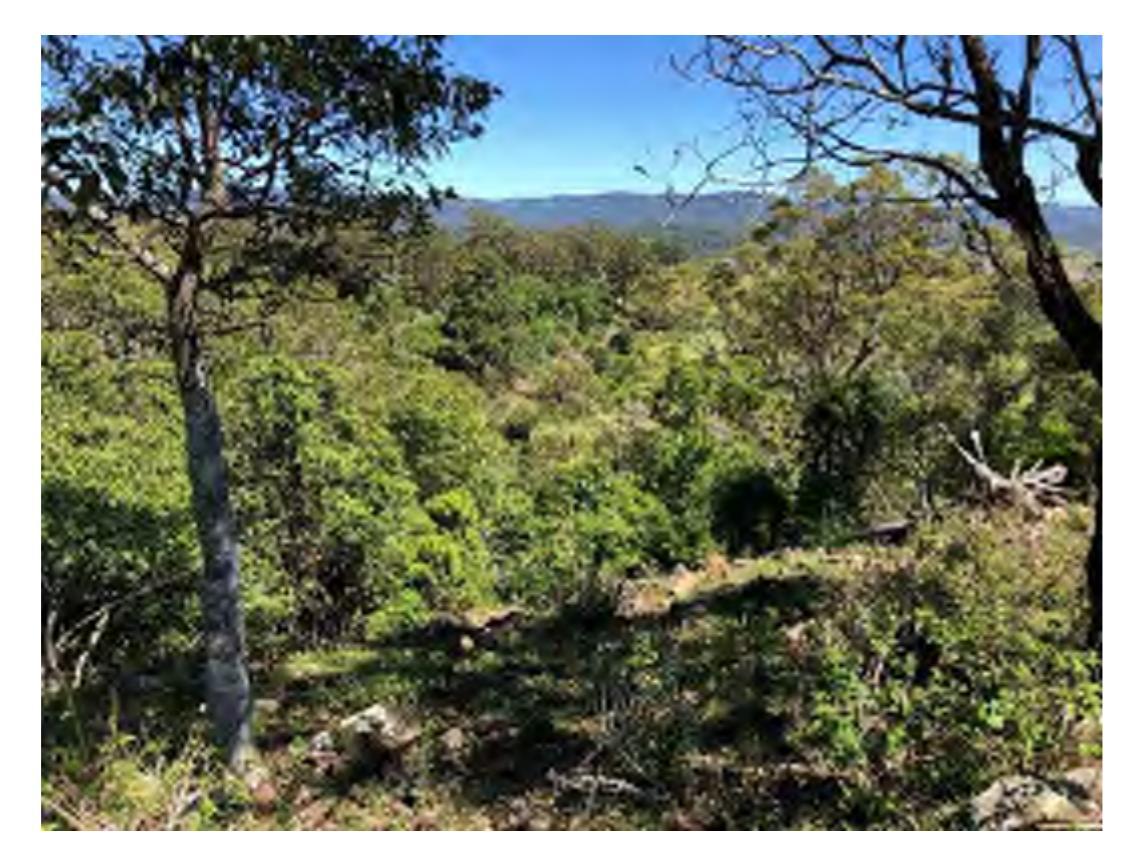
Photograph 11: looking north west over area 3 toward the northern section of Terrace 1B
