Residential Subdivision of No. 105 Cooby Road, Tullimbar NSW

Report on Preliminary Geotechnical Assessment

Our Ref: TERRA18320.Rep1.Rev1

15 August 2019

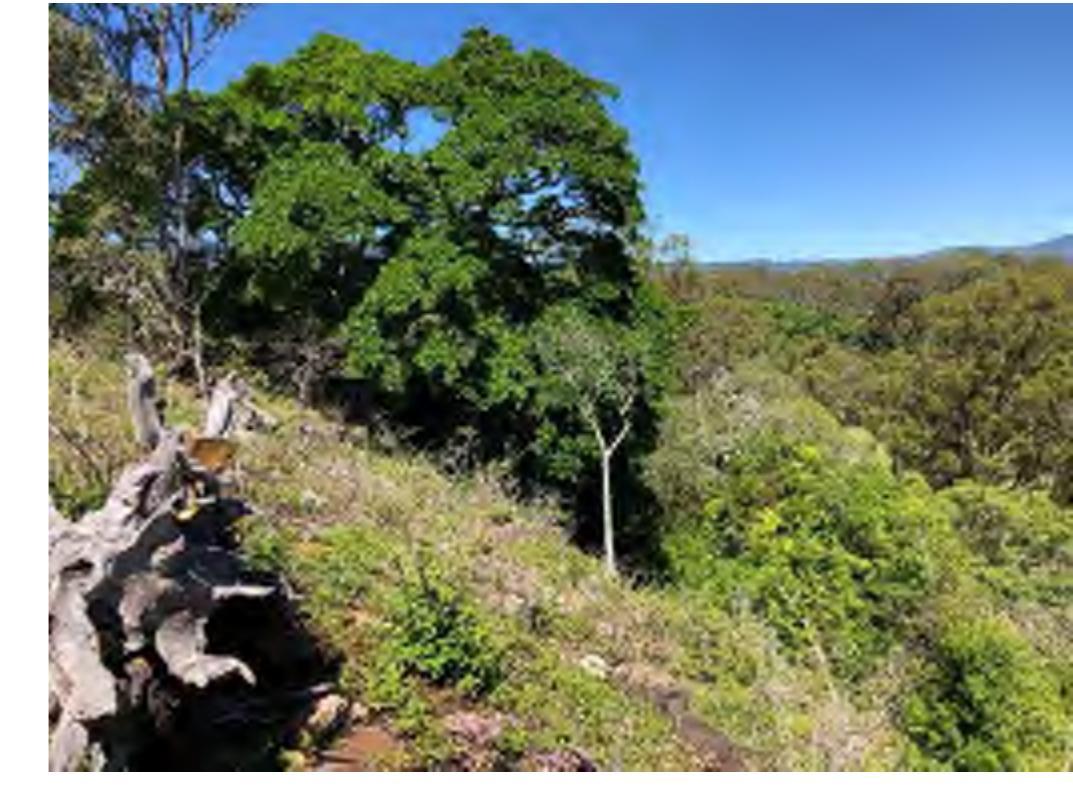
- Along the northern edge of the terrace (at the transition from Area 1 to Area 2), latite rock was visibly outcropping in many locations. The slopes were also extremely steep, with some rock outcroppings resulting in cliff /escarpment like slopes (refer Photographs 6 to 14). On the north-western corner of Terrace 1A, some seepage was also observed flowing along the shallow rock surface.

Photograph 10: View looking west from Terrace 1A showing the steep nature of Area 2

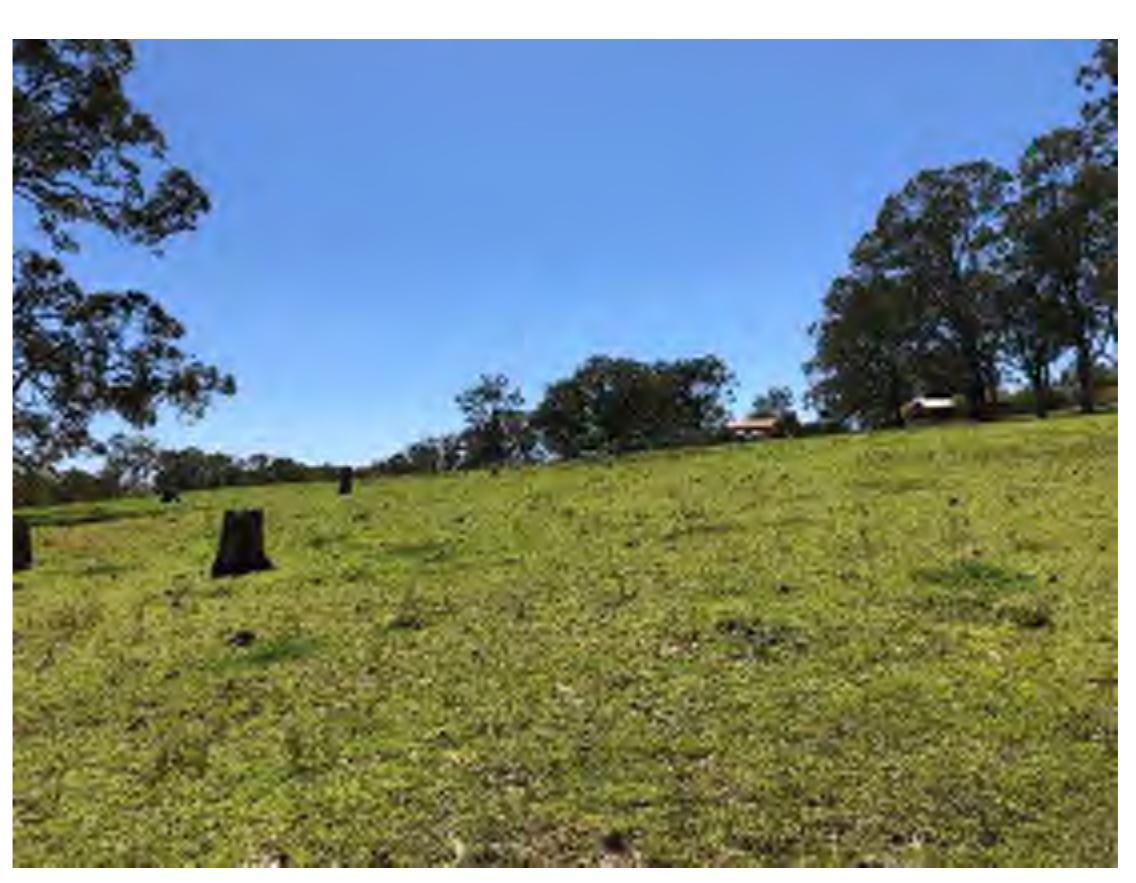
Photograph 12: view of Terrace 1A looking east

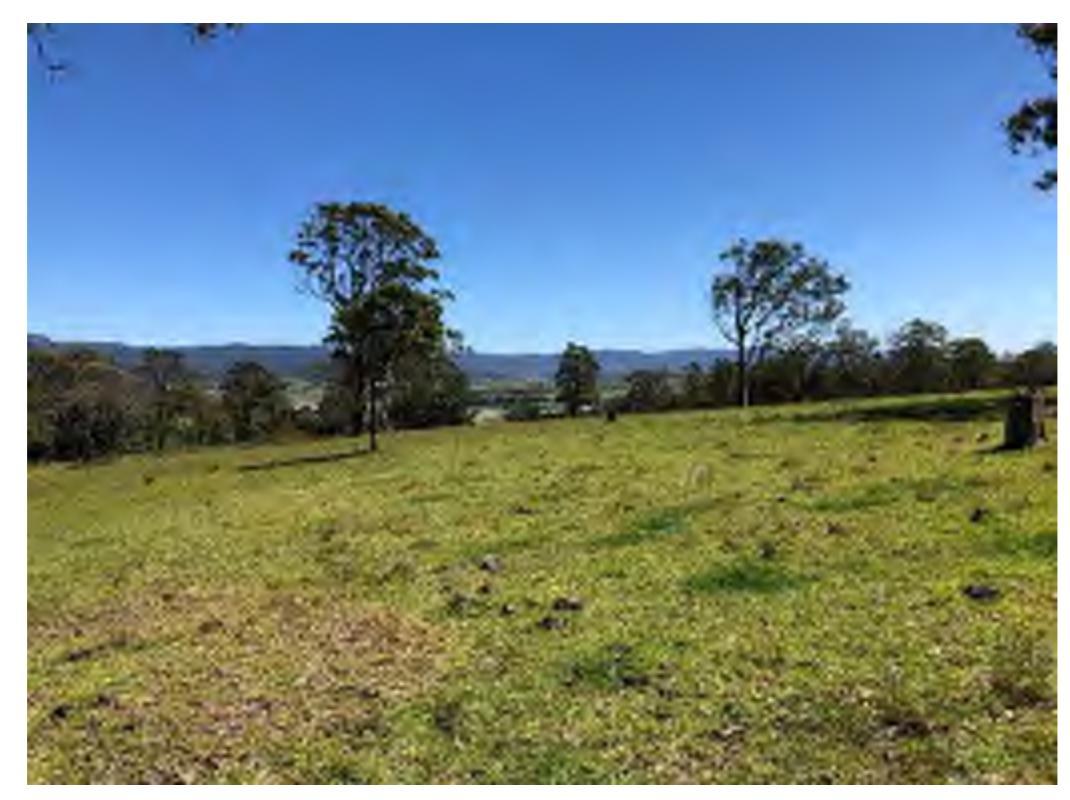
Photograph 13: View looking north over Terrace 1A

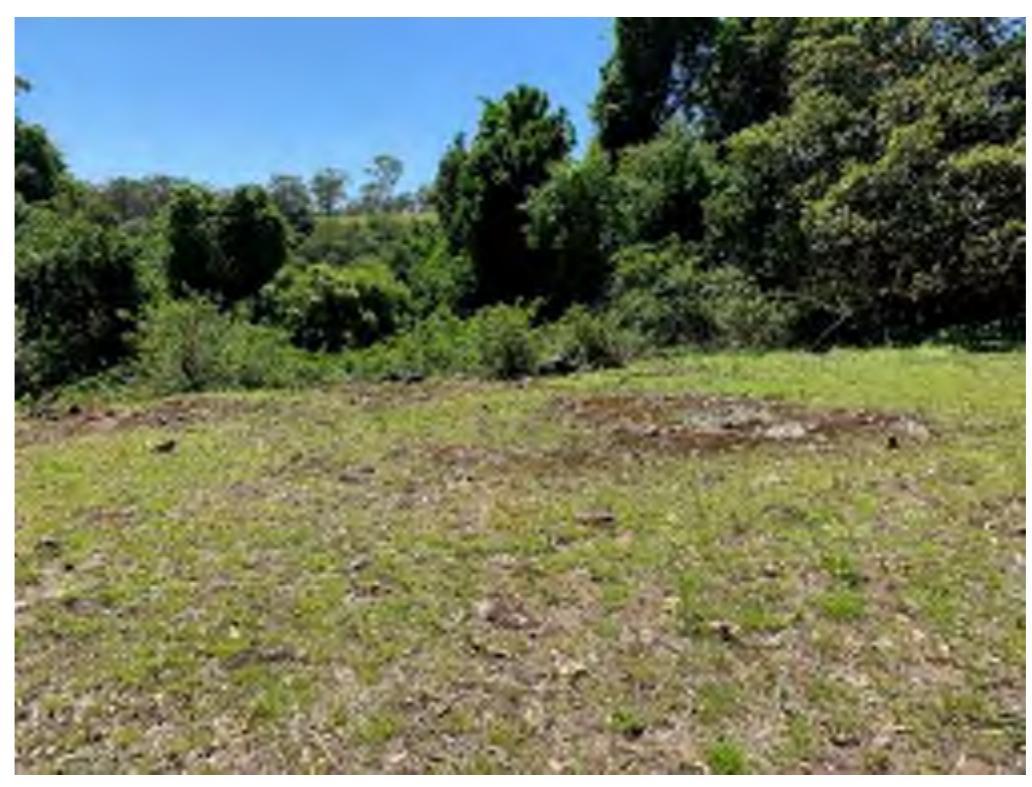
Photograph 14: View looking east from the middle section of Terrace 1B

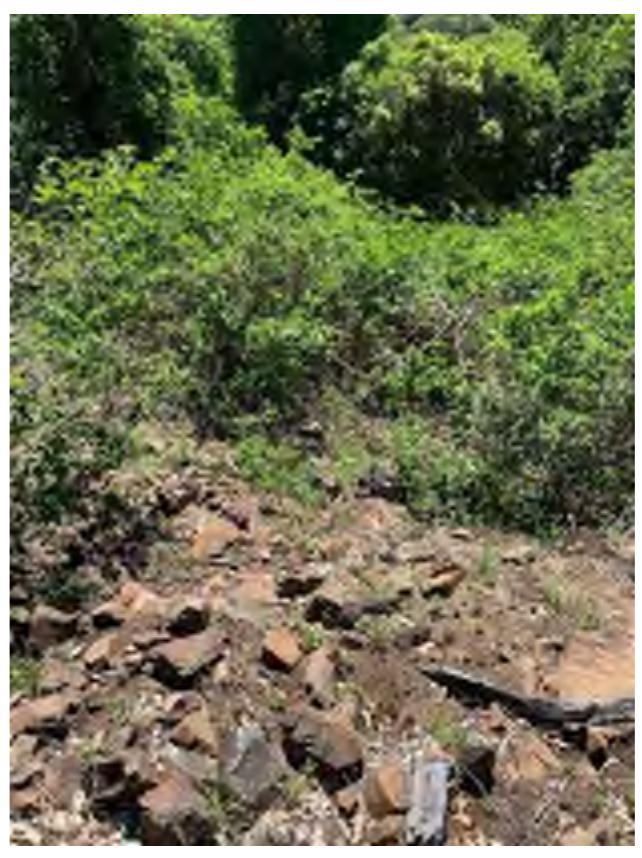
Photograph 16: View looking east down Area 2 from Terrace 1B

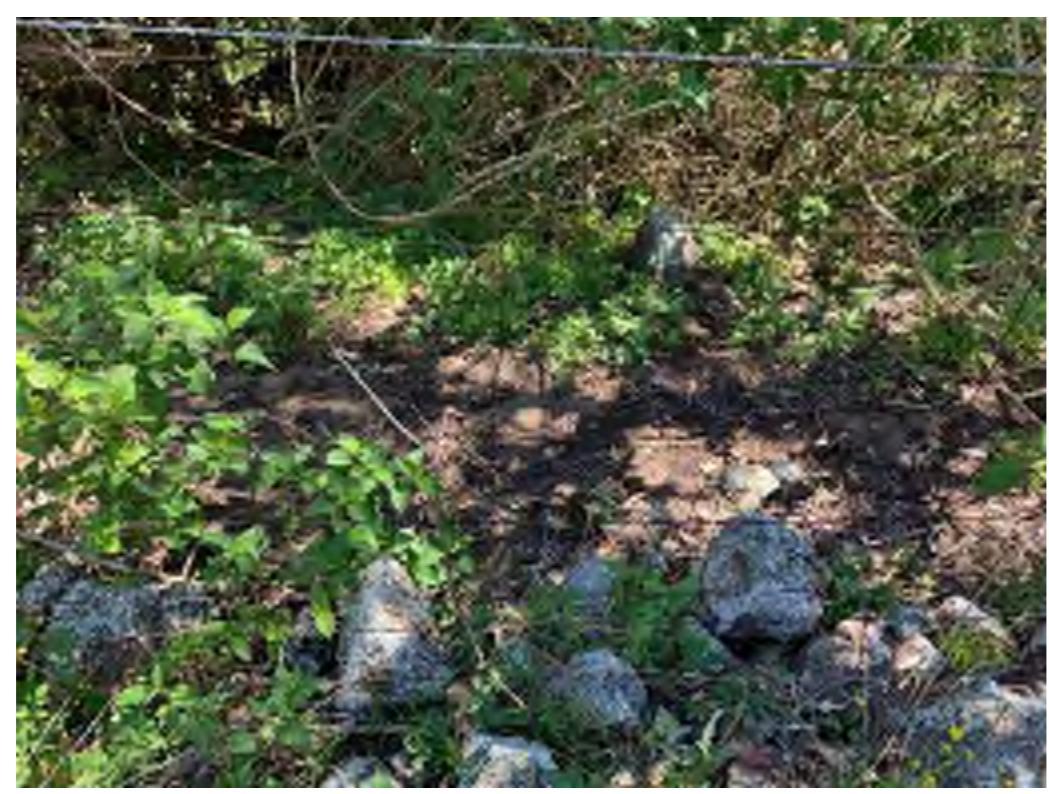
Photograph 21: Outcropping latite on the south eastern boundary between Terrace 1B and Area 2

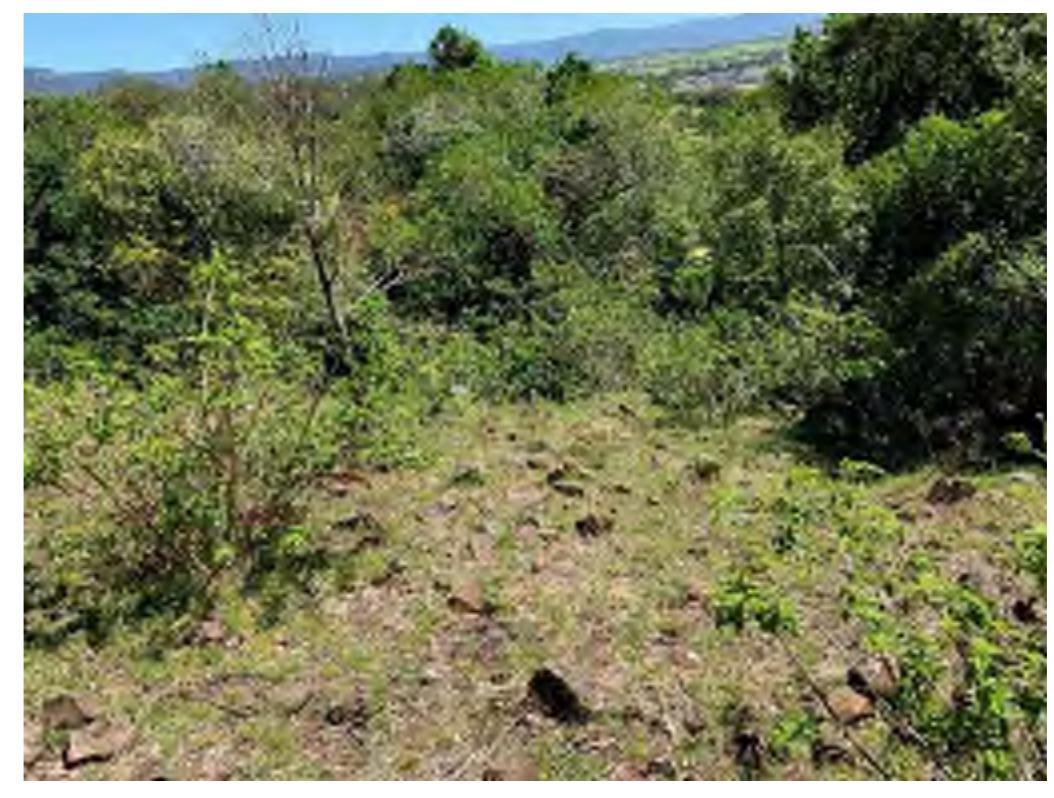
Photograph 22: Looking down area 2 from Terrace 1B north toward Area 3

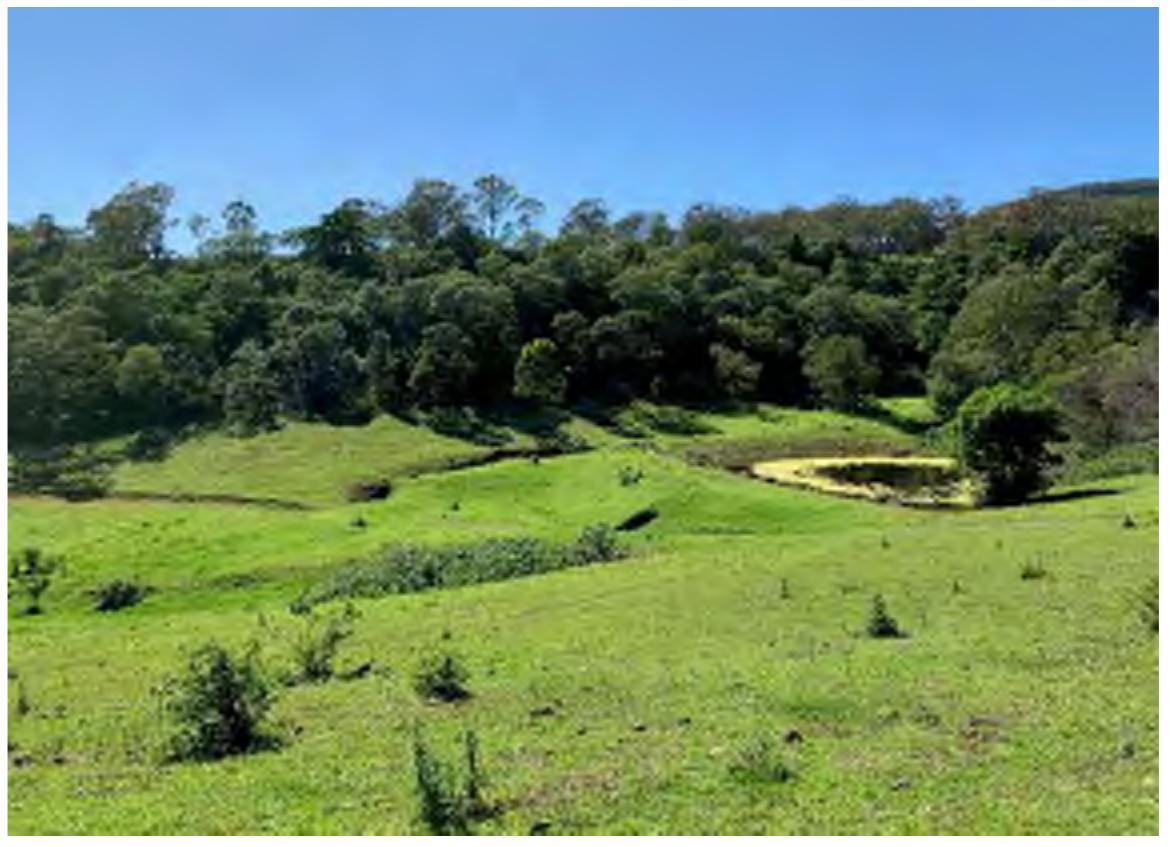
Photograph 32: View of Dam West in Area 3 looking south east. Shows the steep nature of Area 2 as it steps up to Terrace 1A

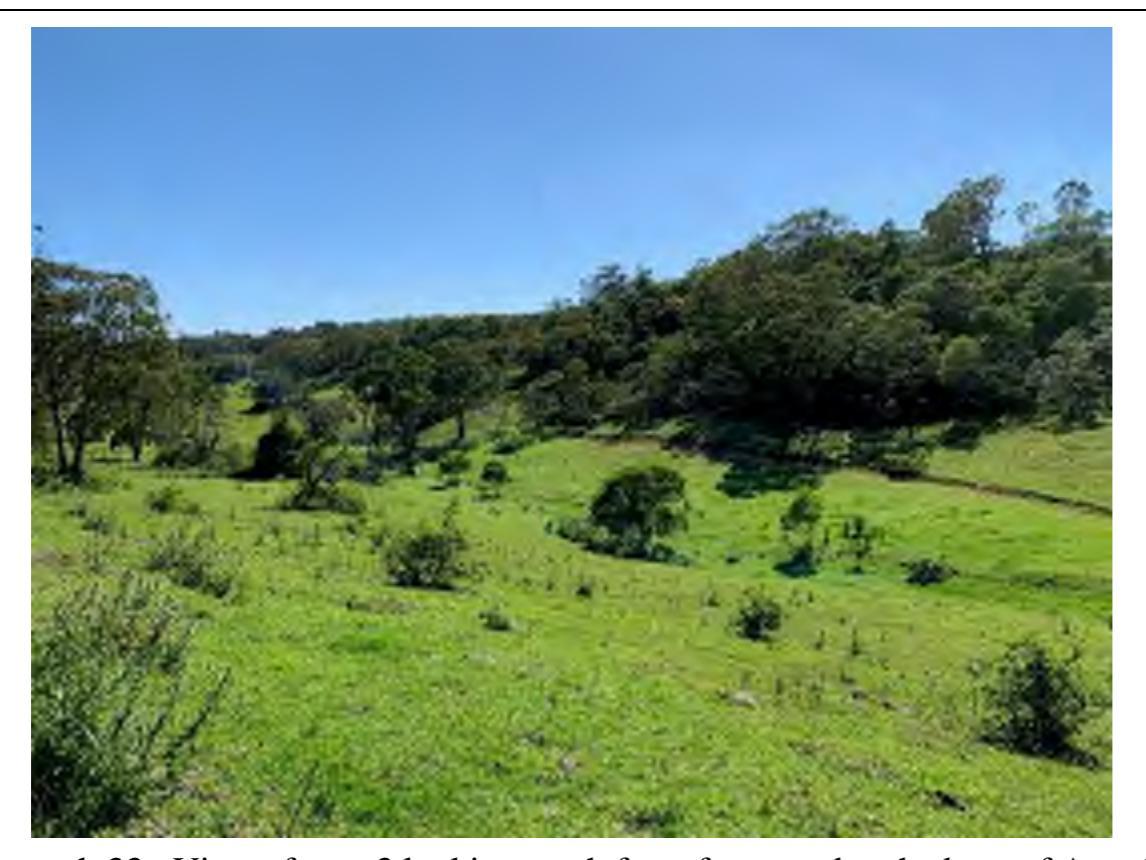
Photograph 34: View of the slope on the western side of Area 3 looking north

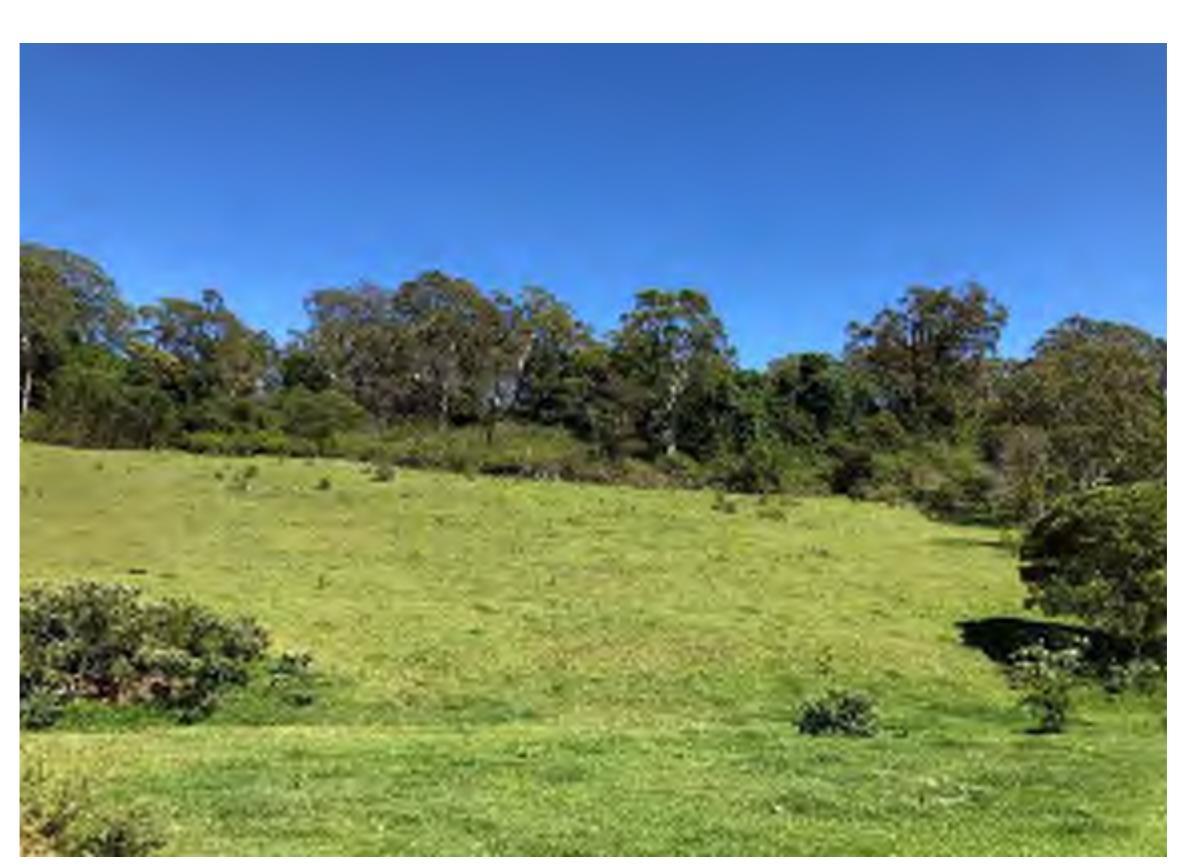
Photograph 36: Looking west at the slope of Area 3 up to Area 2 and Terrace 1B

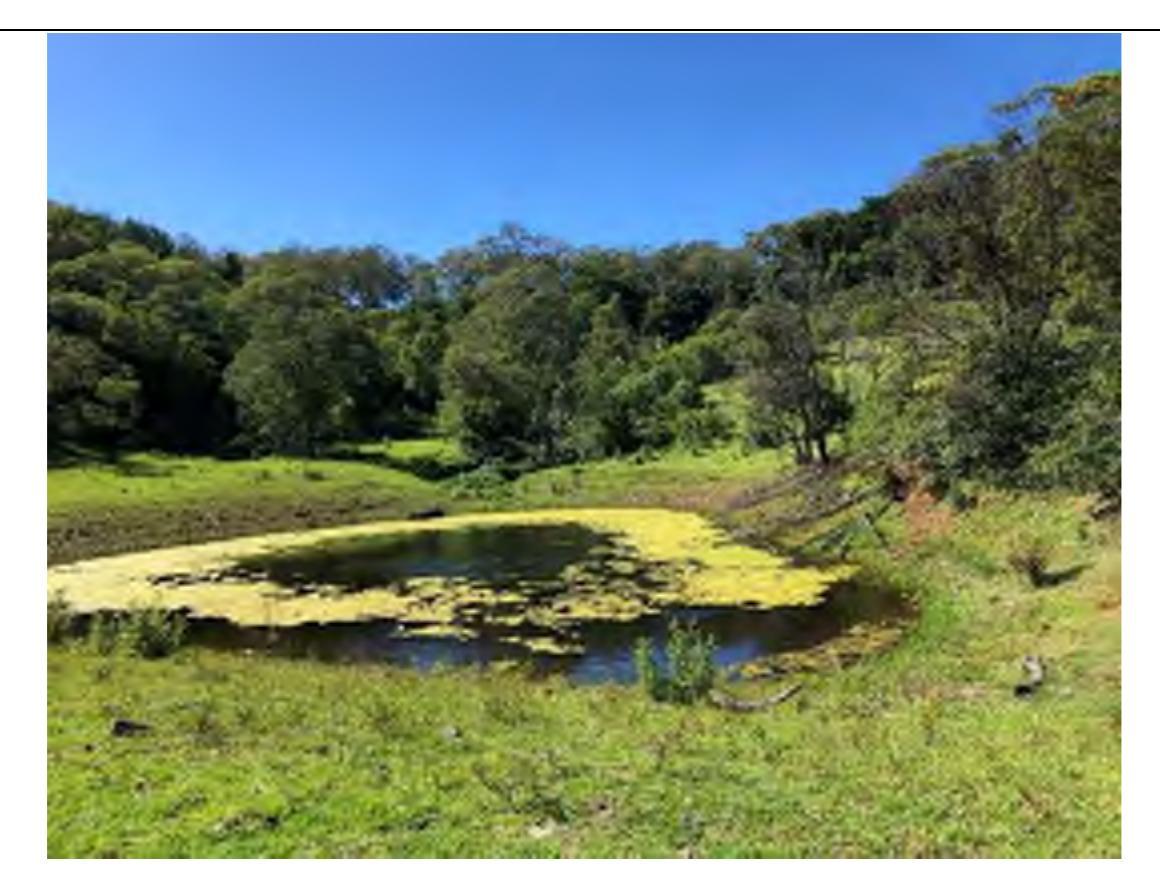
Photograph 37: Looking south at Dam West in Area 3. Depicts the steep nature of Area 2 surrounding the gully

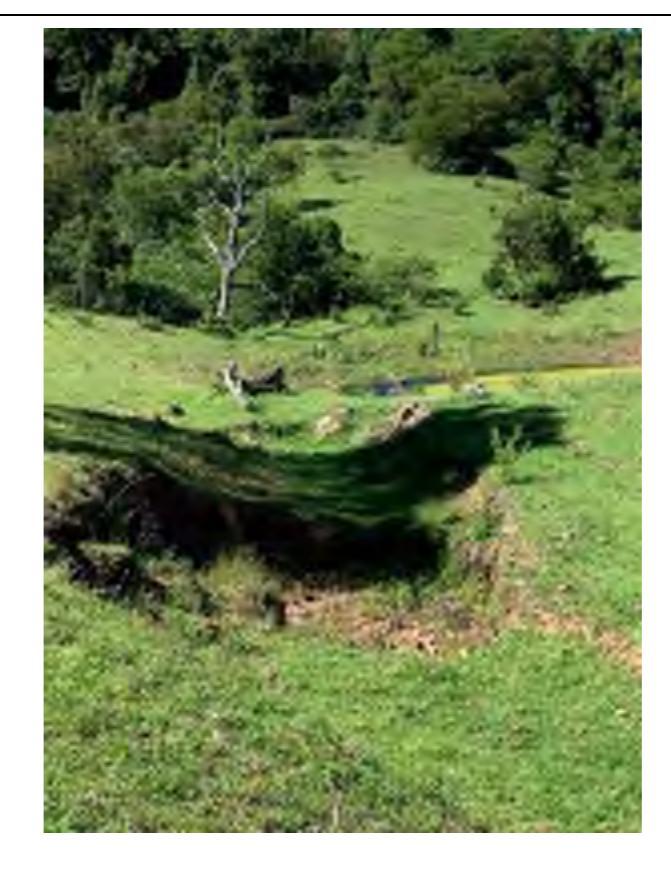
Photograph 38: View of spill way for Dam West. Located north east of Dam West in Area 3

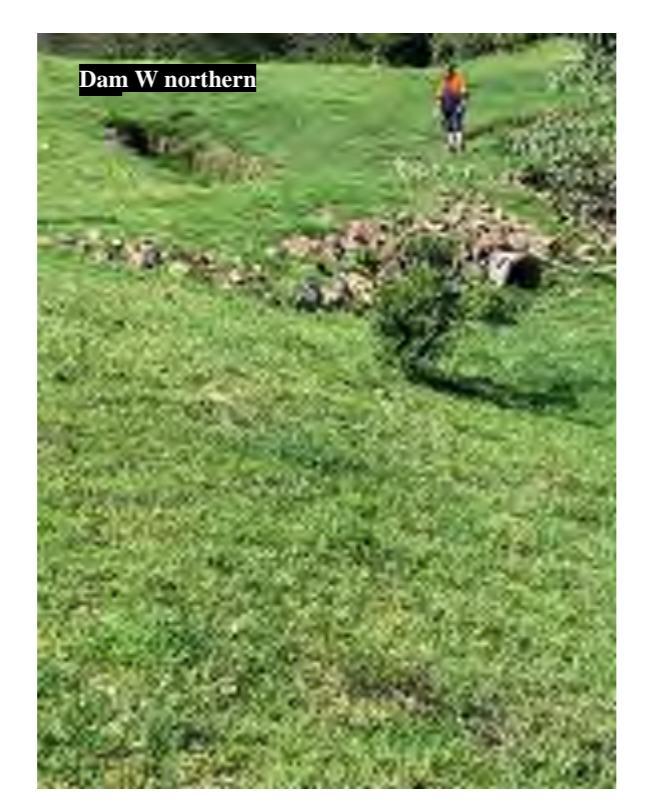
Photograph 41: View looking south west at storm water culvert north of the dam wall

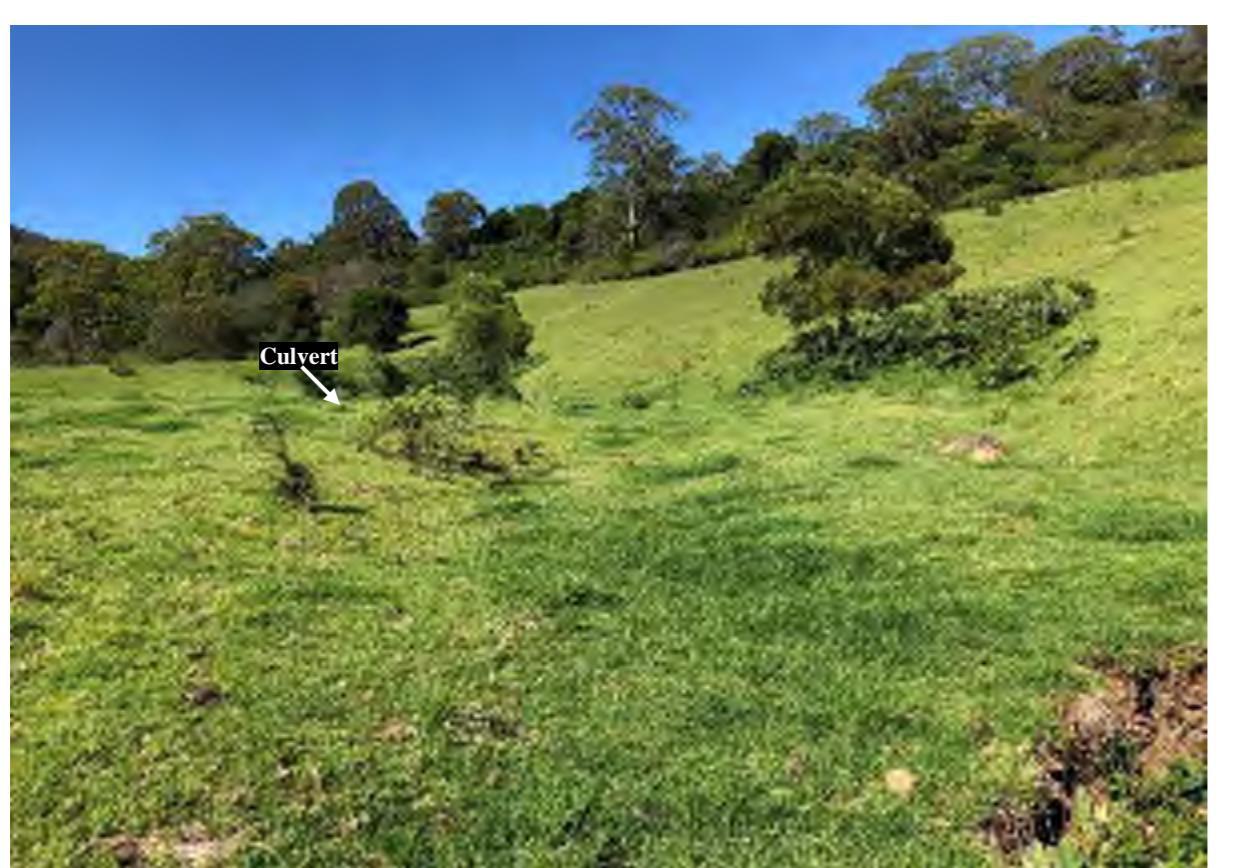
Photograph 43: looking south west showing the storm water channel through Area 3 looking back towards the culvert

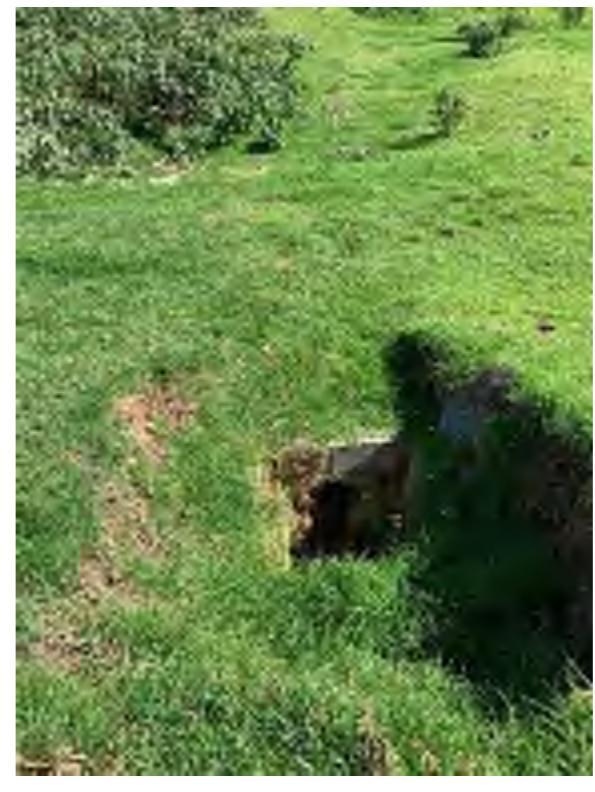
Photograph 42: View of the storm water culvert looking north from the Dam West

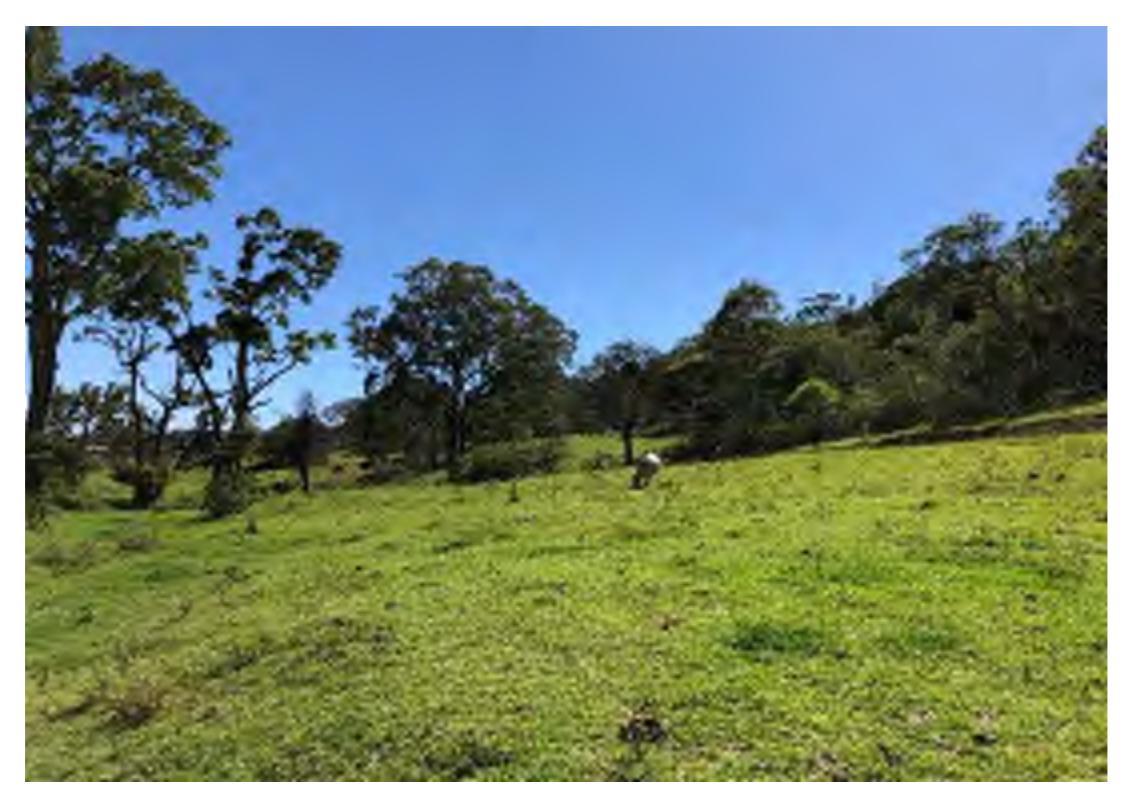
Photograph 45: View from western side of Area 3 looking east

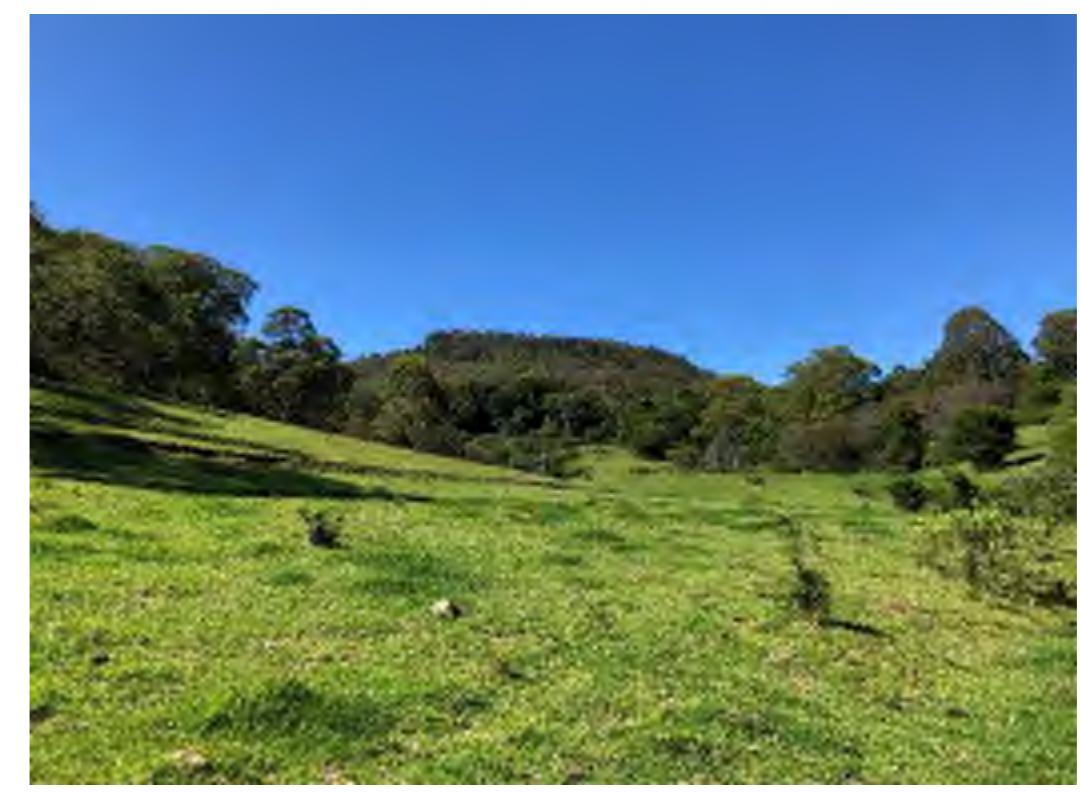
Photograph 46: View looking south west across the western side of Area 3 toward Dam West

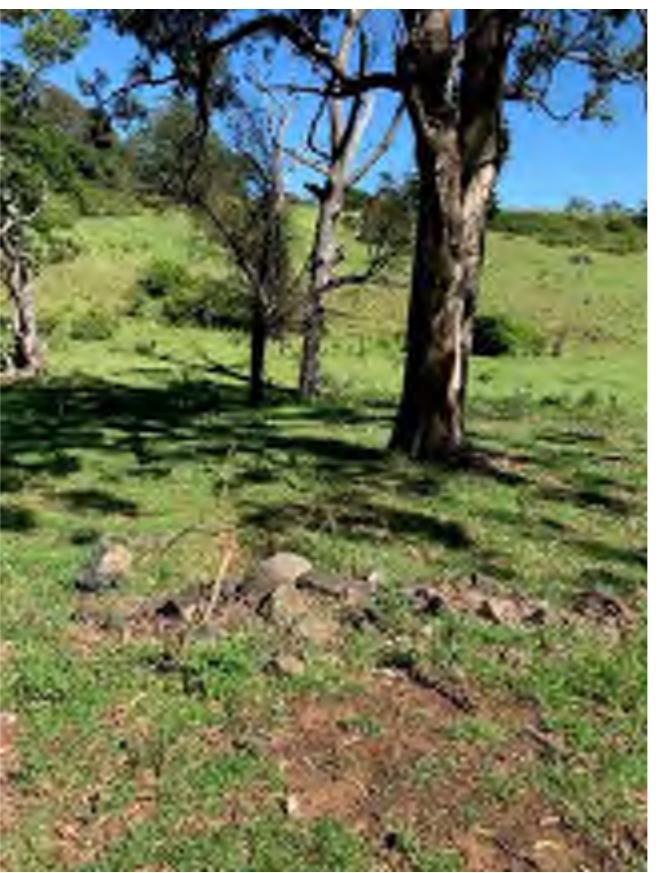
Photograph 47: Showing latite boulders and cobbles in Area 3 from Area 2s escarpment

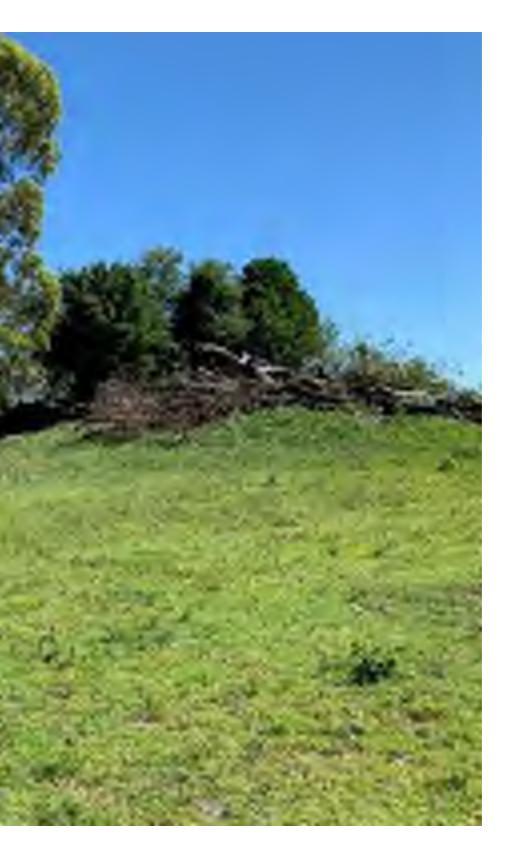
Photograph 48: View looking north at Area 4 from Area 3

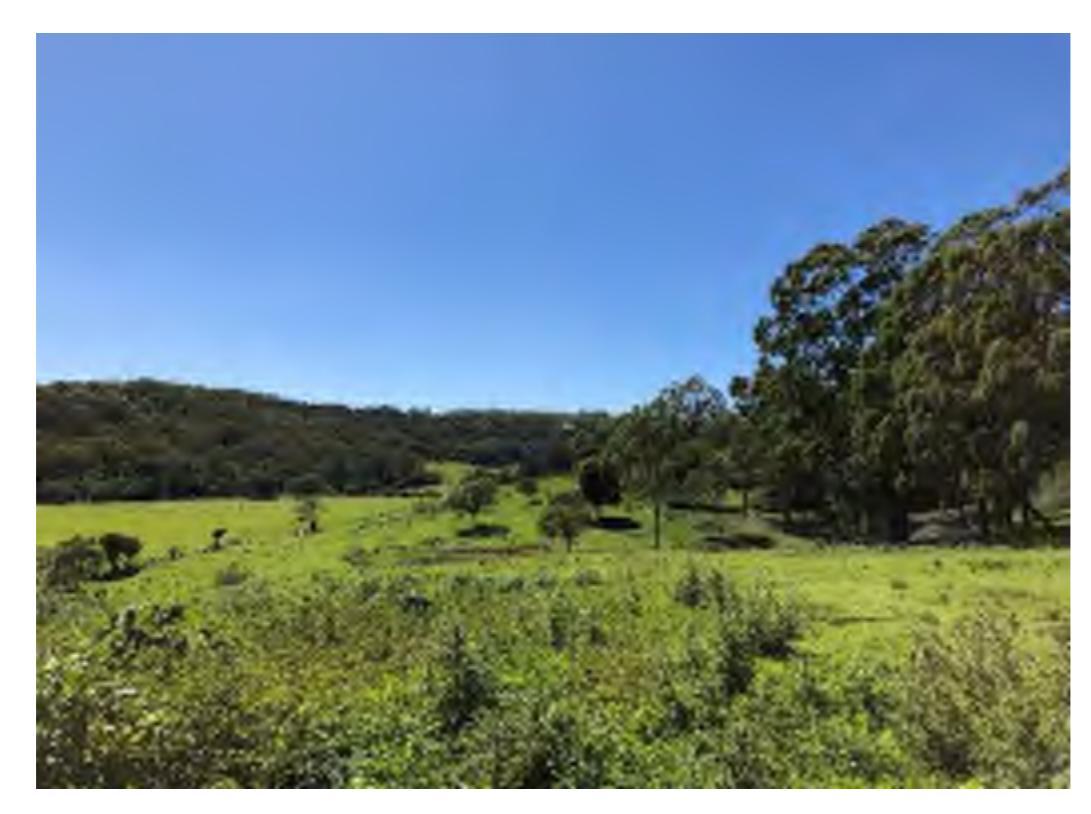
Photograph 49: View from the southern side of Area 4 looking south east over the eastern section of Area 3

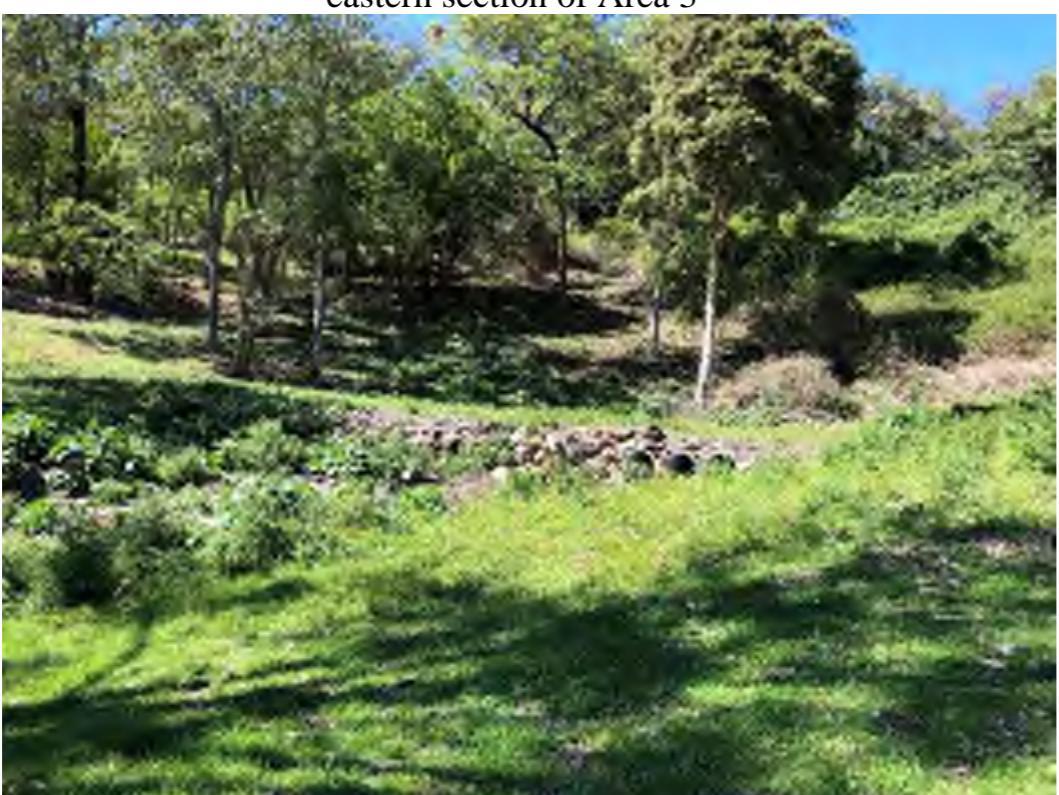
Photograph 51: View looking south from Dam East looking at the storm water culverts under the farm road

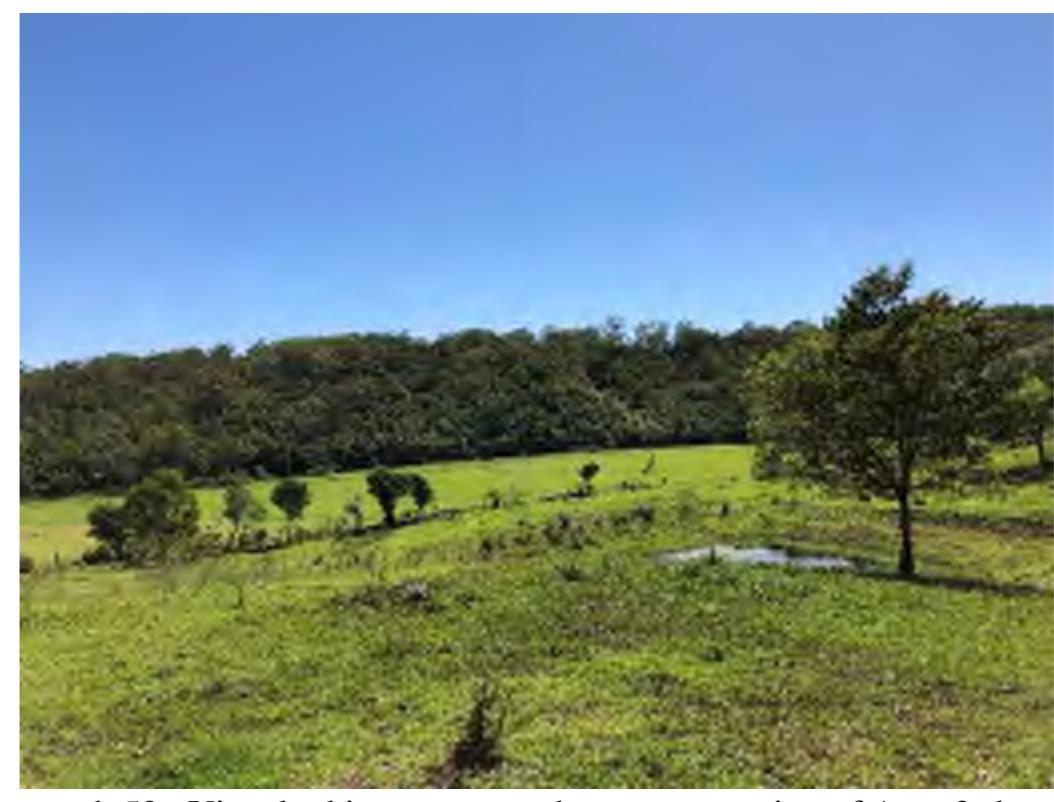
Photograph 50: View looking east over the eastern section of Area 3 showing Dam East

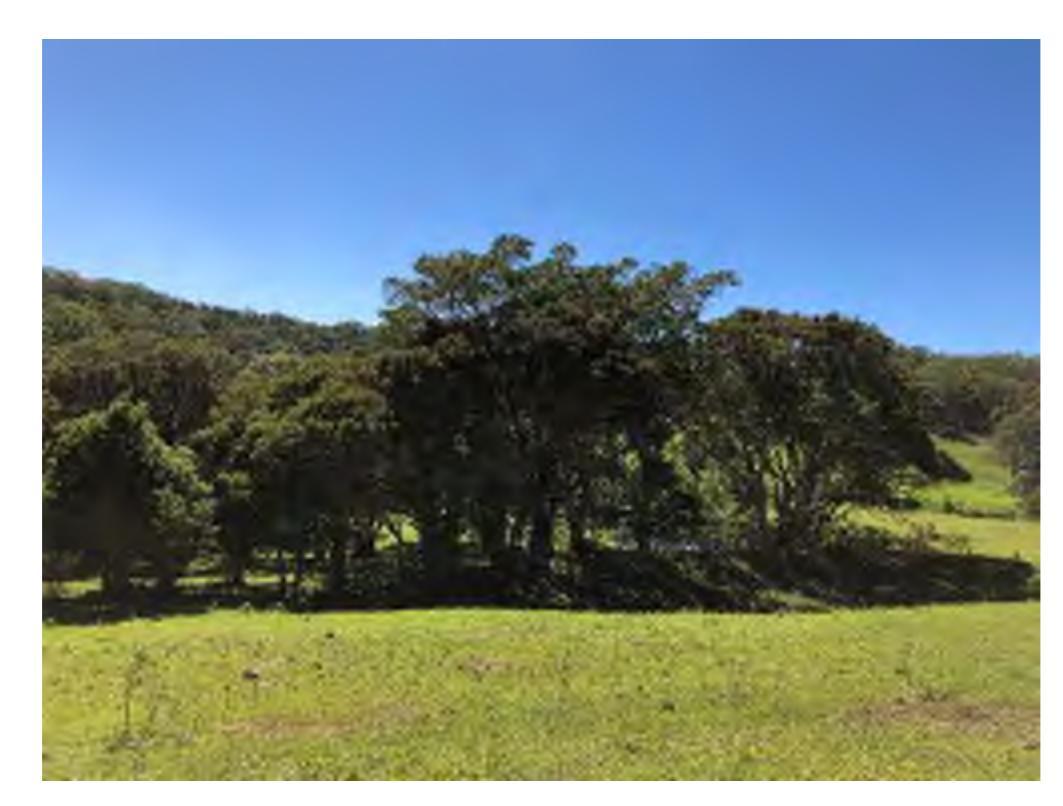
- A dam (named Dame South-East) is located on the eastern part of the site (refer photograph 53). This dam was partly full of water. No signs of seepage were visible down stream. There were minimal signs of erosion.

Photograph 53: View of south eastern section of Area 3.

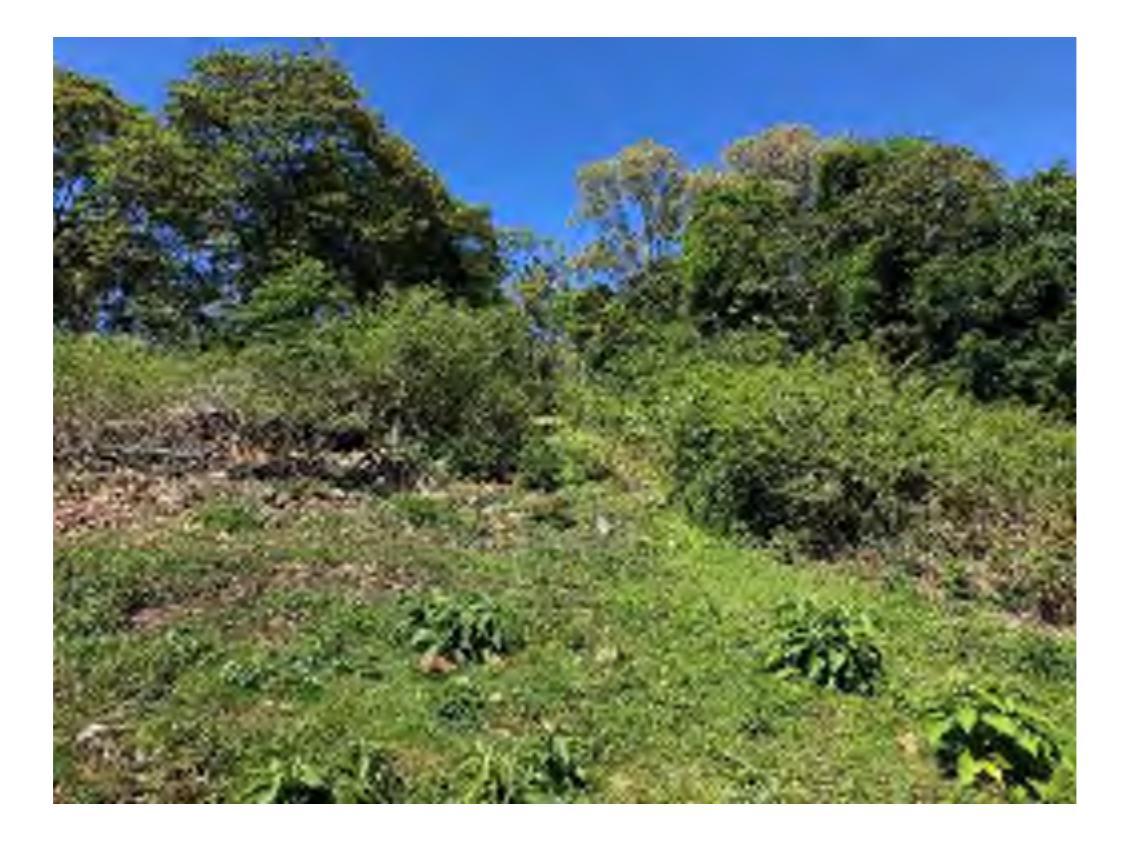
Very steep hill face with loose latite (photograph 54). Very steep hill face with loose latite under vegetation (photographs 55 and 56)

Photograph 55: View looking south from the eastern section of Area 3 up at Area 2. Showing an access track through Area 2 to Terrace 1A

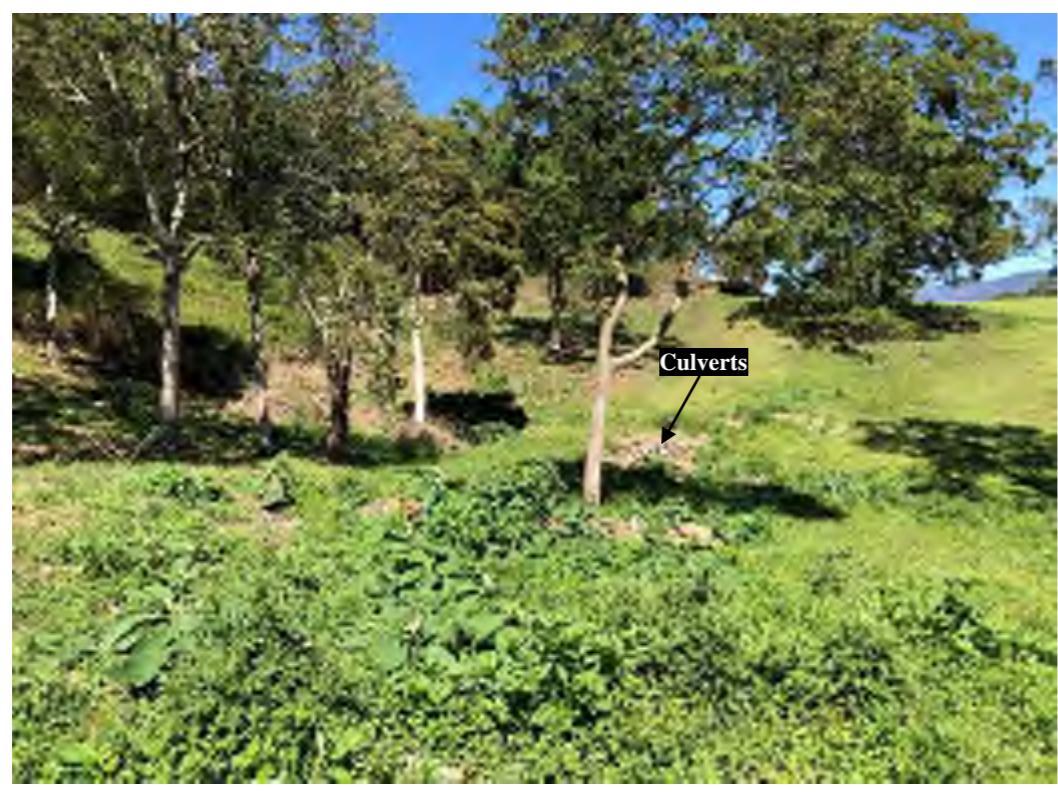
Photograph 57: View looking south west in Area 3 looking toward the culverts under the farm road

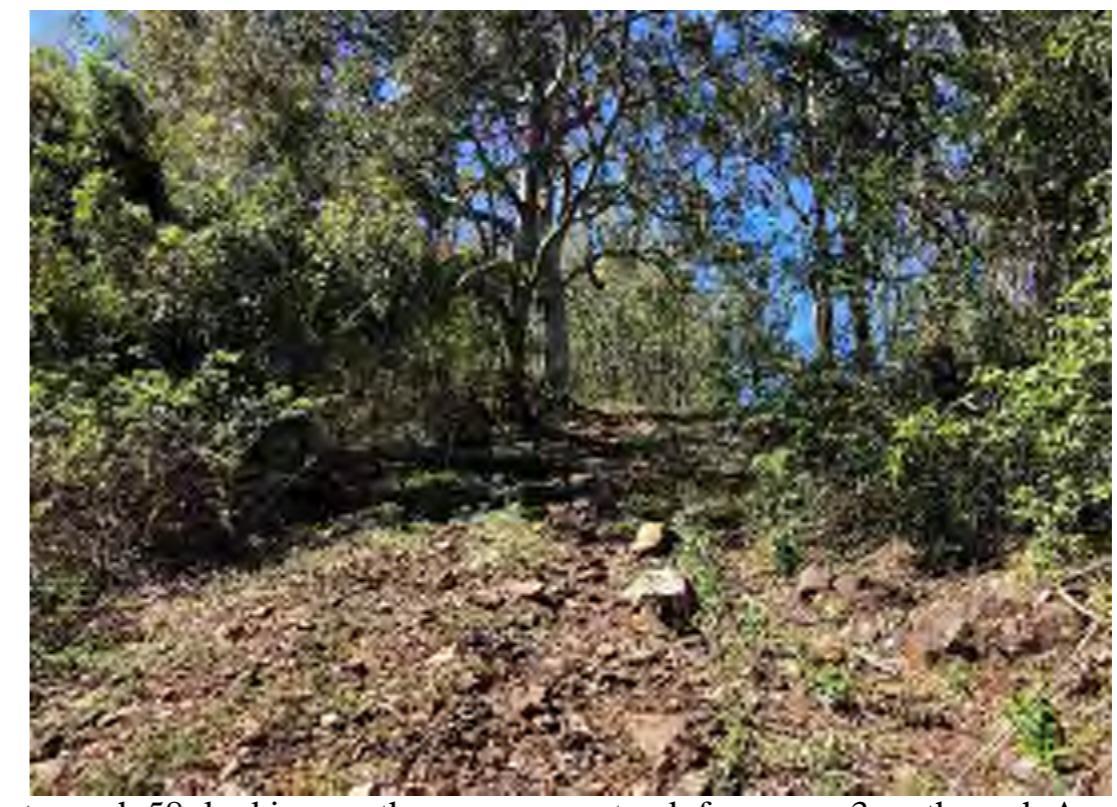
Steep access track with loose latite photograph 58), in-situ latite on the access track (photograph 59)

Photograph 58: looking south up an access track from area 3 up through Area 2 to Terrace 1A

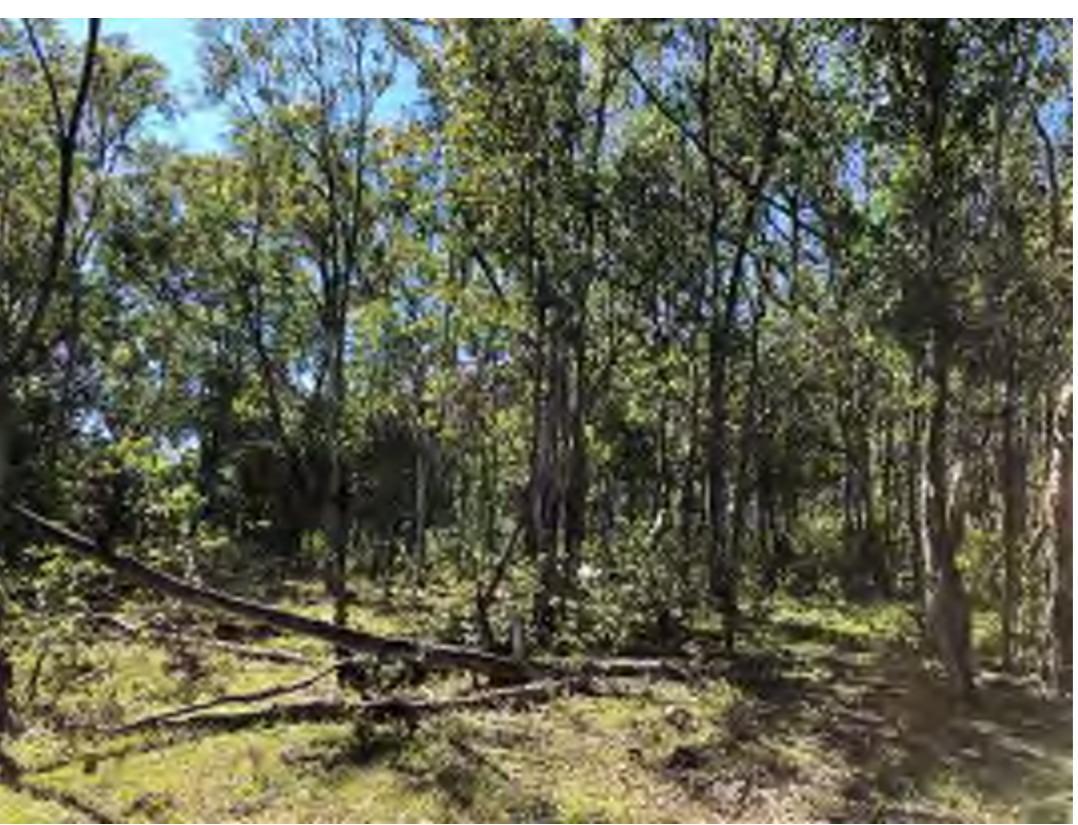
Photograph 60: looking east from the boundary between Area 2 and Terrace 1A
