Residential Subdivision of No. 105 Cooby Road, Tullimbar NSW

Report on Preliminary Geotechnical Assessment

Our Ref: TERRA18320.Rep1.Rev1

15 August 2019

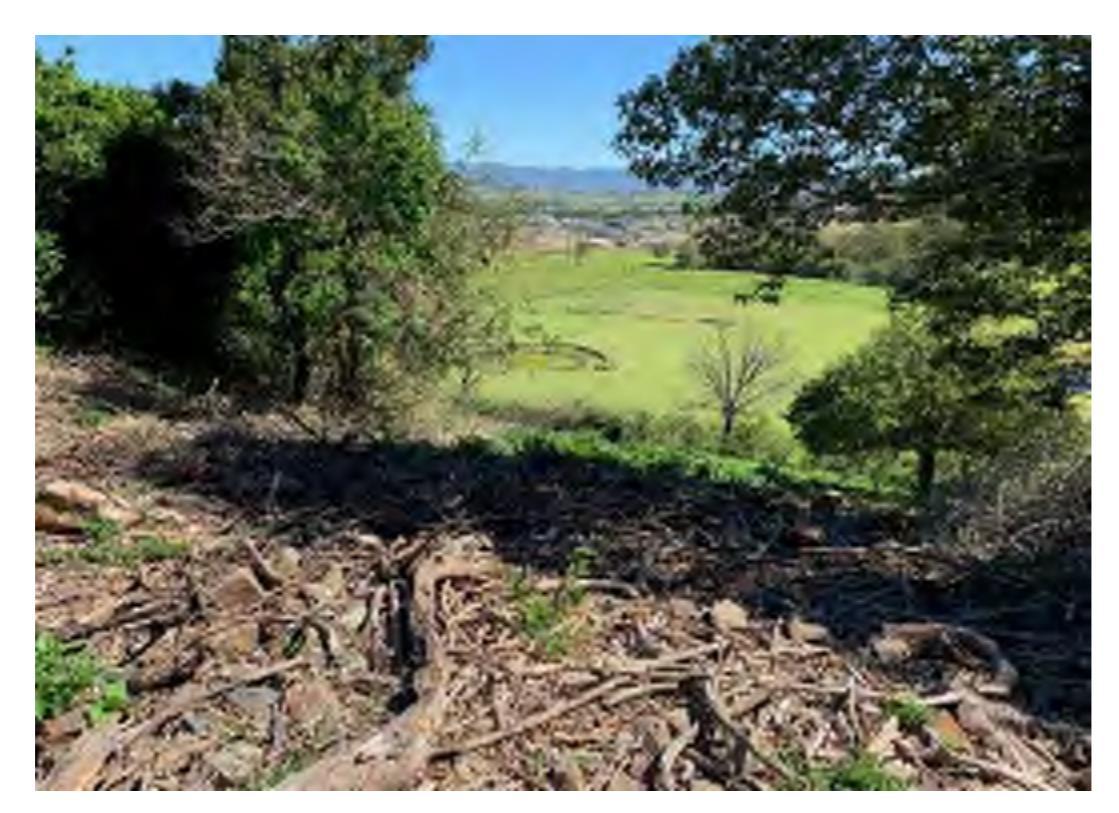
Photograph 61: View from the top of Zone 4 looking down the western slope

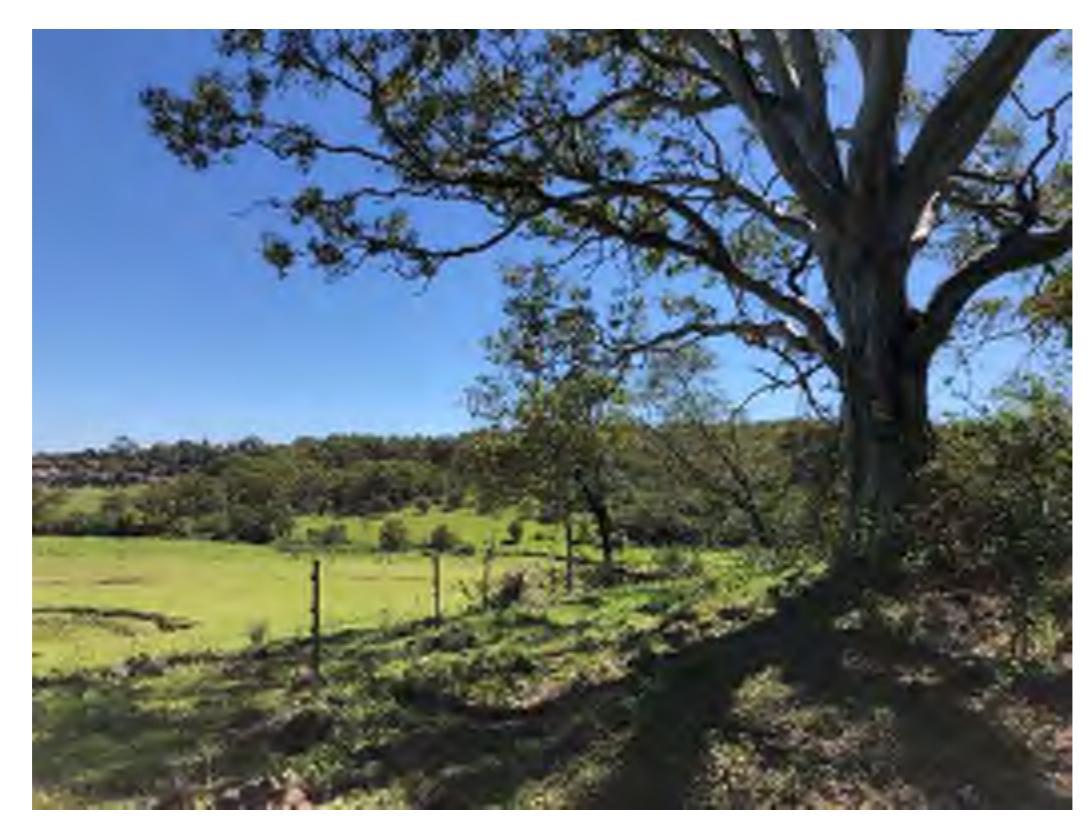
Photograph 63: View looking east at the northern side of Area 4

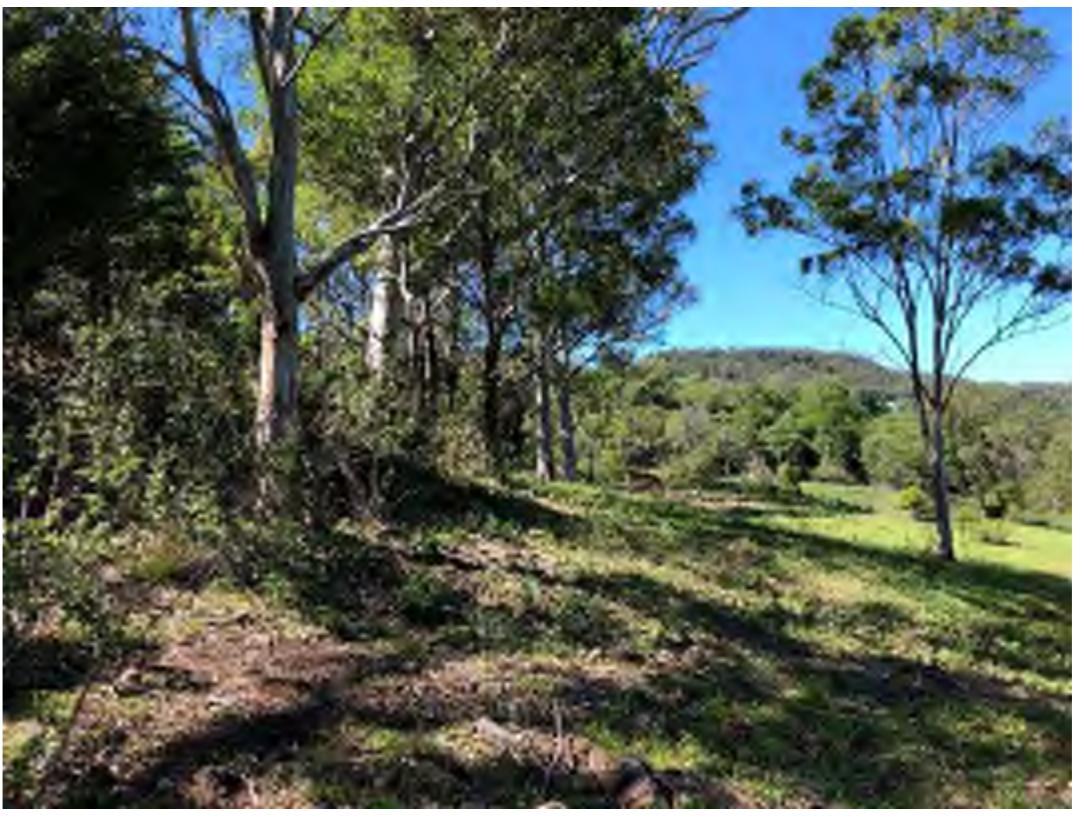
Photograph 64: Looking south down the western side of Area 4
