Report on  
Stability Assessment

Proposed Residential Subdivision  
South Creek West, Precinct 5, Cobbitty

Project 92225.06  
March 2023

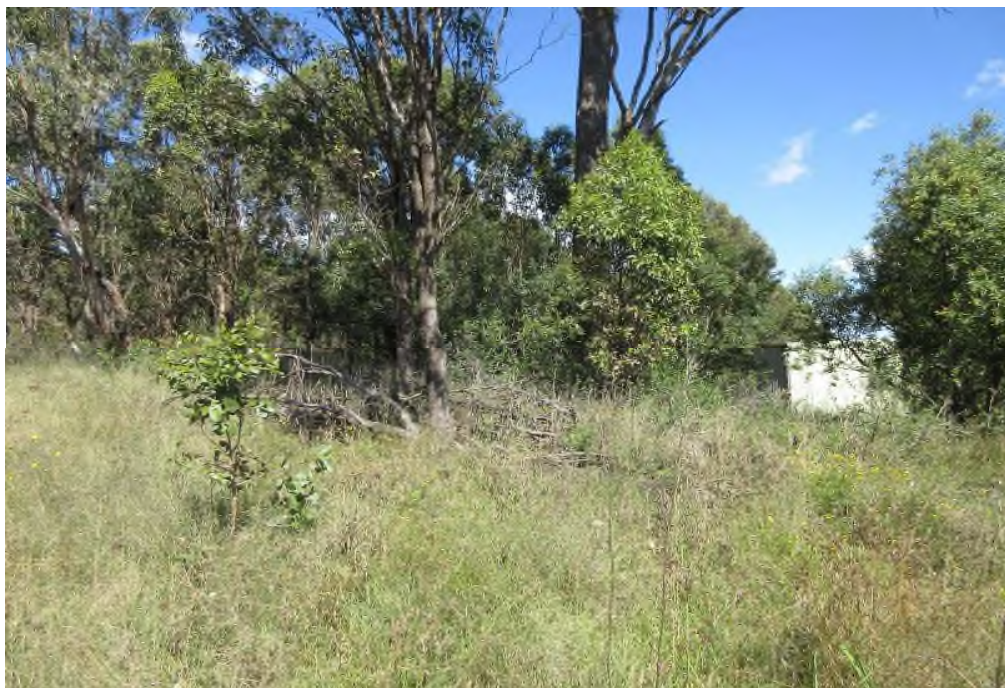
Photo 1 - View towards the west near Test Pit 301, near the crest of the ridgeline.

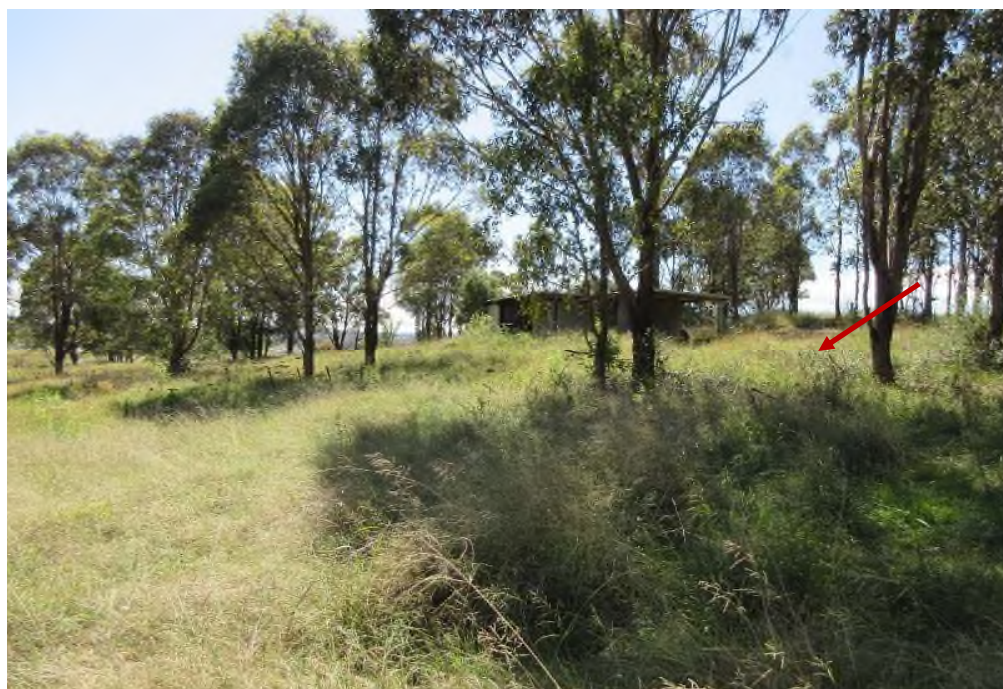
Photo 2 - View towards the south-east near Test Pit 301. The approximate test location is indicated.

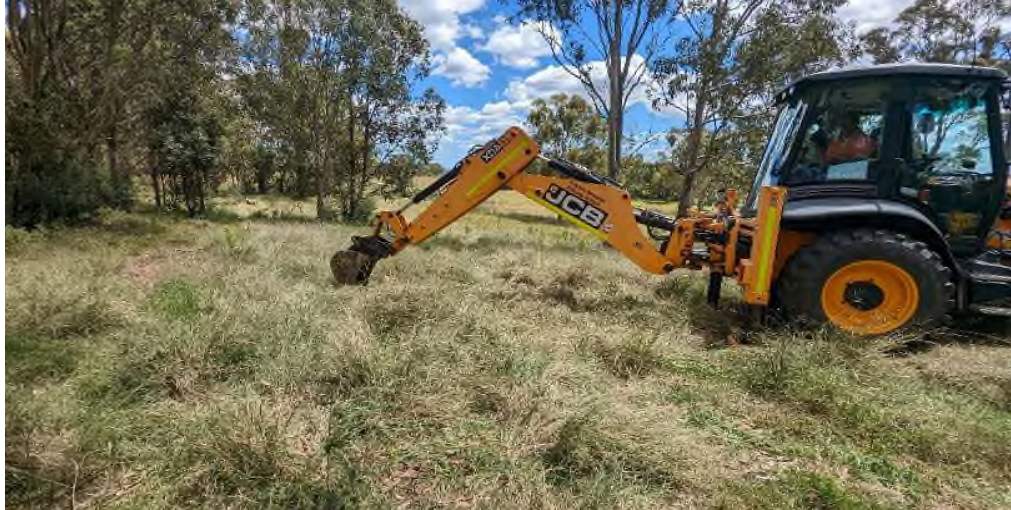
Photo 3 - View towards the west at Test Pit 301.

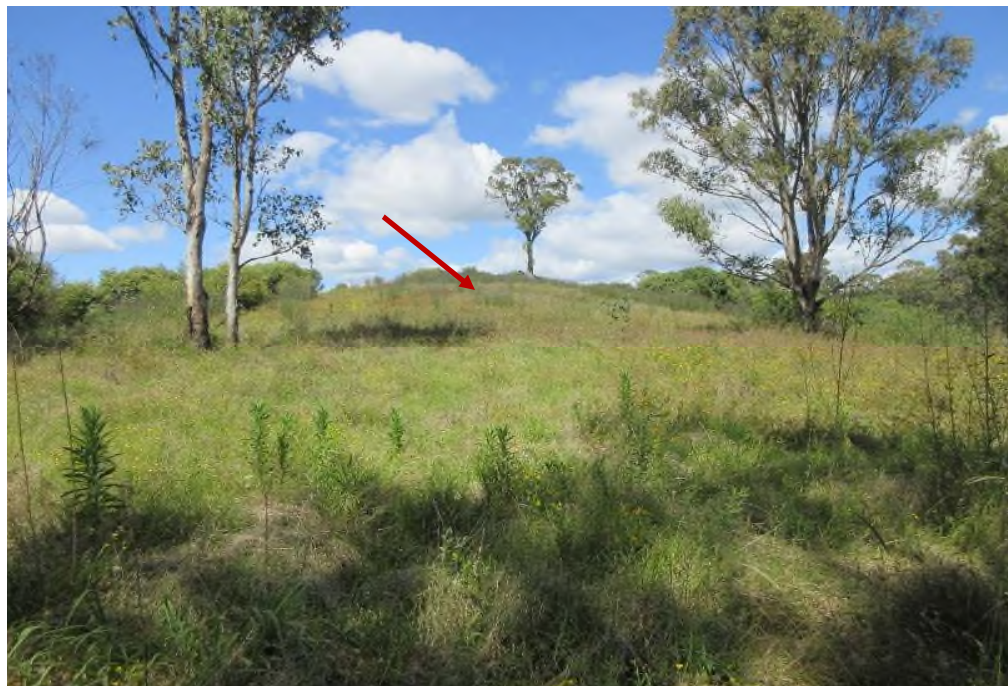
Photo 4 - View towards the south-west and Test Pit 302. The approximate test location is indicated.

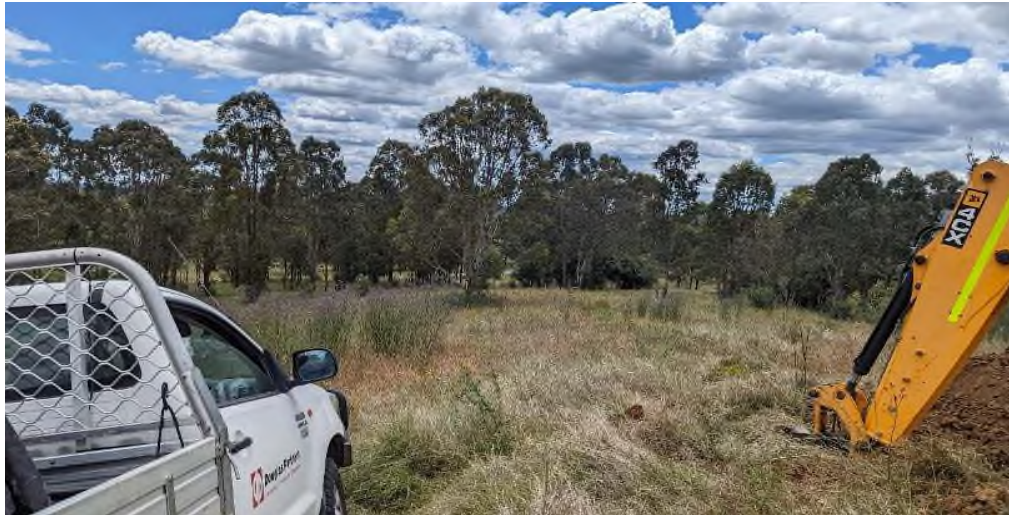
Photo 5 - View towards the north-east and downslope, from the location of Test Pit 302.

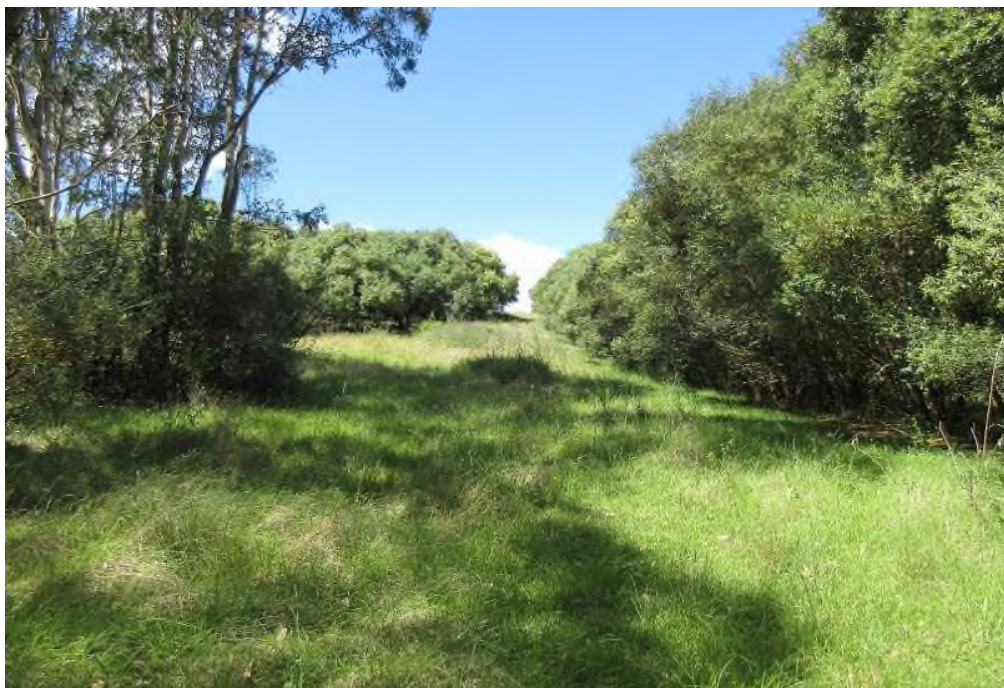
Photo 7 - View towards the south, upslope along a fenceline obscured by wild olives, west of Test Pit 302.

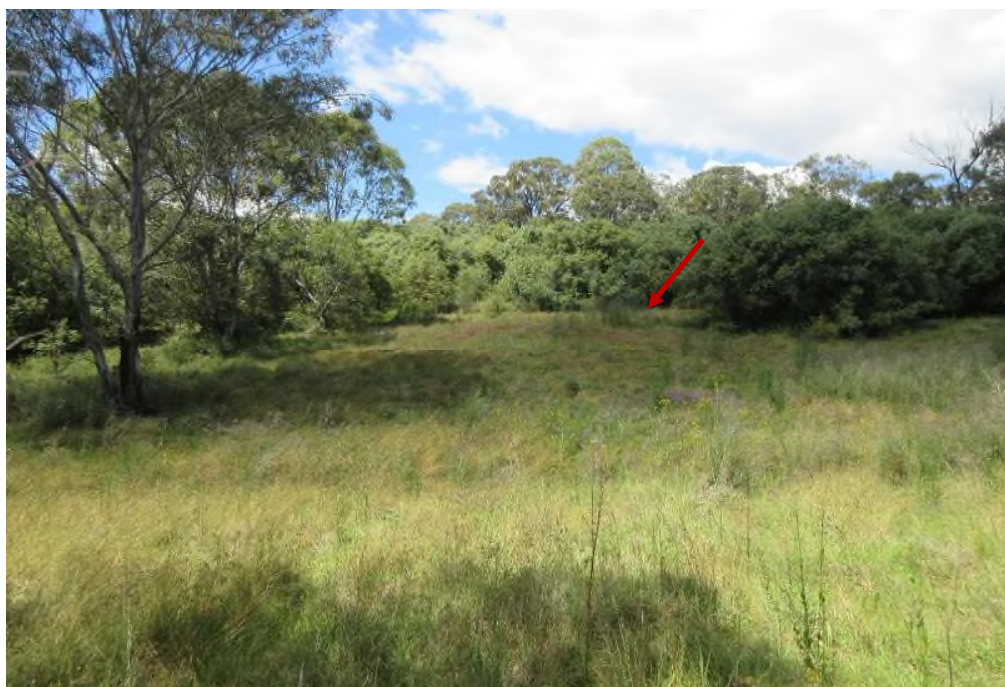
Photo 8 - View towards the south-west. The approximate position of Test Pit 303 is indicated.

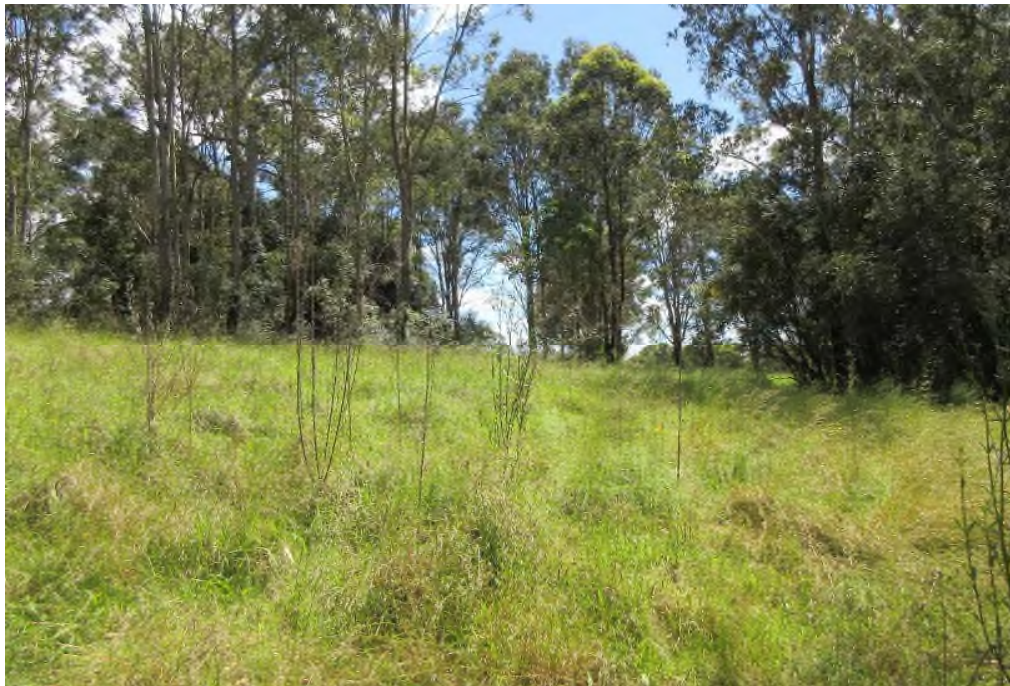
Photo 9 - View towards the north and upslope, east of Test Pit 304.

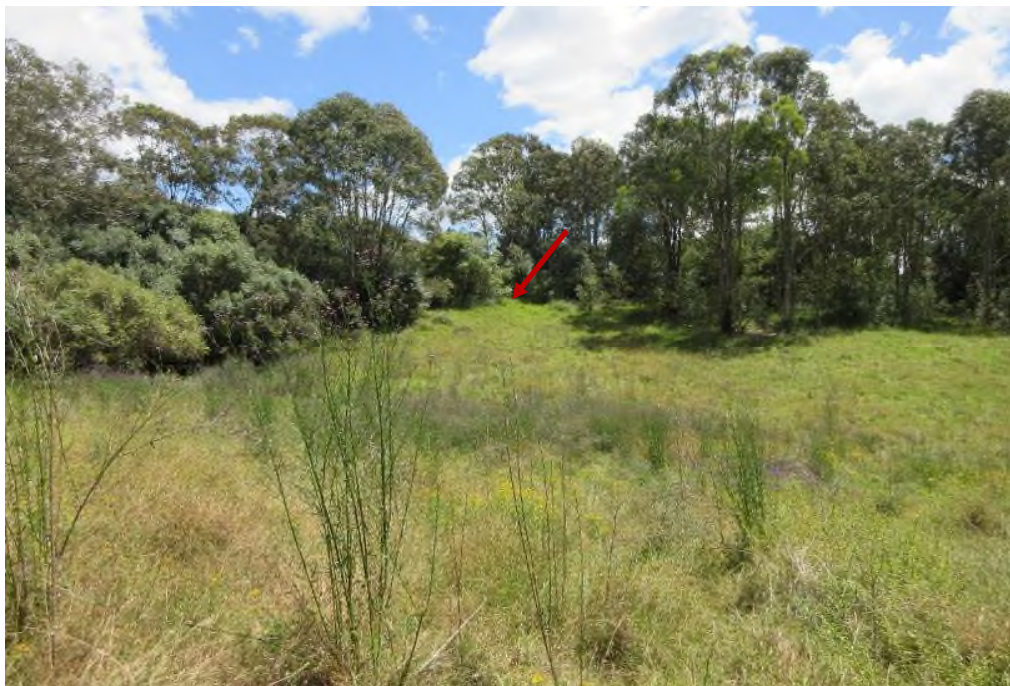
Photo 10 - View north-west towards the location of Test Pit 304. The approximate test location is indicated.

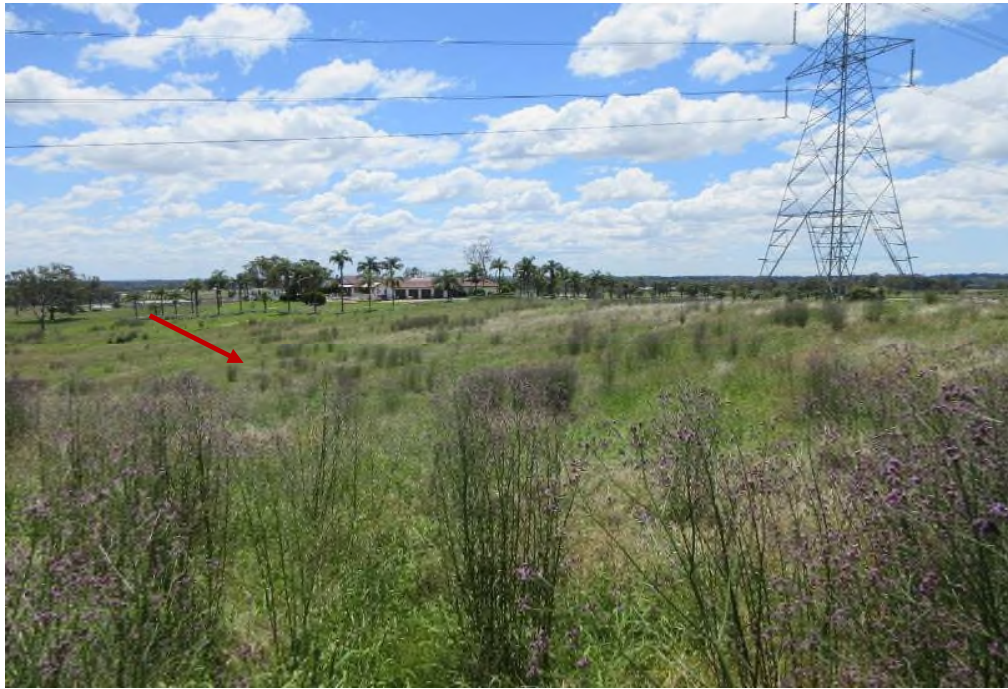
Photo 11 - View north towards the location of Test Pit 305. The approximate position of the test location is indicated.

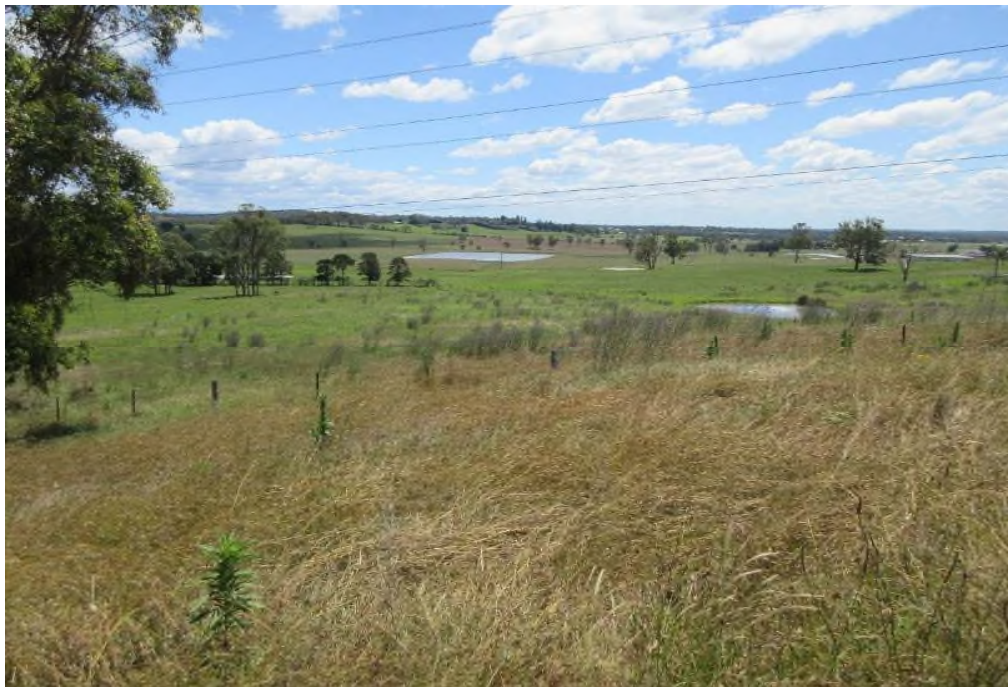
Photo 12 - View north-west, upslope and south of the location of Test Pit 305.

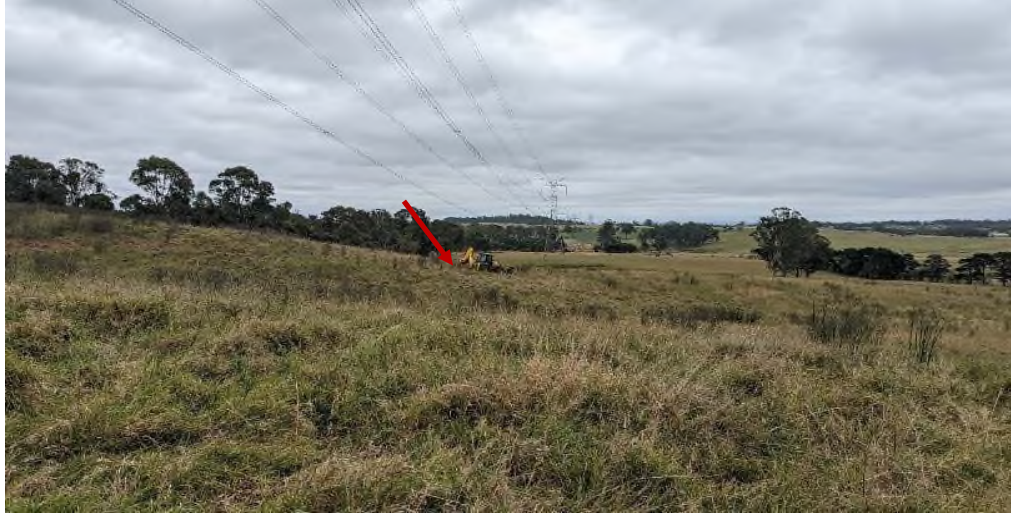
Photo 13 - View west towards the location of Test Pit 305. The approximate test location is indicated.

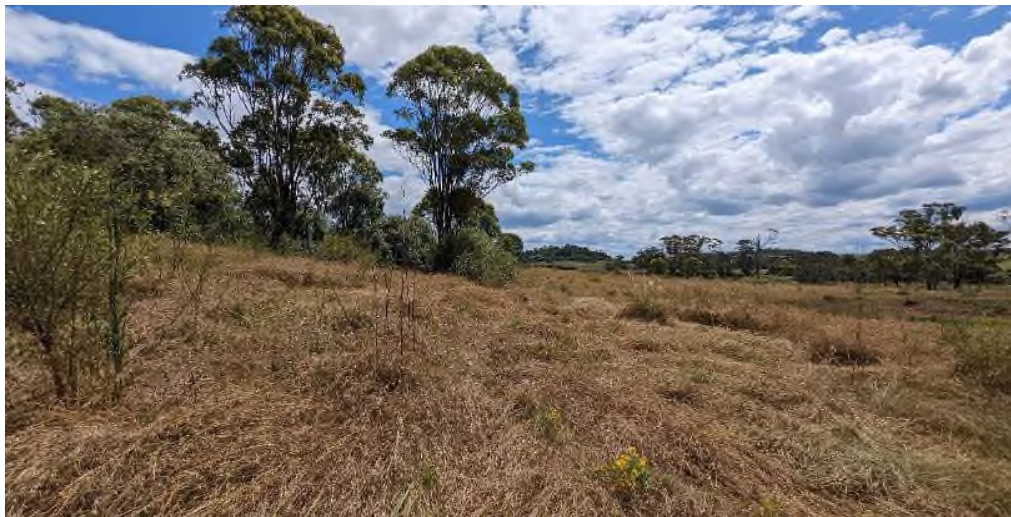
Photo 14 - View west from the location of Test Pit 306.

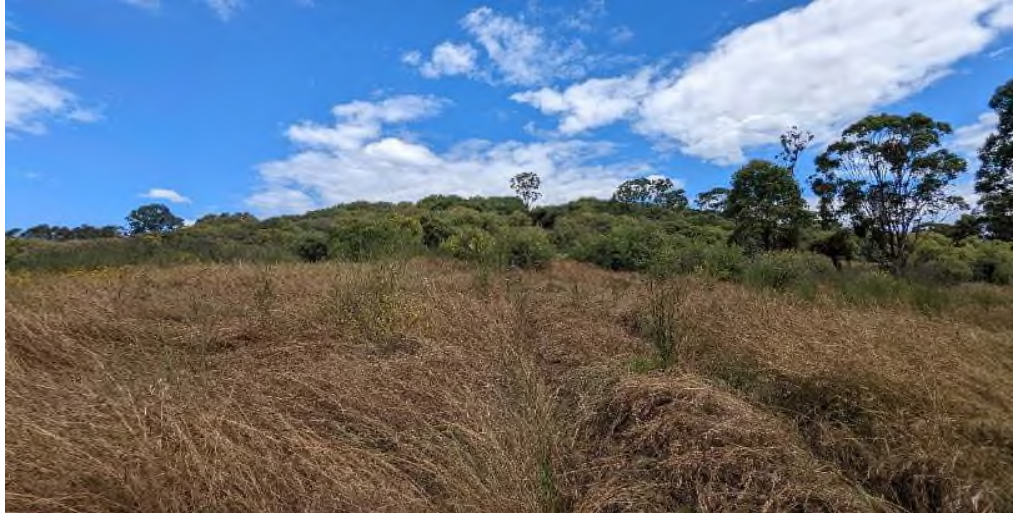
Photo 15 - View south from the location of Test Pit 307.

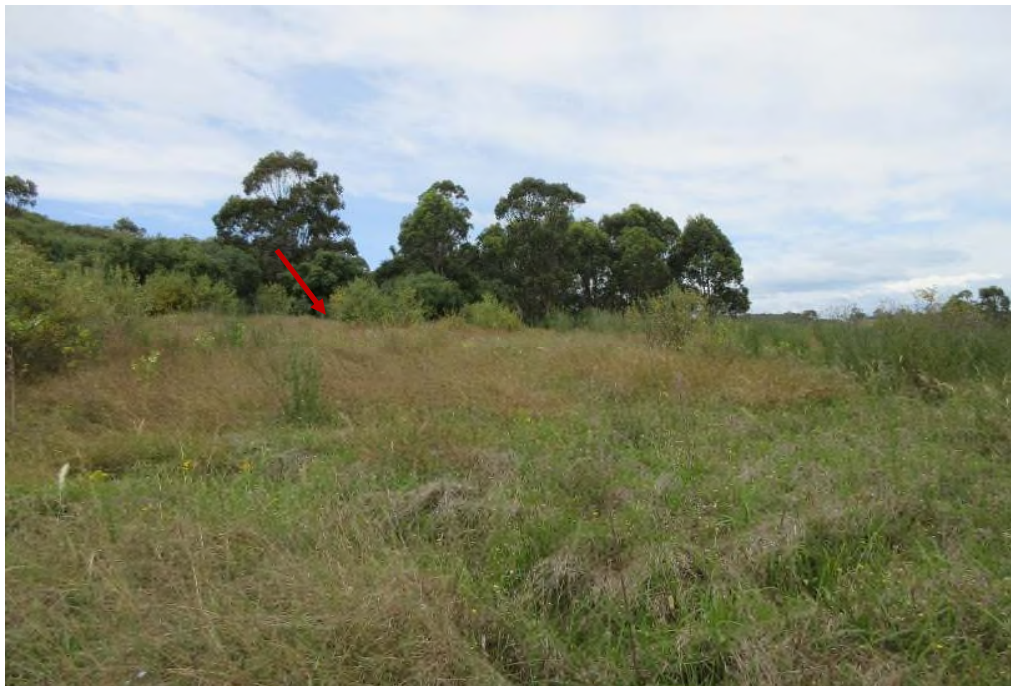
Photo 16 - View south-east towards the location of Test Pit 308. The approximate test location is indicated.

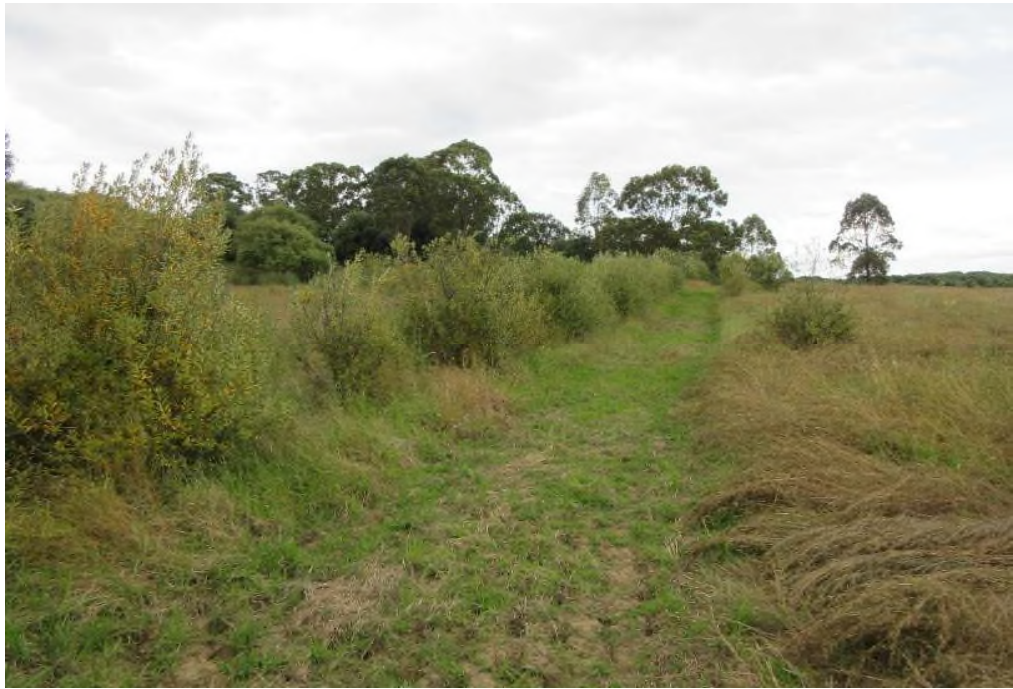
Photo 17 - View south along a fenceline, west of Test Pit 308.

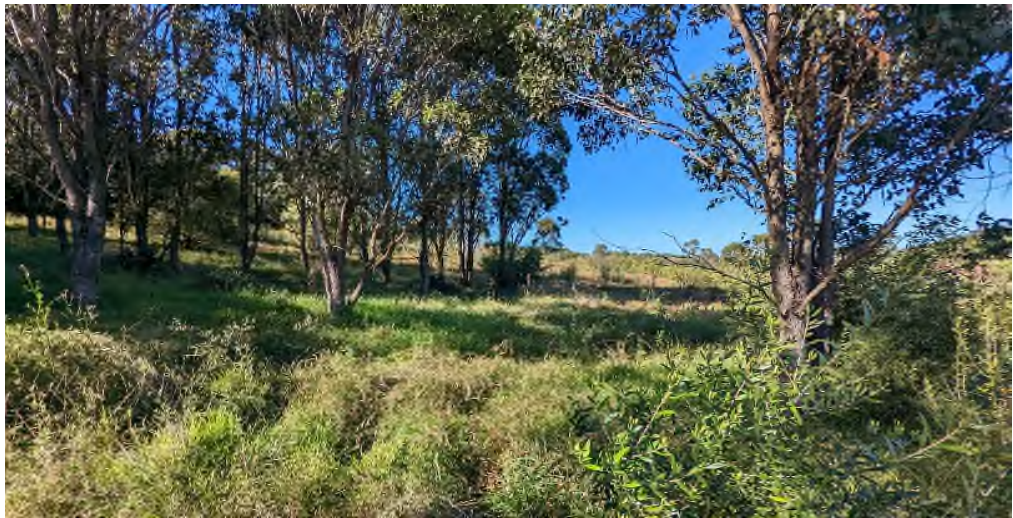
Photo 18 - View south from the location of Test Pit 308.

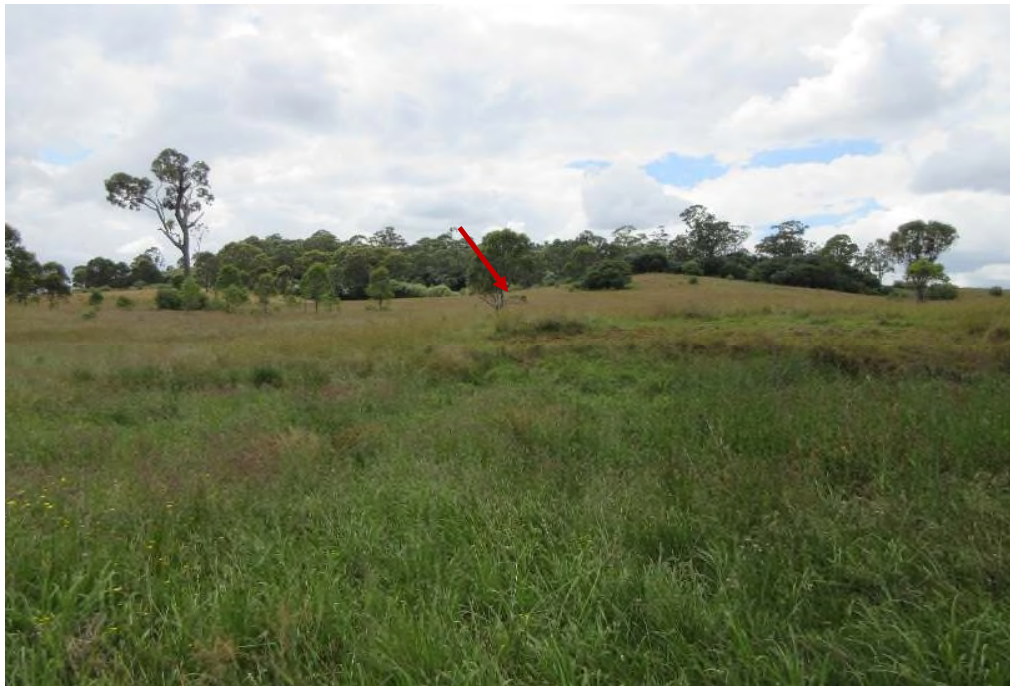
Photo 19 - View east towards the ridgeline and the location of Test Pit 309. The approximate test location is indicated.

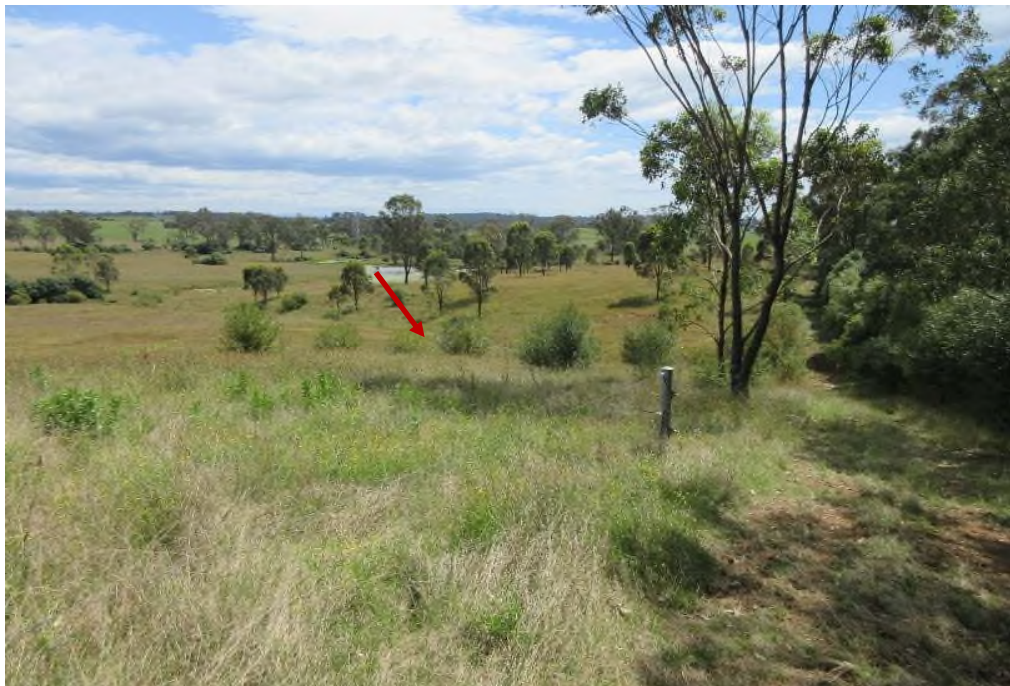
Photo 20 - View north towards the location of Test Pit 309 on the slope below. The approximate test location is indicated.

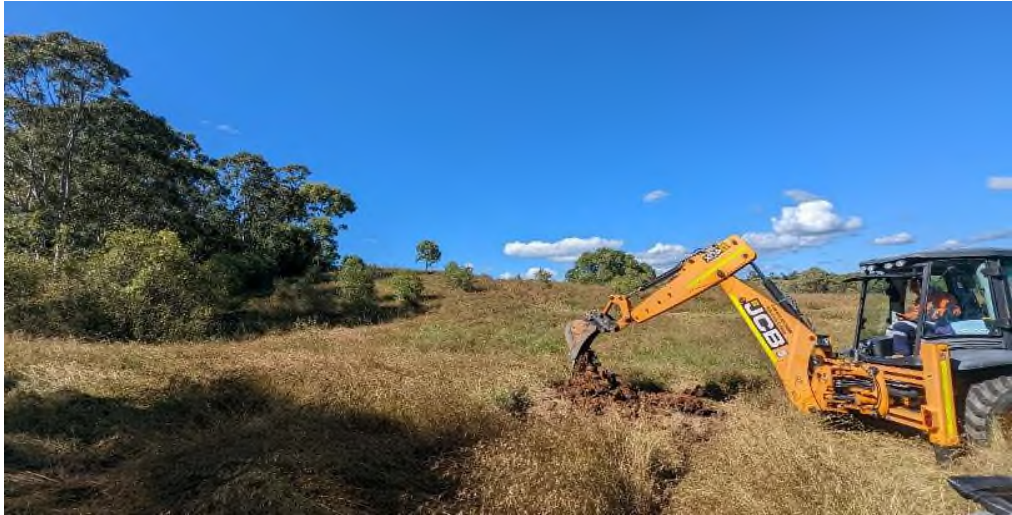
Photo 21 - View south-east at the location of Test Pit 309.

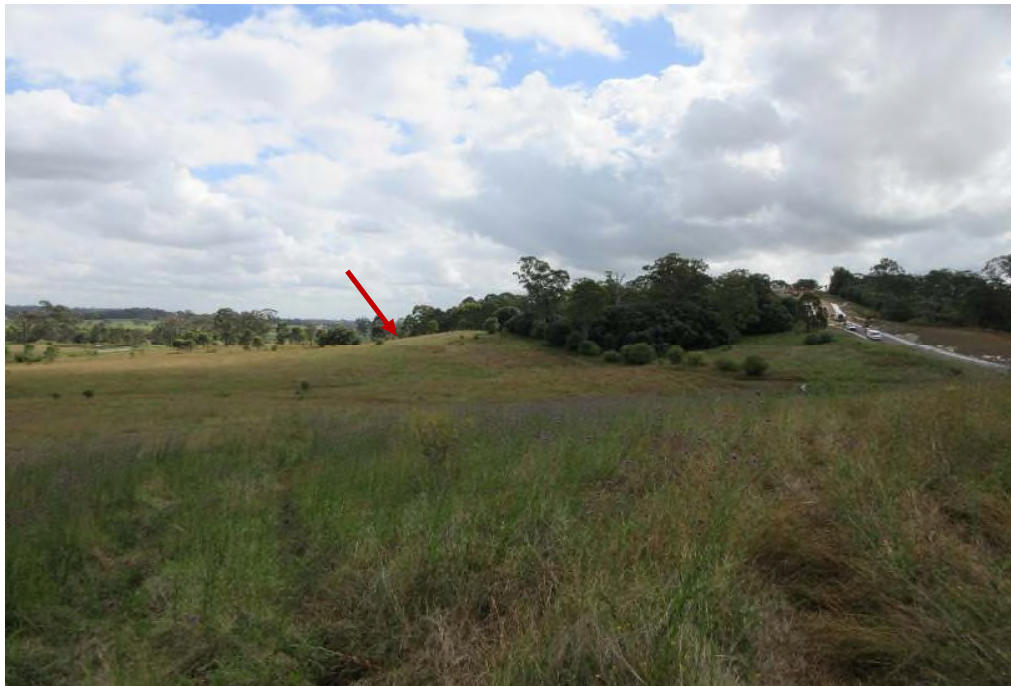
Photo 22 - View north from the location of Test Pit 310 towards Test Pit 309 (obscured on far side of side-slope).

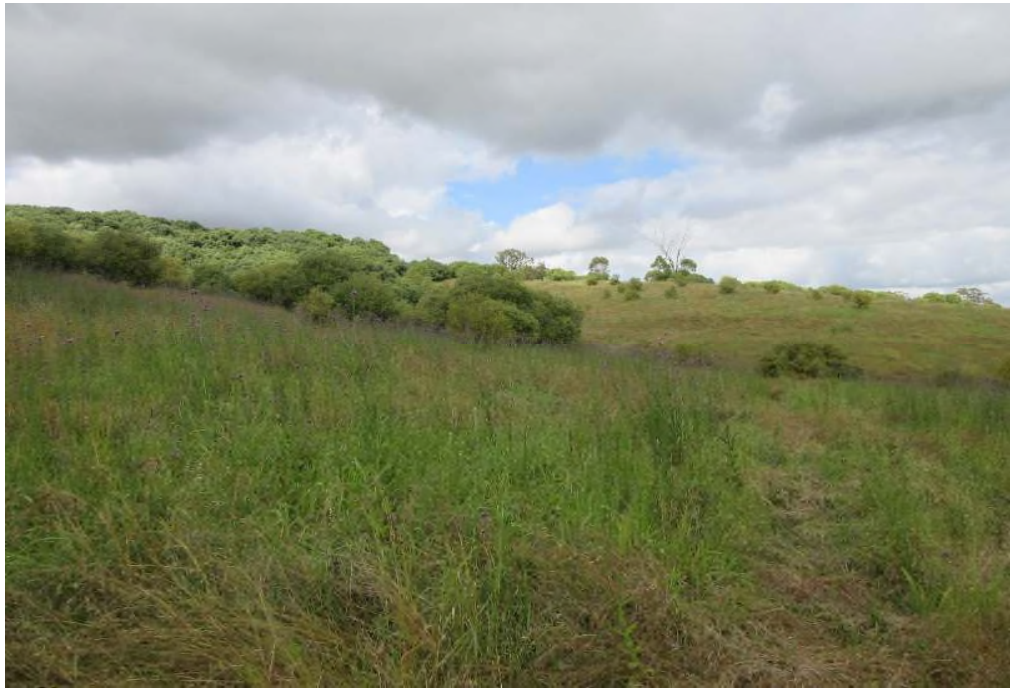
Photo 23 - View west near the location of Test Pit 311.

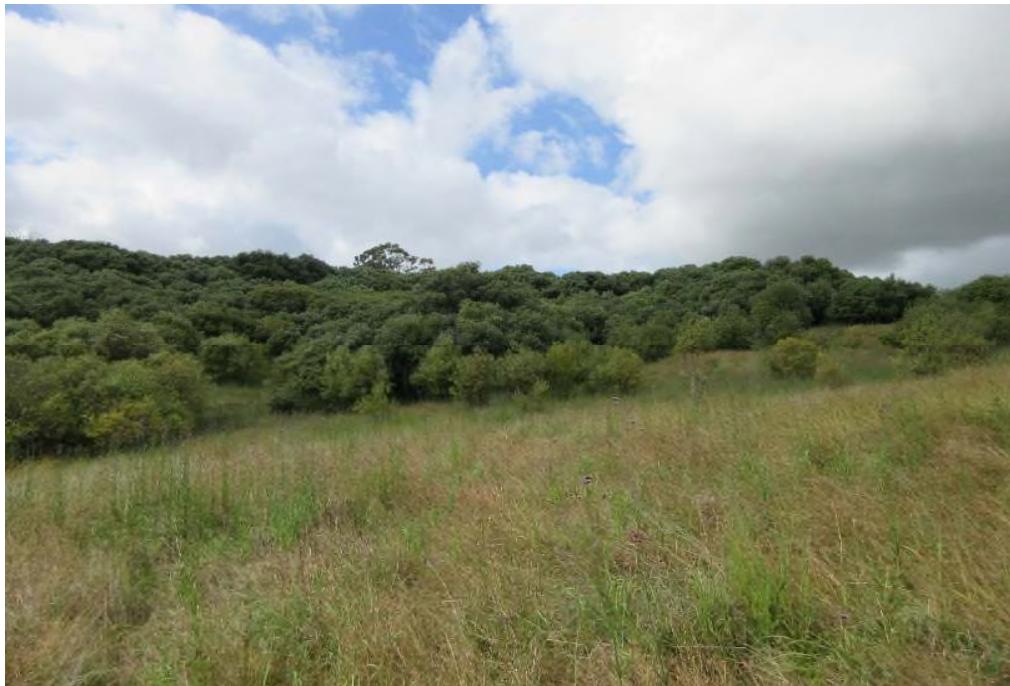
Photo 24 - View south-west towards a nearby ridgeline on an adjoining property, west of Test Pit 311.

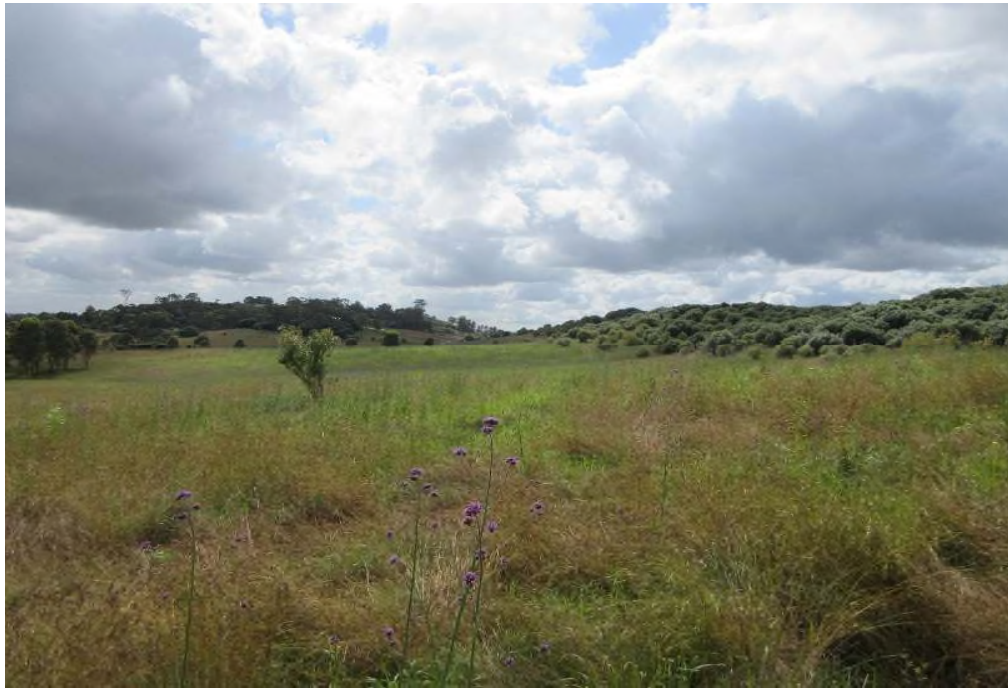
Photo 25 - View east from the neighbouring Lot towards the location of Test Pit 311.

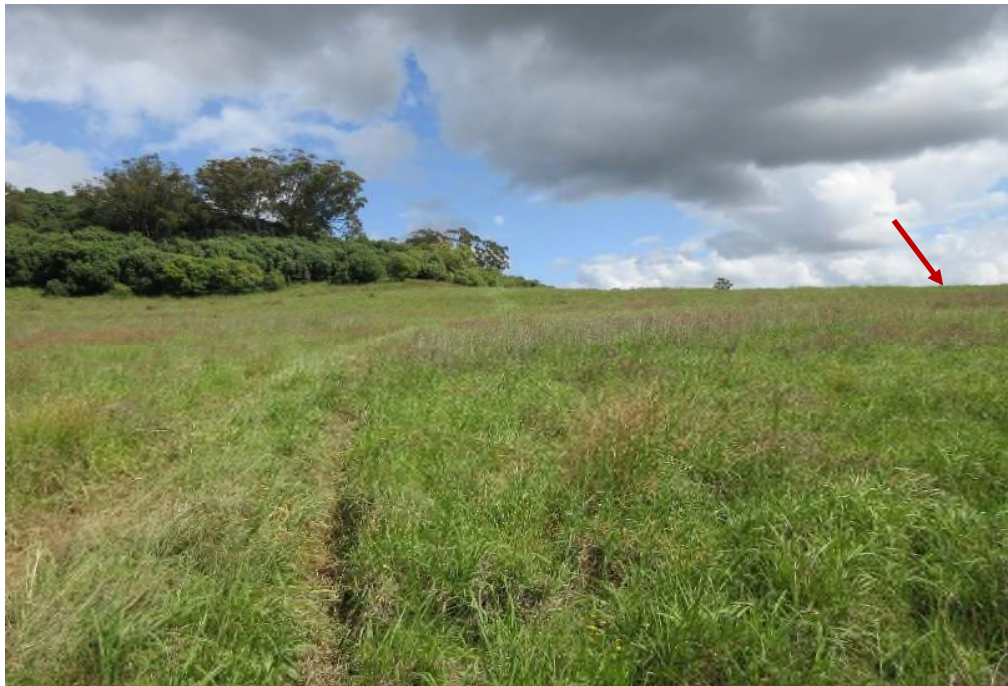
Photo 26 - View north and upslope towards the location of Test Pit 312. The test pit is positioned near the crest of the slope.

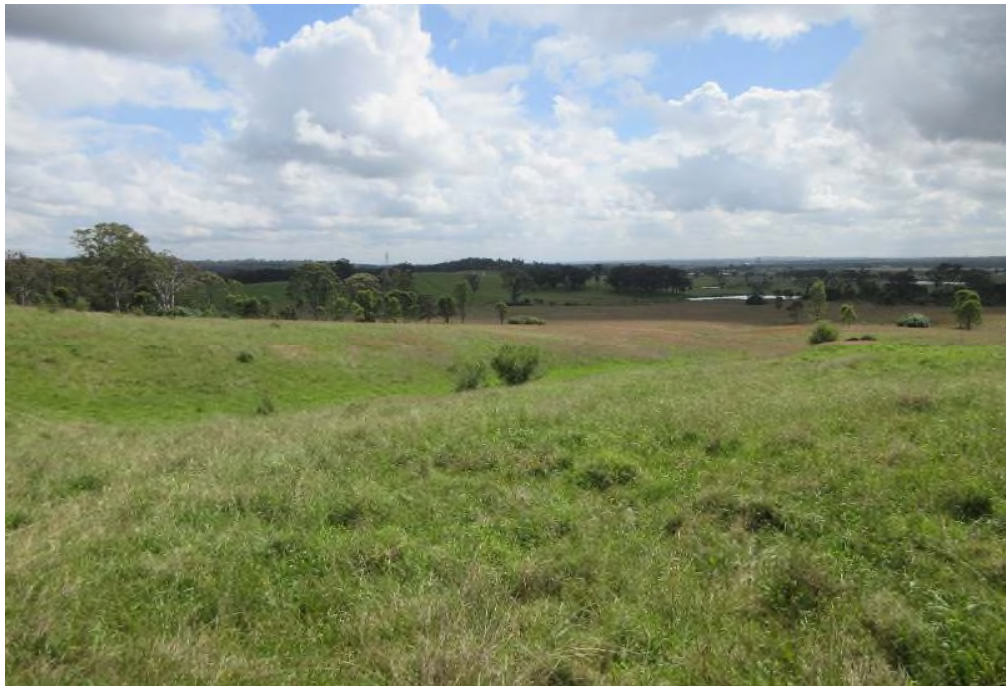
Photo 27 - View east at the location of Test Pit 312, towards a shallow gully.

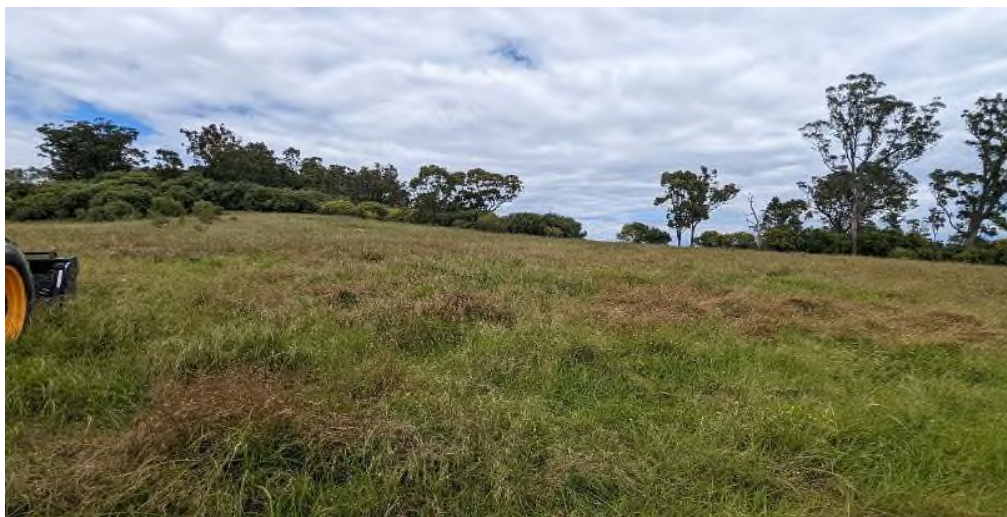
Photo 28 - View west and upslope to a neighbouring property from the location of Test Pit 313.

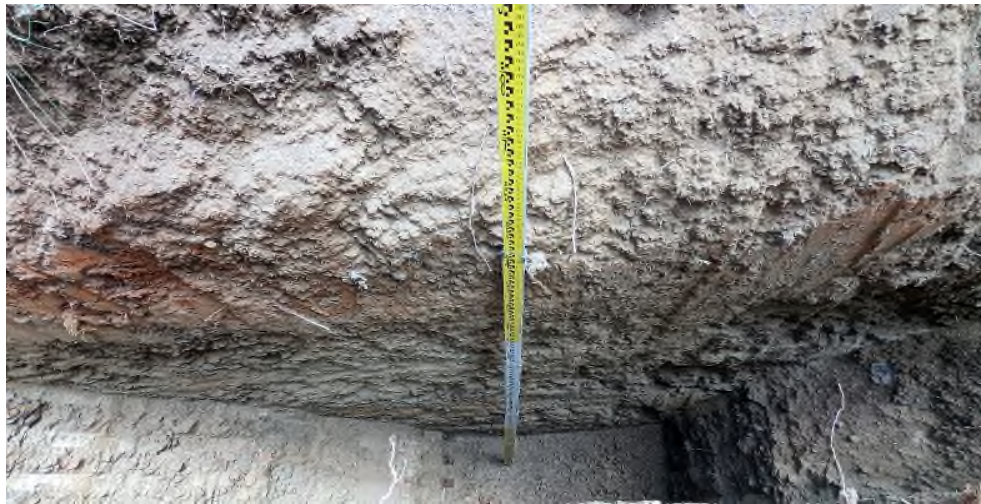
Photo 1 - View of side of Test Pit 301

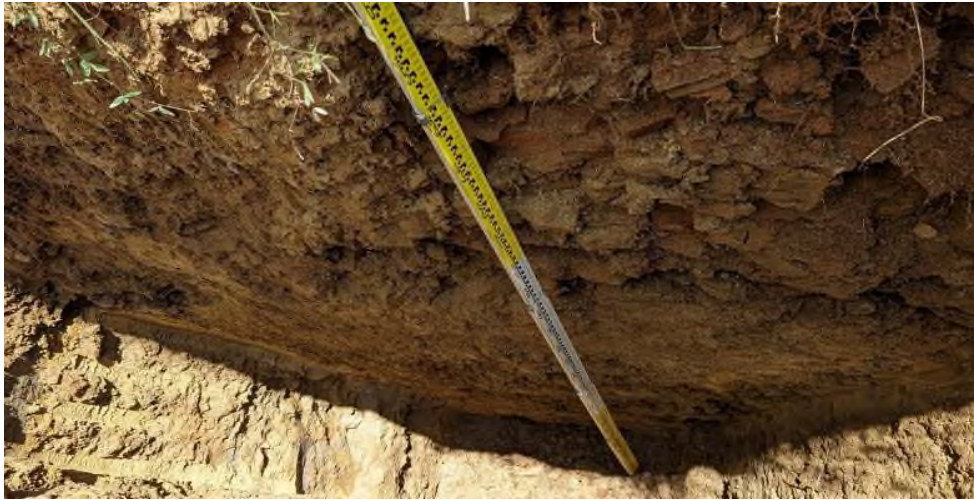
Photo 3 - View of side of Test Pit 302

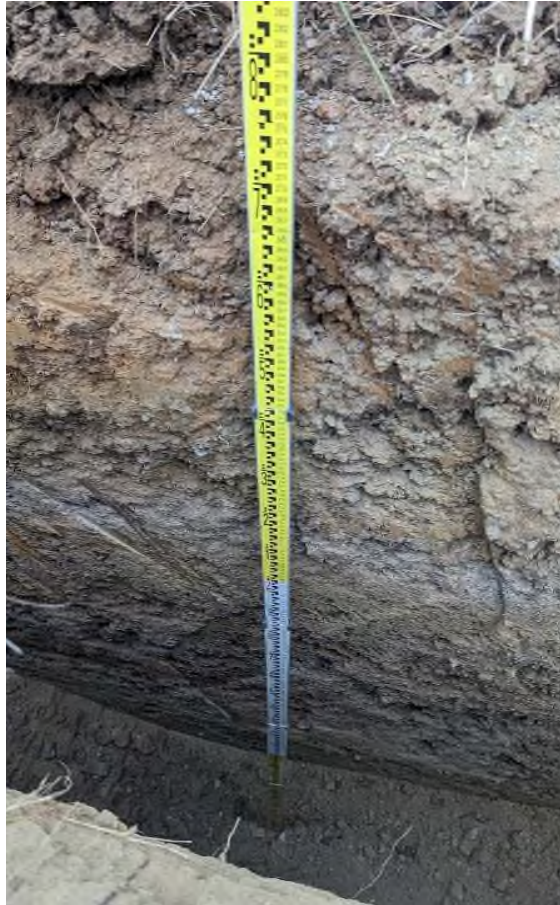
Photo 4 - View of side of Test Pit 303

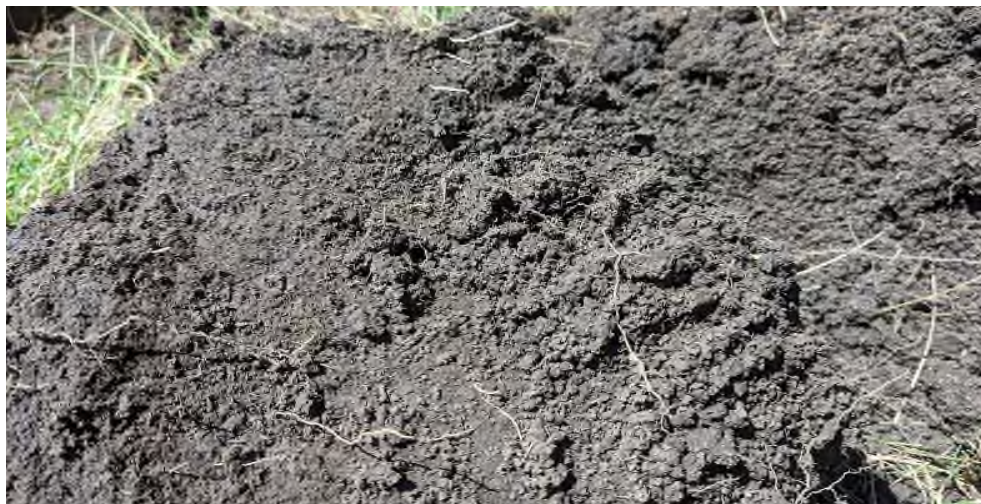
Photo 5 - View of inferred colluvial spoil from Test Pit 303

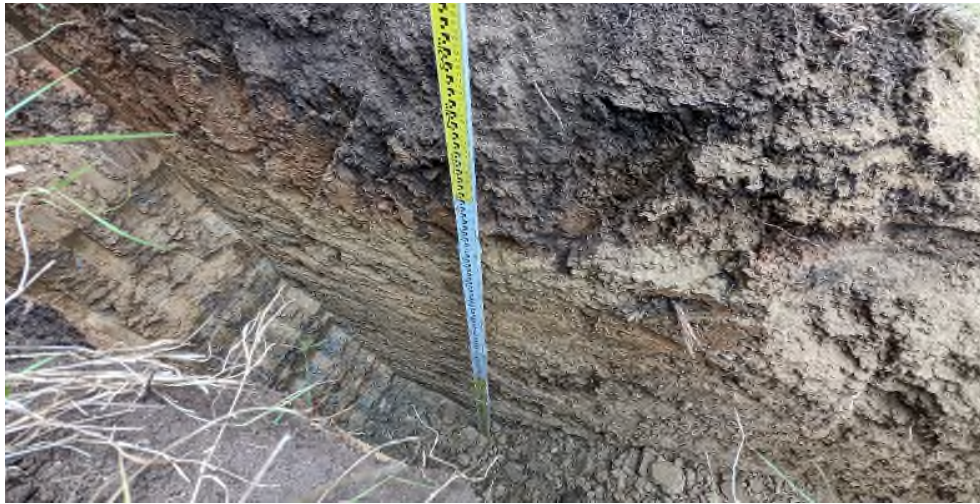
Photo 6 - View of side of Test Pit 304

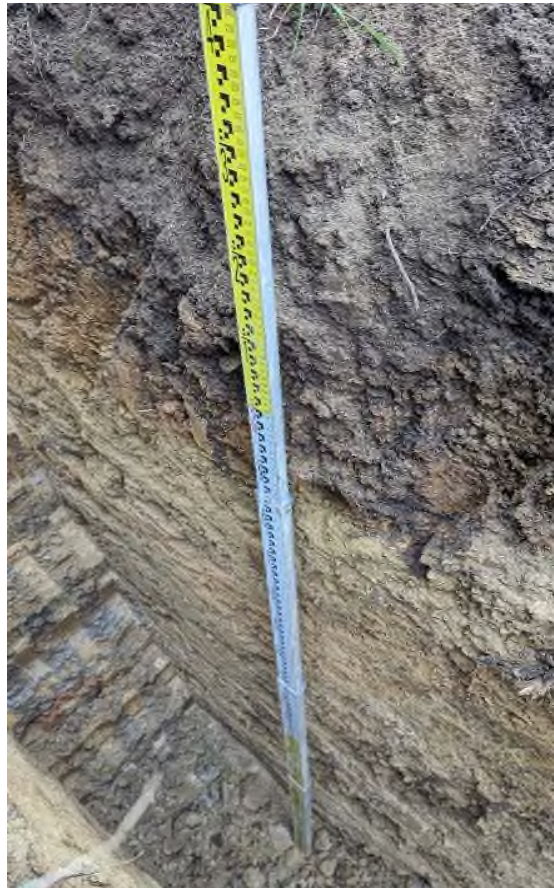
Photo 7 - View of side of Test Pit 304

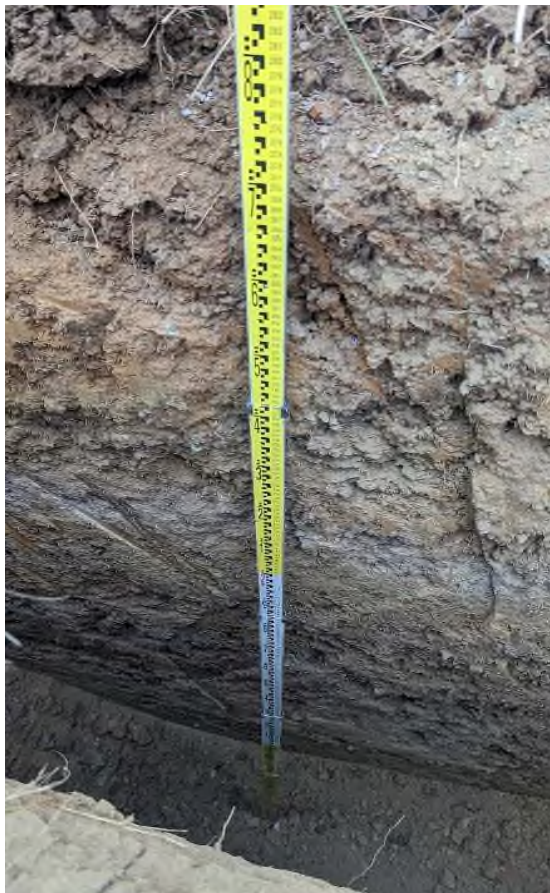
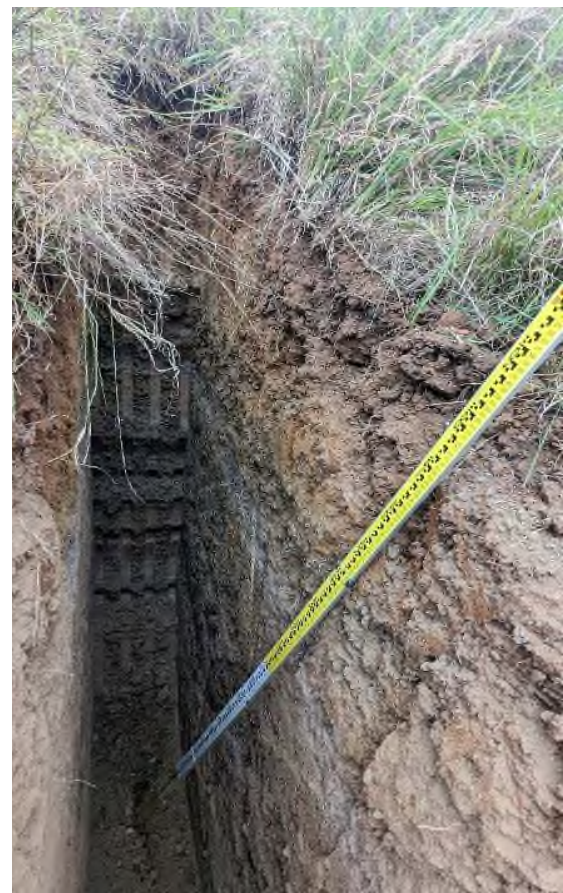
Photographs 8 and 9 - View of side and end of Test Pit 305

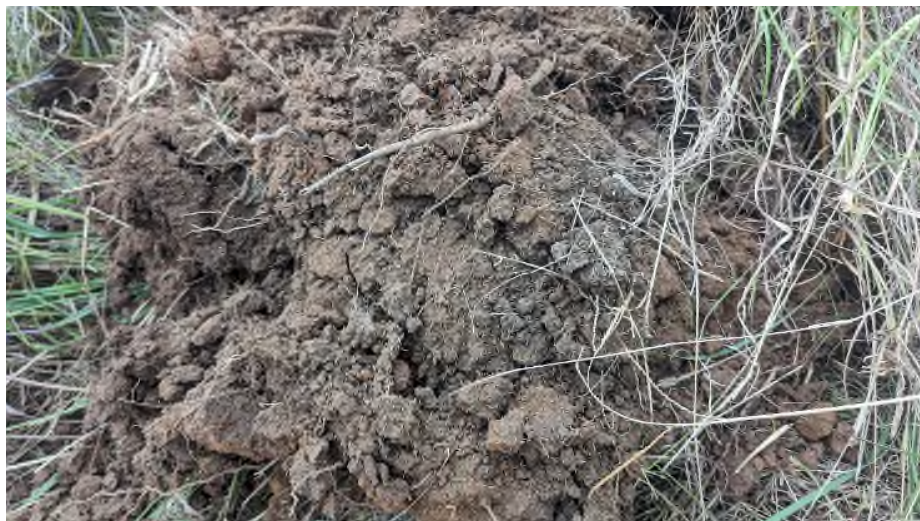
Photo 10 - View of inferred colluvial spoil from Test Pit 305

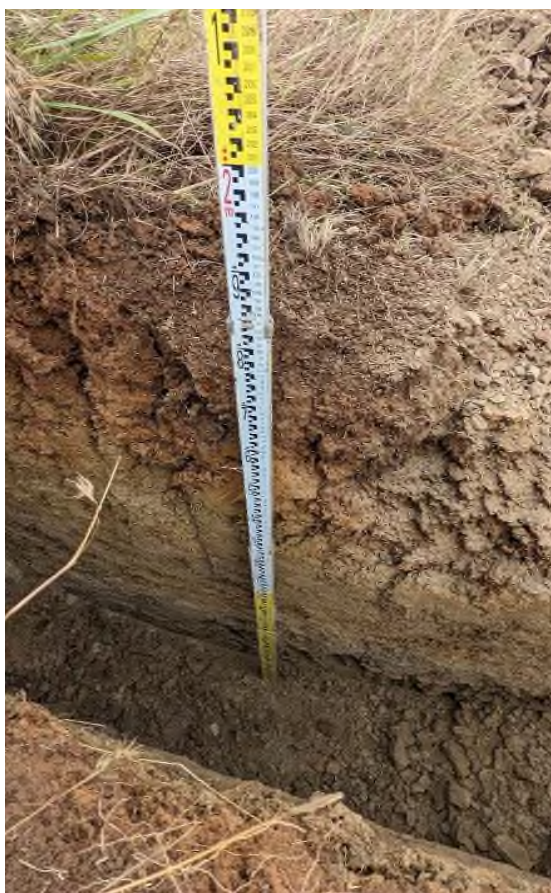
Photo 11 - View of side of Test Pit 306
