Report on  
Stability Assessment

Proposed Residential Subdivision  
South Creek West, Precinct 5, Cobbitty

Project 92225.06  
March 2023

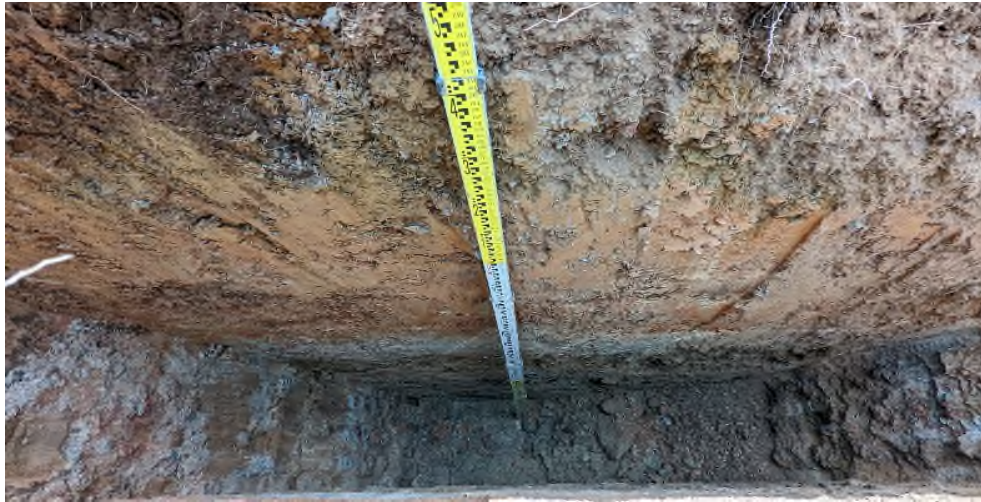
Photo 12 - View of side of Test Pit 307

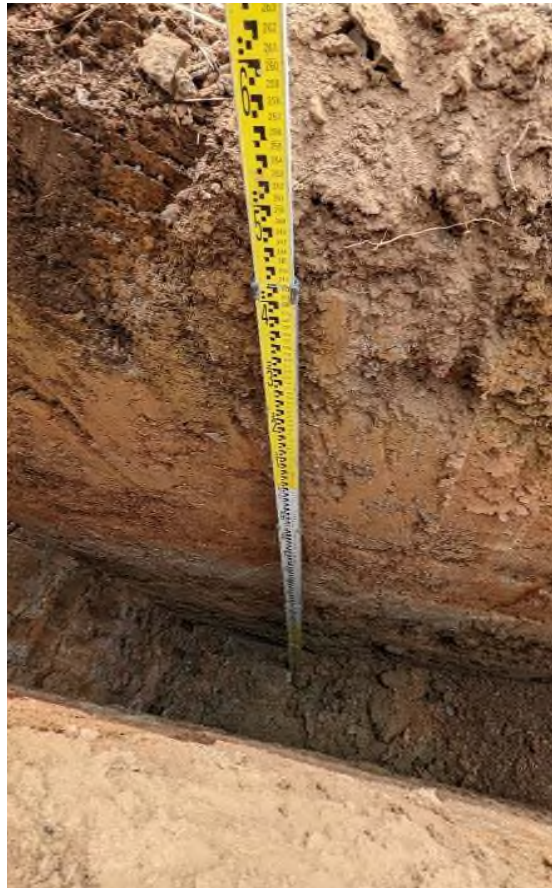
Photo 13 - View of side of Test Pit 307

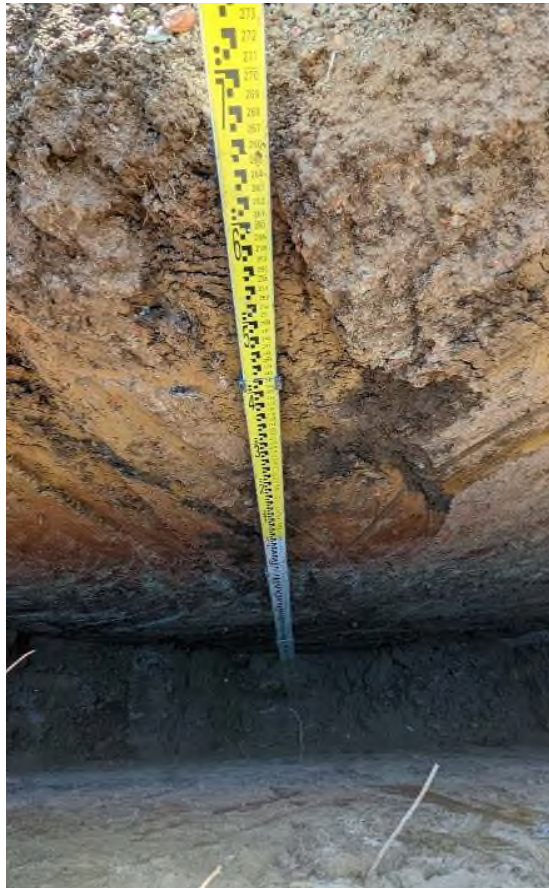
Photo 15 - View of side of Test Pit 308

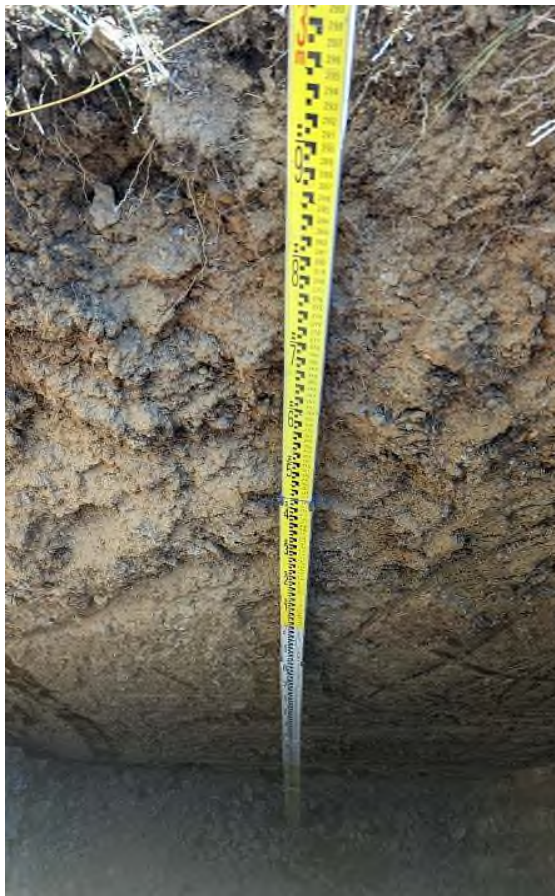
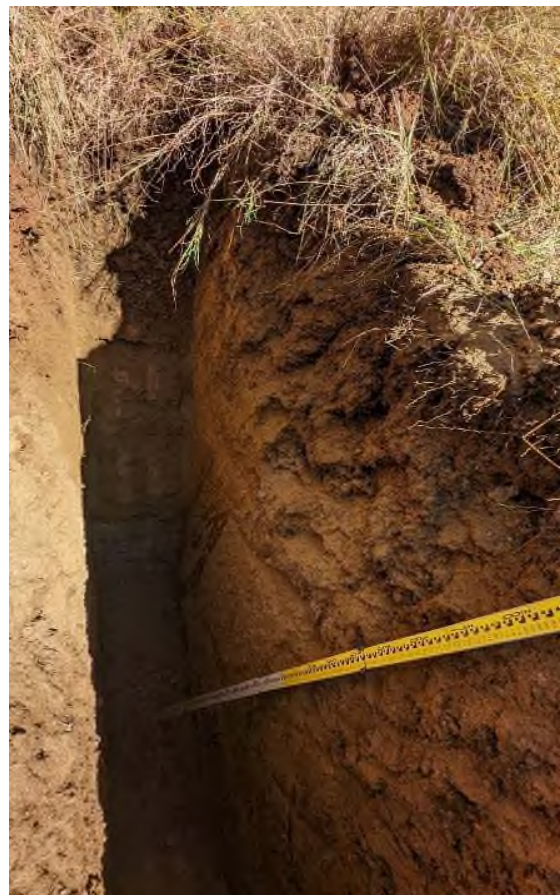
Photographs 16 and 17 - View of side and end of Test Pit 309

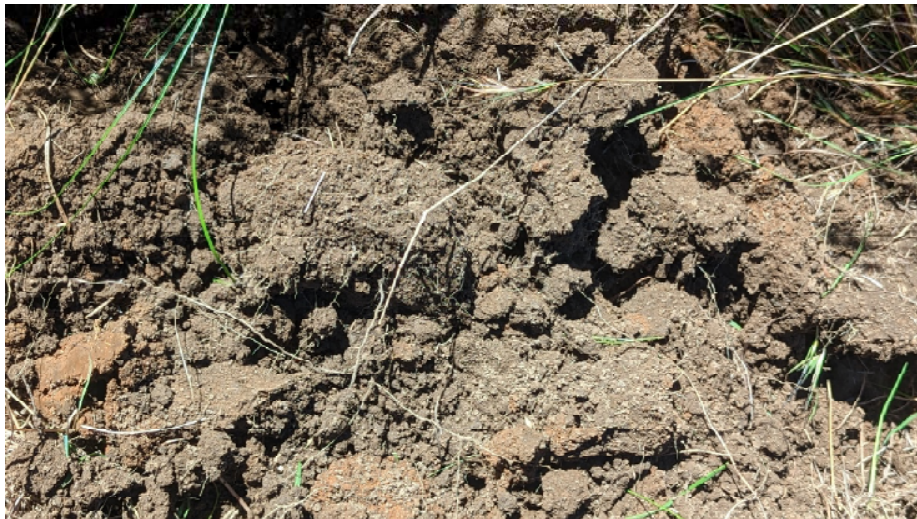
Photo 18 - inferred colluvial spoil from Test Pit 309

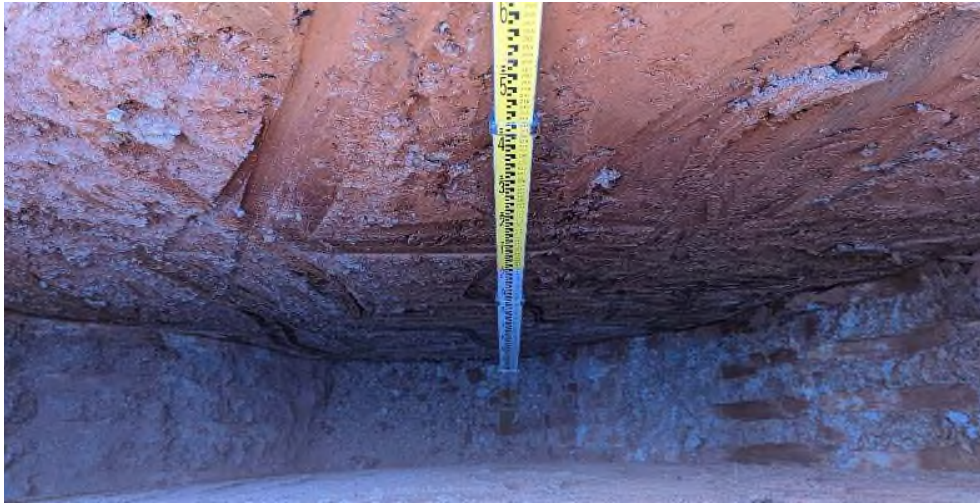
Photo 19 - View of side of Test Pit 310

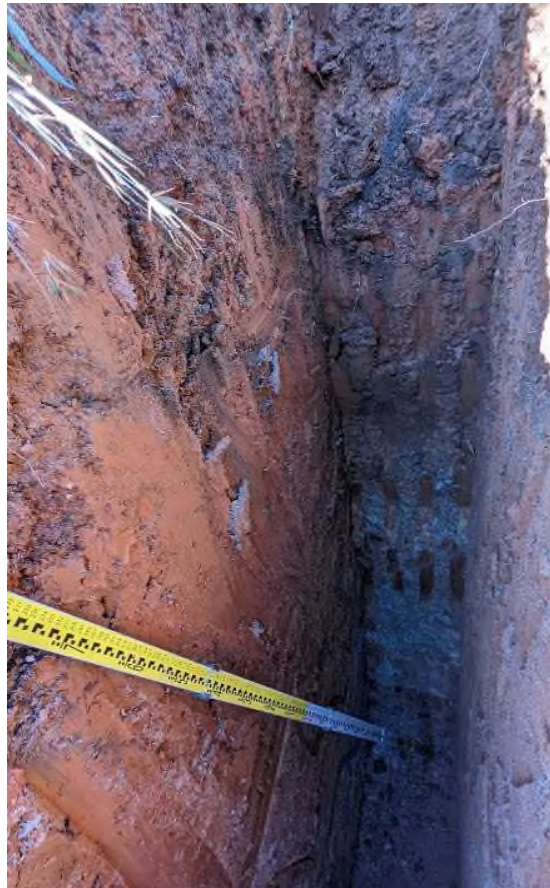
Photo 20 - View of side and end of Test Pit 310

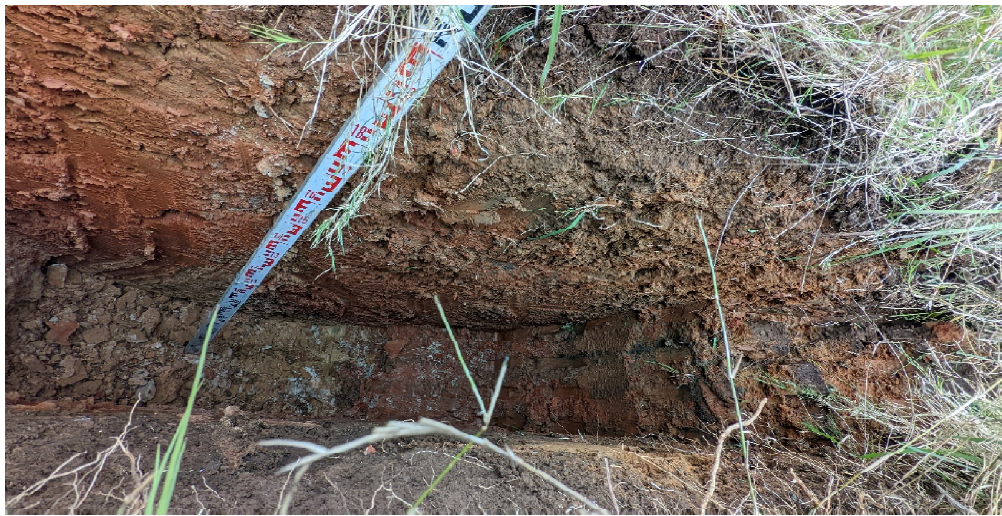
Photo 21 - View of side and end of Test Pit 311

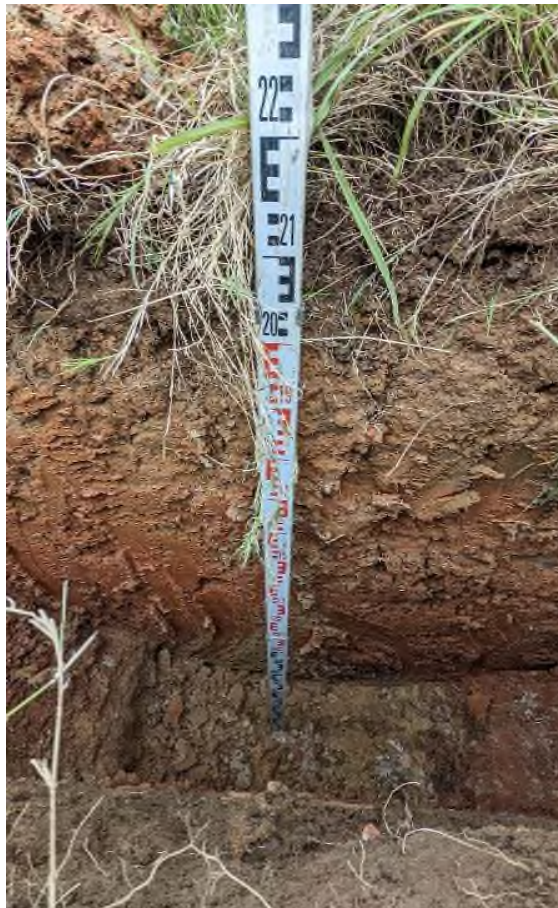
Photo 22 - View of side of Test Pit 311

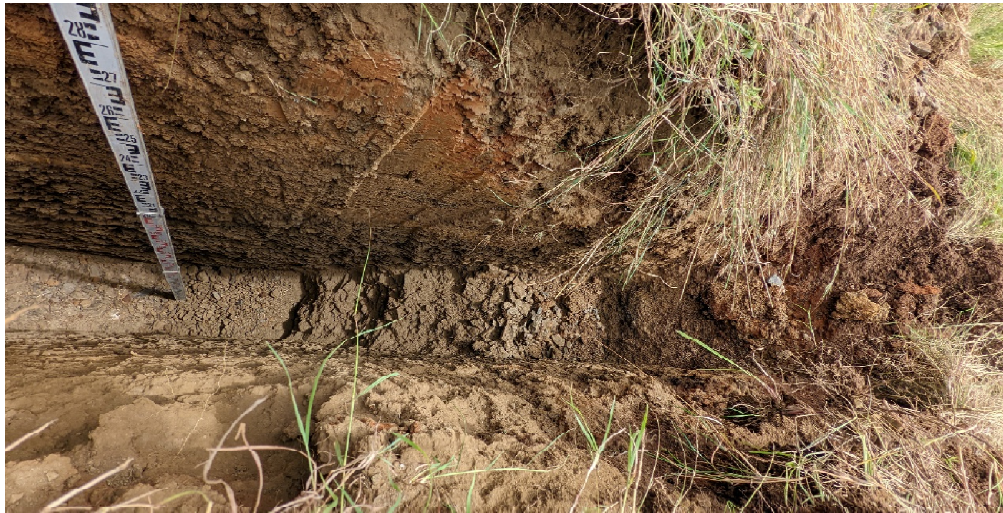
Photo 23 - View of side and end of Test Pit 312

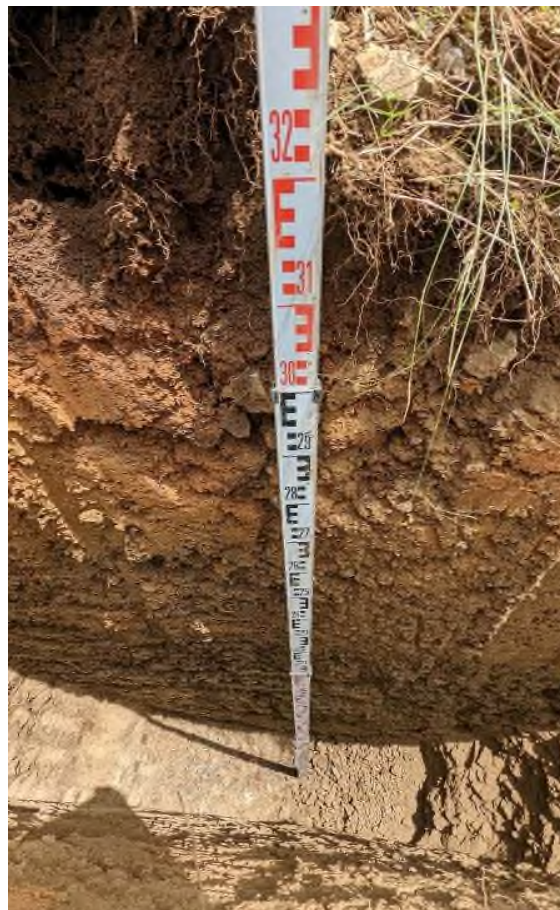
Photo 24 - View of side of Test Pit 312

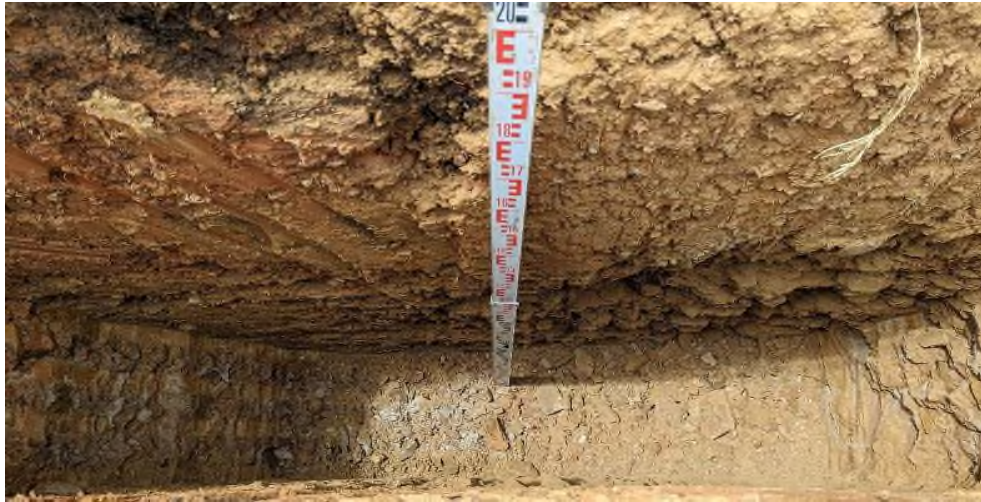
Photo 25 - View of side of Test Pit 313

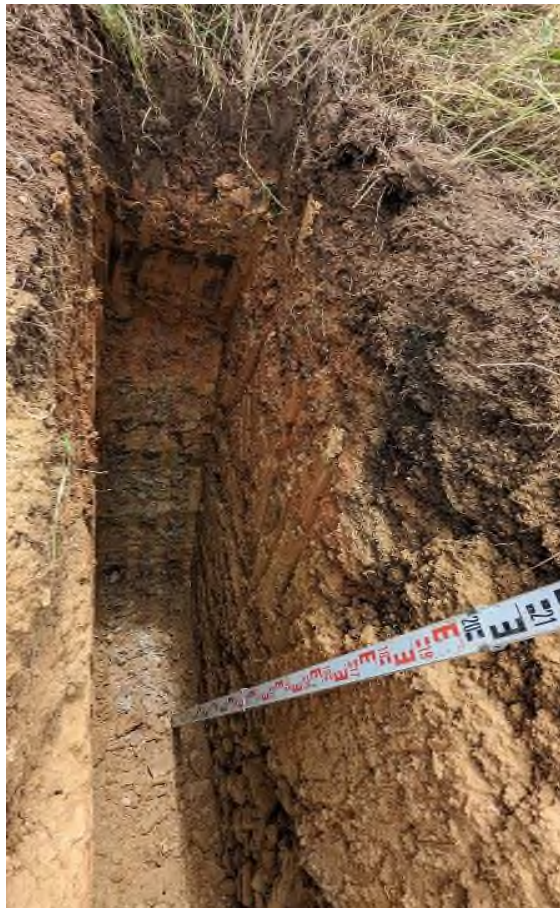
Photo 26 - View of side and end of Test Pit 313

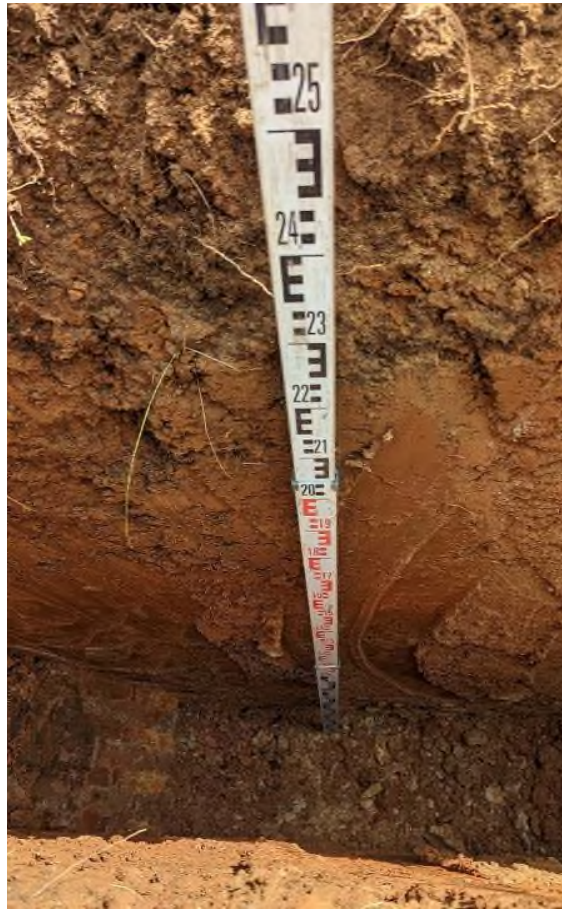
Photo 27 - View of side of Test Pit 314

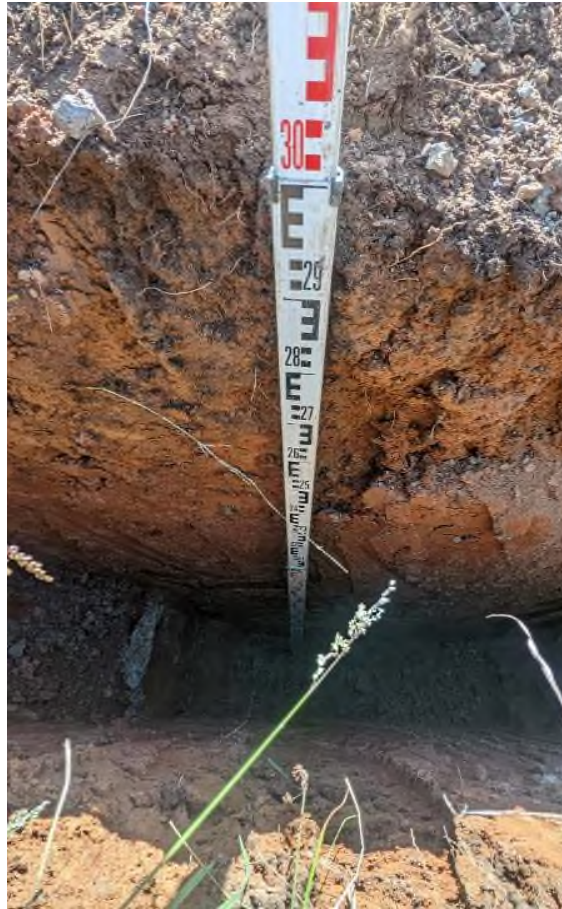
Photo 28 - View of side of Test Pit 315

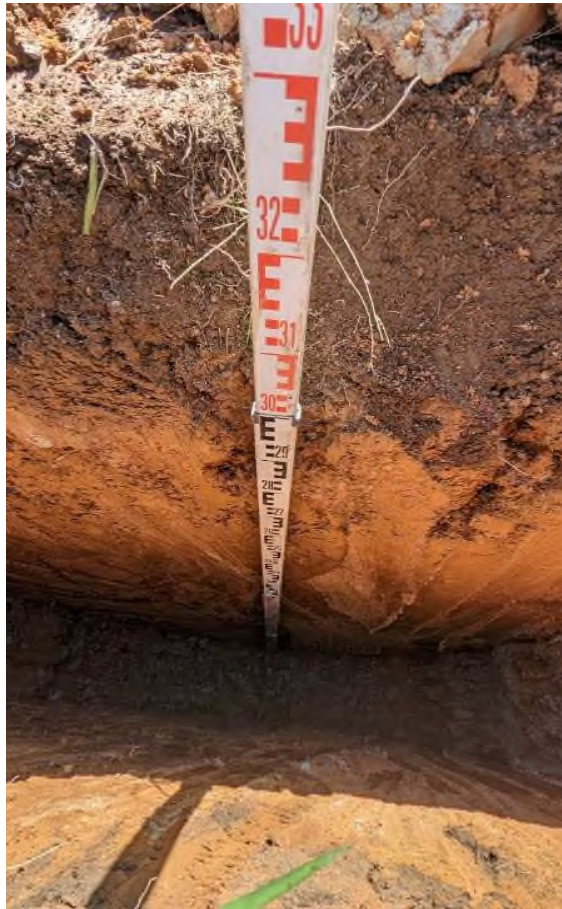
Photo 29 - View of side of Test Pit 316

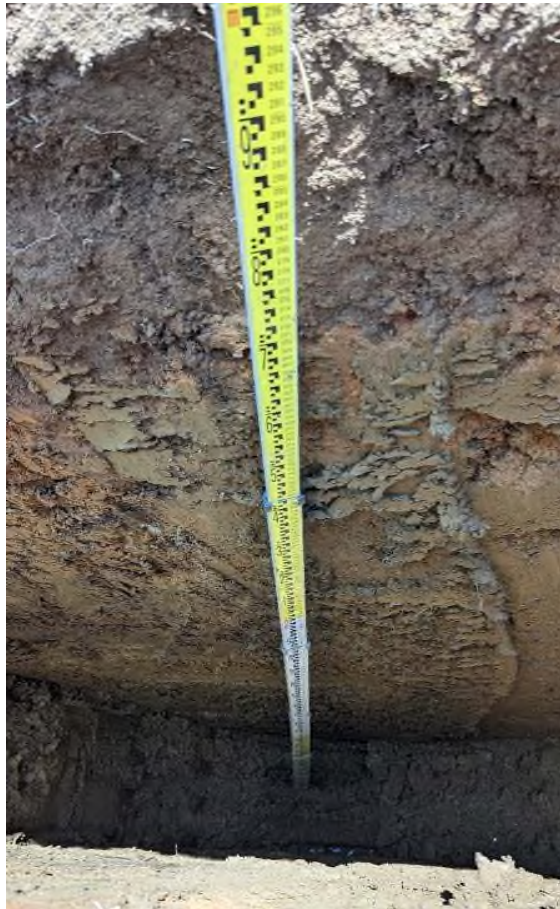
Photo 30 - View of side of Test Pit 317

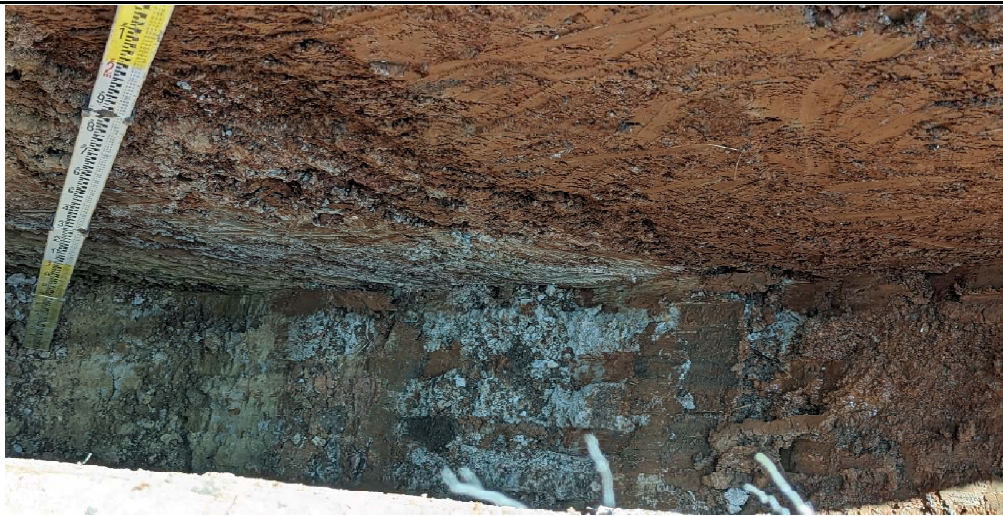
Photo 31 - View of side and end of Test Pit 318 (oblique view)

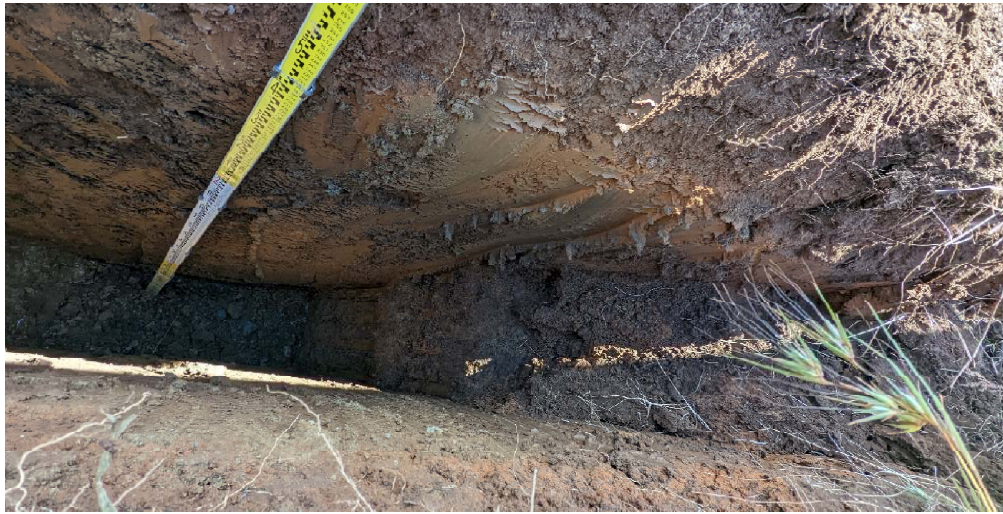
Photo 33 - View of side and end of Test Pit 319 (oblique view)

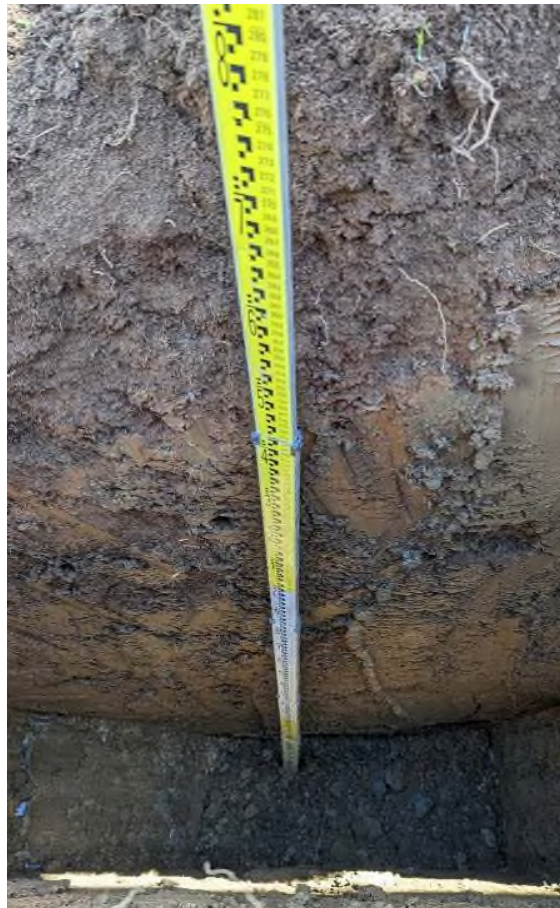
Photo 34 - View of side of Test Pit 319
