Slope Risk Assessment Report

Patyegarang Project

Reference No. 30012988
Prepared for Metropolitan Local Aboriginal Land Council
14 July 2023

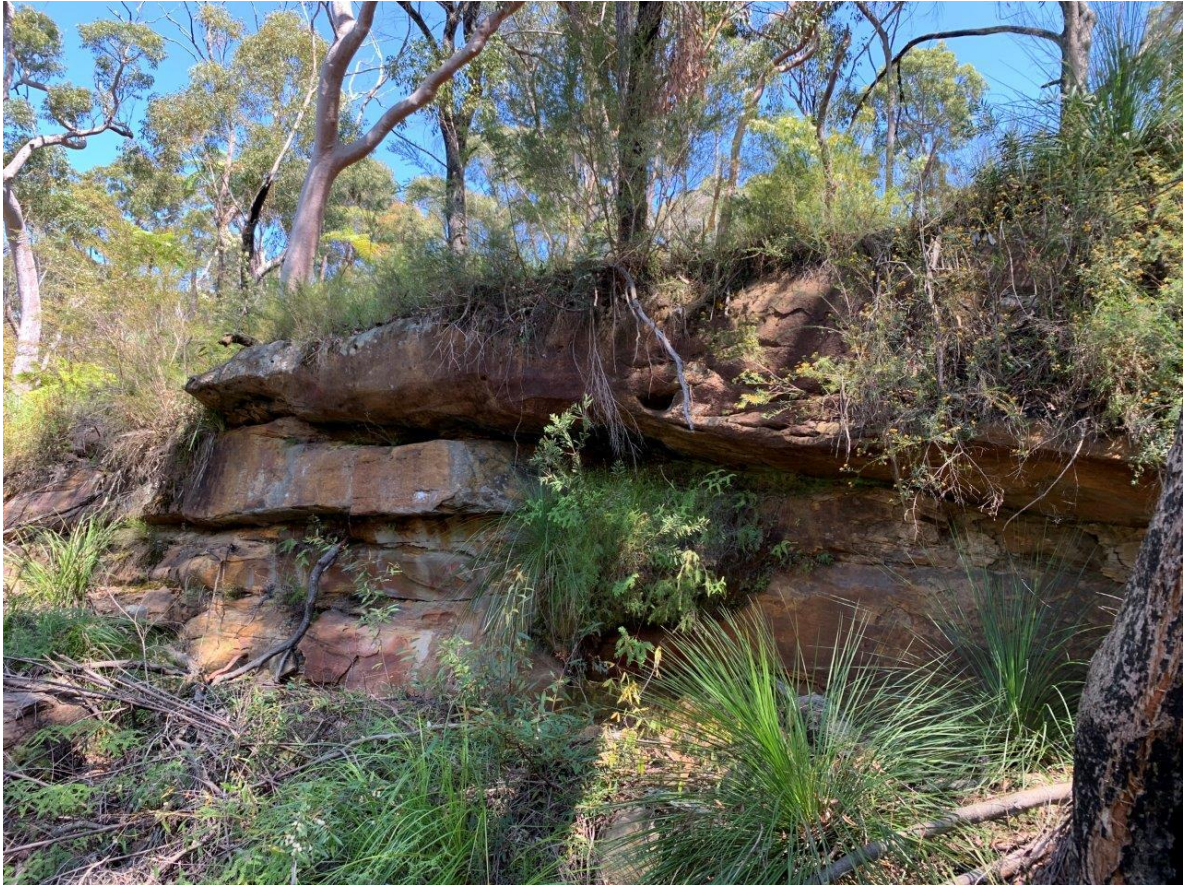
Photograph 7: View of overhangs a lot sandstone precipice (height approximately 3-4m)

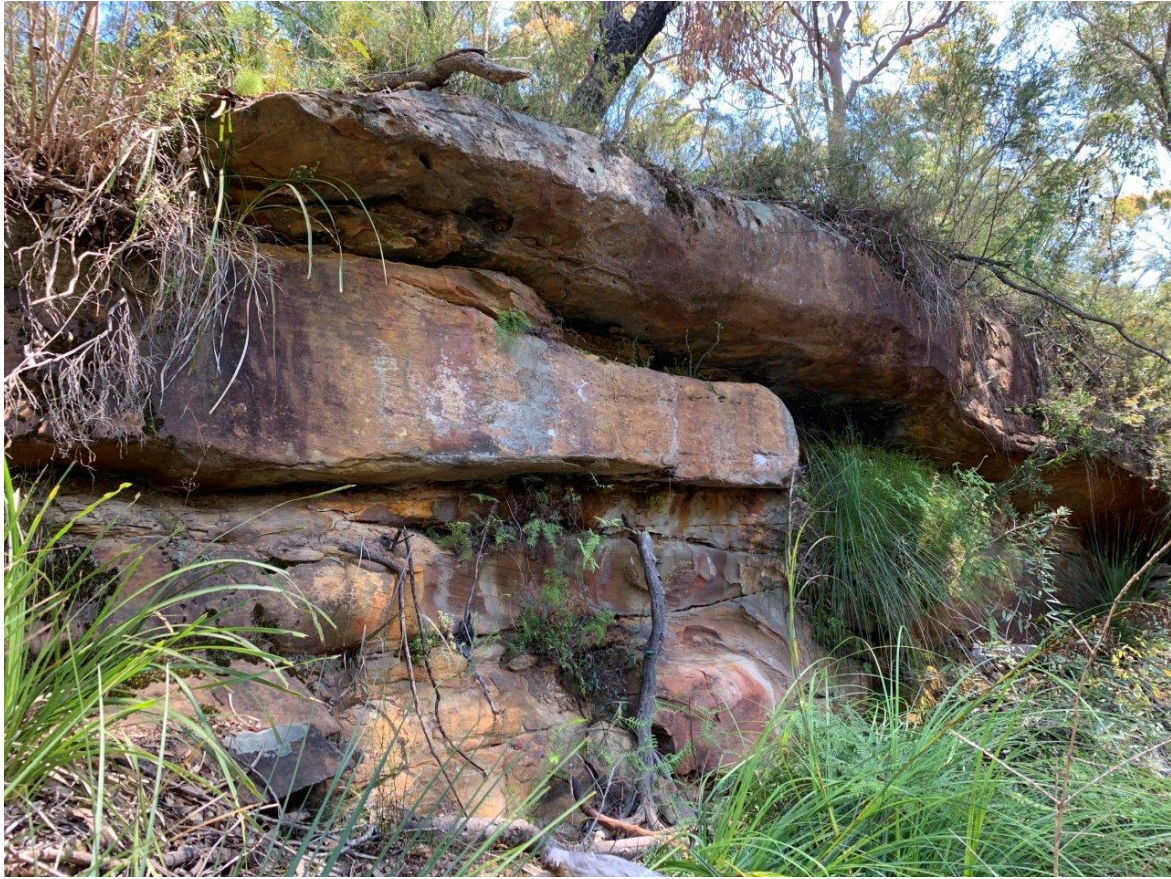
Photograph 9: View of overhangs up to 1m

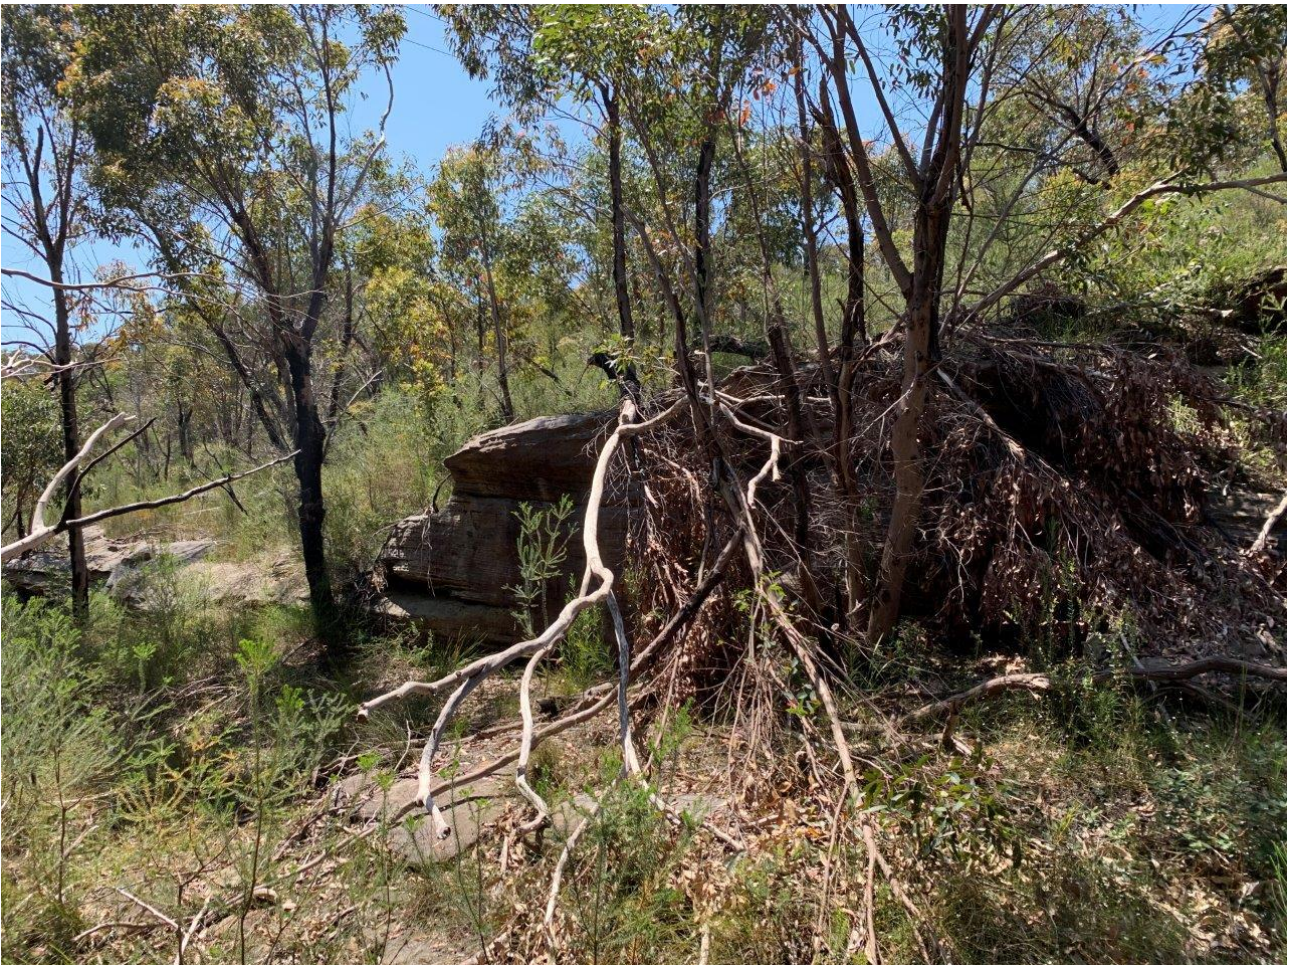
Photograph 12: View looking north, sandstone precipice up to 2m height

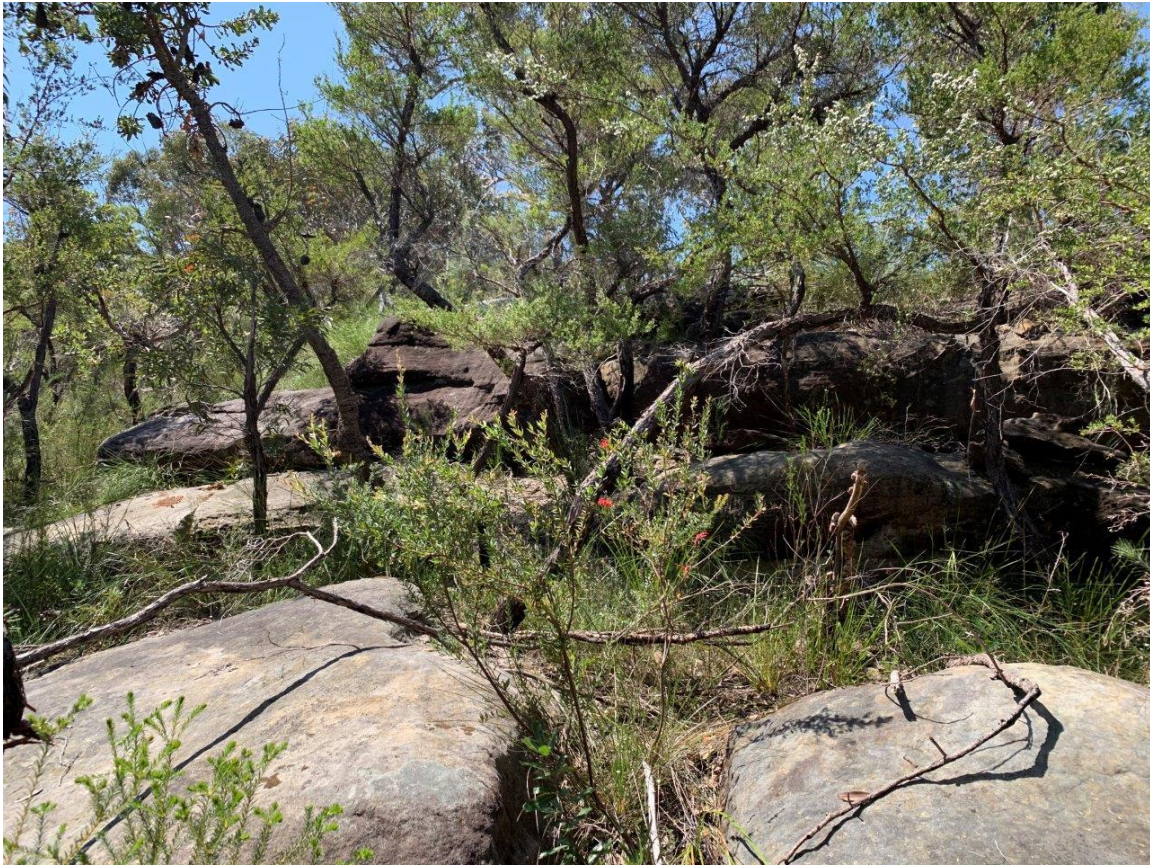
Photograph 1: View looking east at sandstone precipices up to 2m height

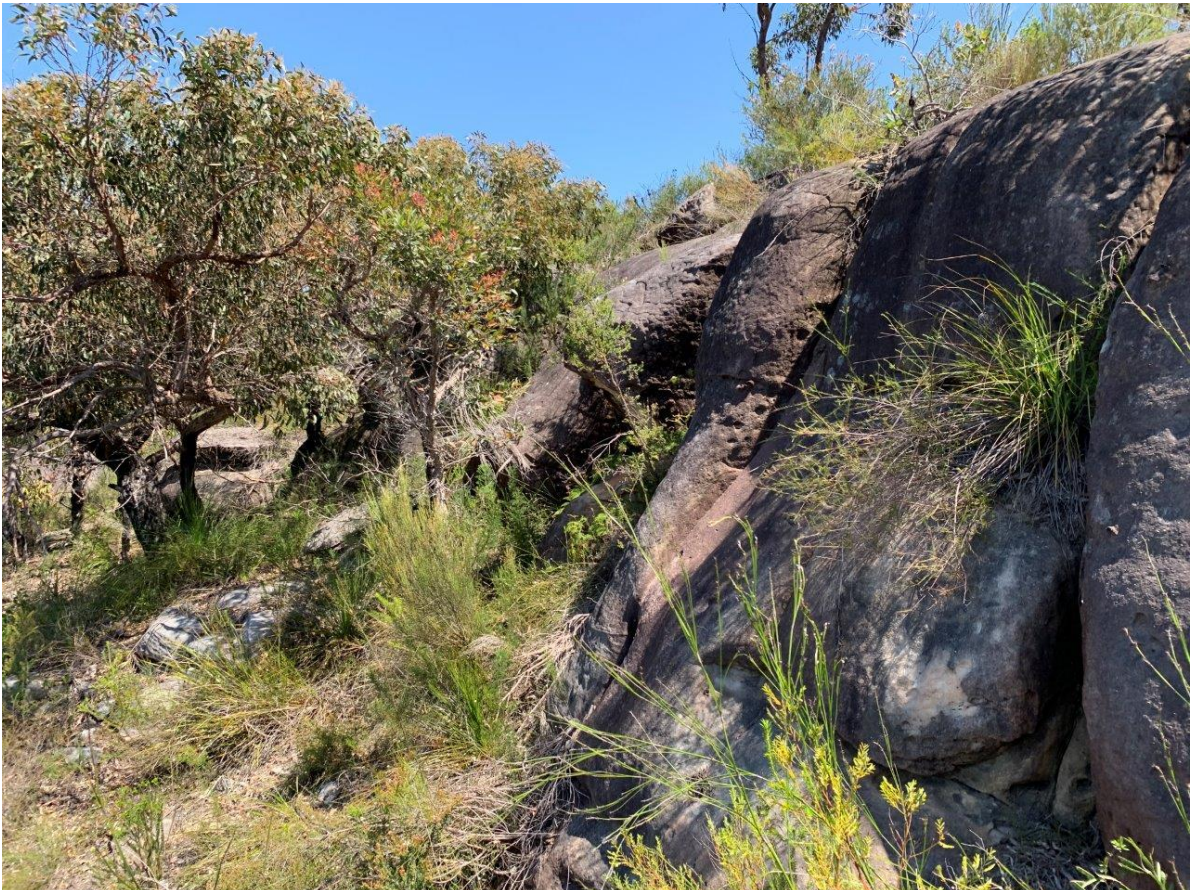
Photograph 6: View looking south along sandstone precipice up to 2.5m height

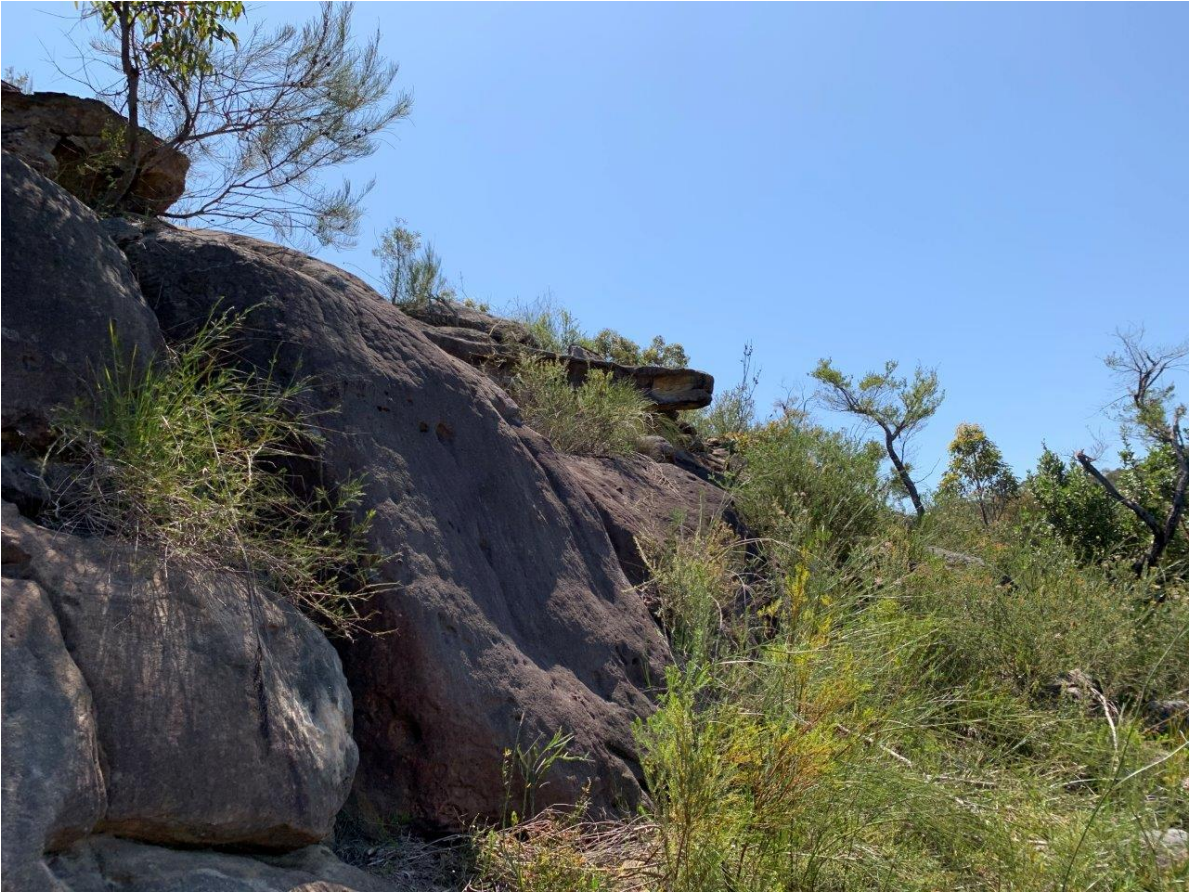
Photograph 7: View looking north along sandstone precipice up to 2.5m height

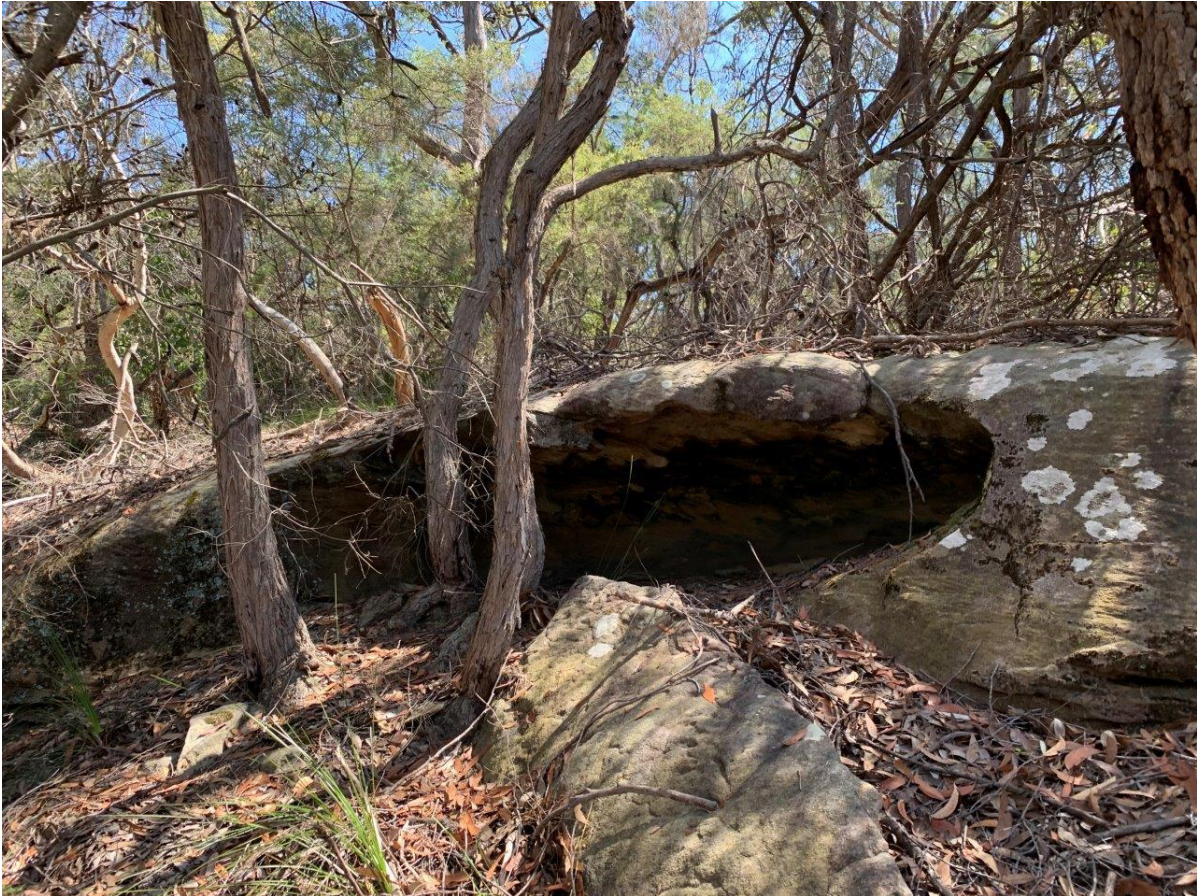
Photograph 3: View looking south, overhangs up to 1m

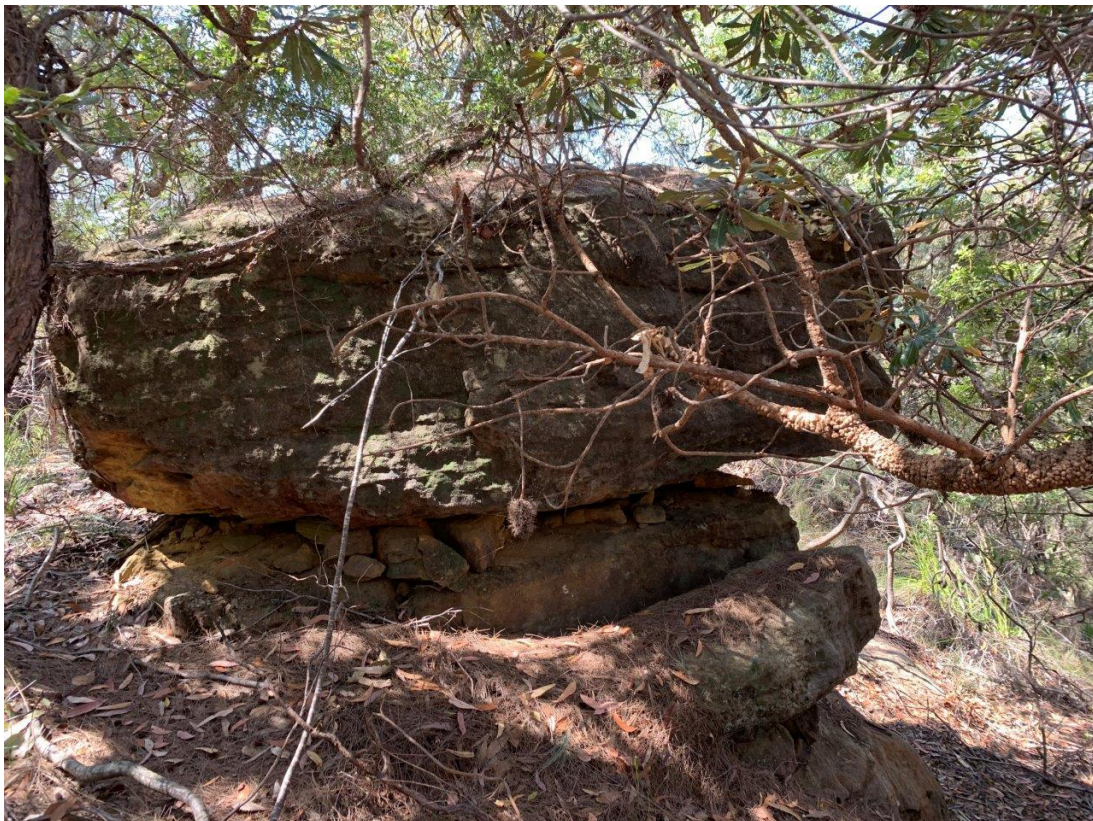
Photograph 6: Large loose sandstone bed (~2m x 4.5m), overhanging up to 1.5m

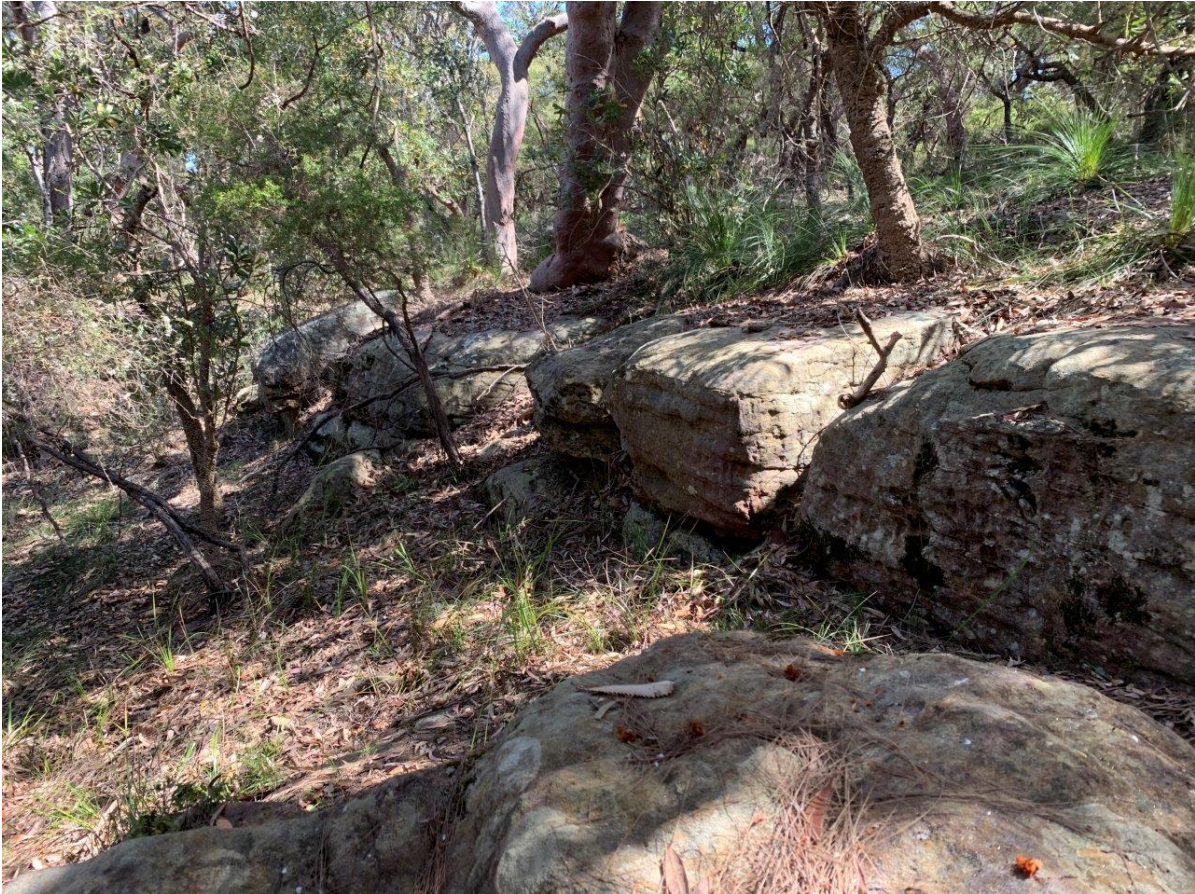
Photograph 7: View looking south along sandstone precipice up to 1.5m height
